## Mis-Build Investigation Notice

**MIN #:** 12124

**Subject:** Gear Train Inspection for Certain Vehicles with MaxxForce® 15 Engines

**BUILD DATES:** 7 December 2011 to 2 April 2012

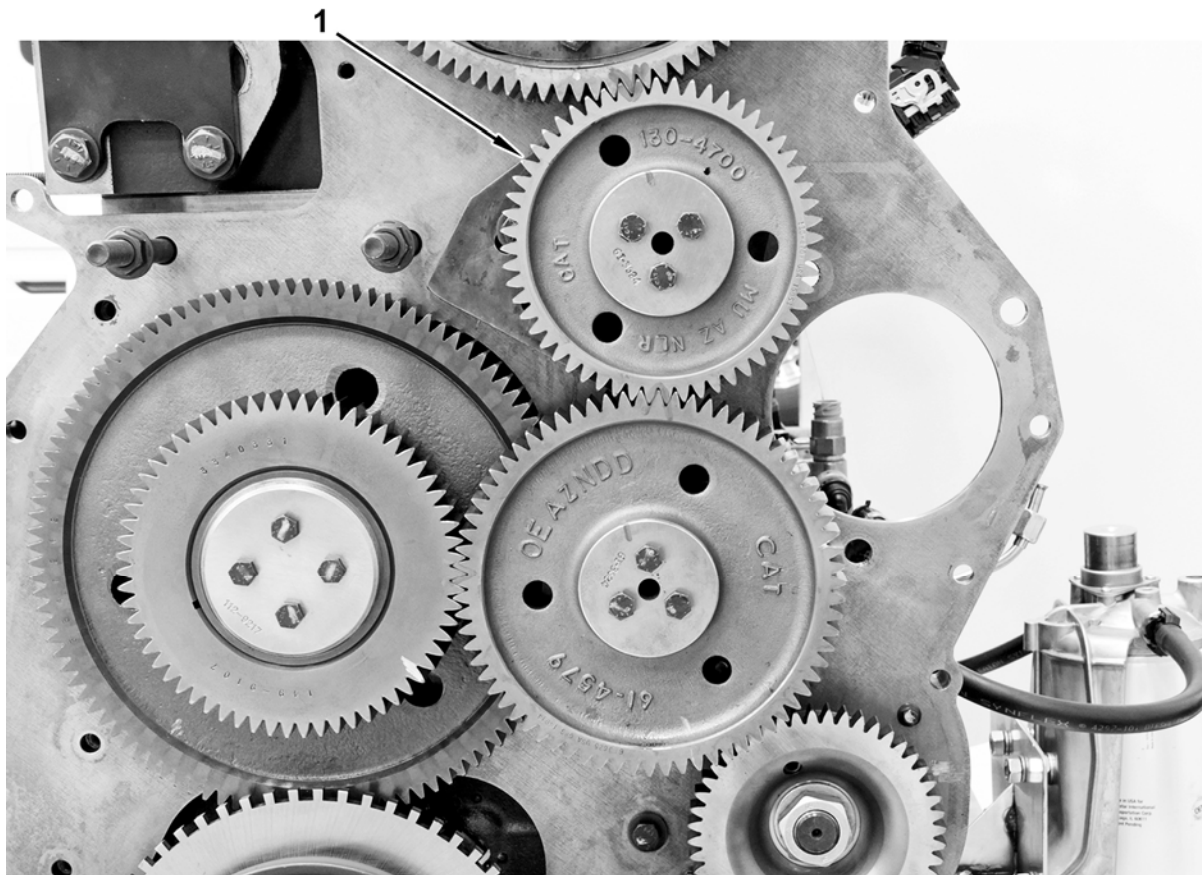
**Figure 4** Adjustable Idler Gear

1. Adjustable idler gear

11. Remove adjustable idler gear (Figure 4, Item 1).

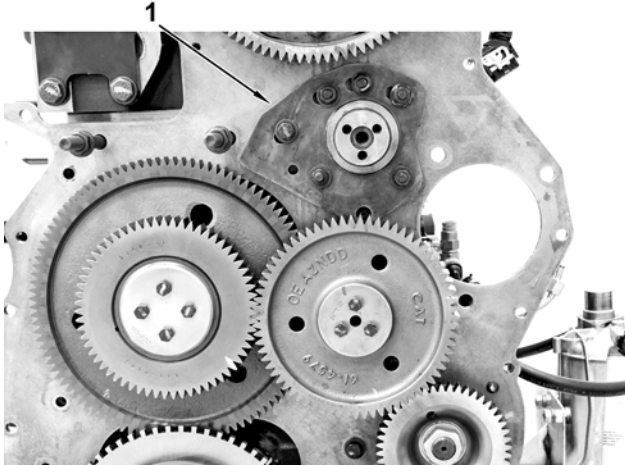
**Figure 5** Adjustable Idler Gear Support

1. Adjustable idler gear support

12. Remove adjustable idler support (Figure 5, Item 1).

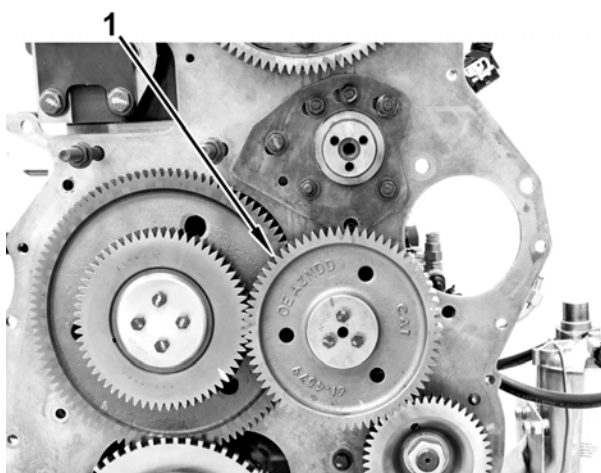
**Figure 9** Fixed Idler Gear

1. Fixed idler gear

15. Remove fixed idler gear and fixed idler support (Figure 9, Item 1 and Figure 10, Item 1).
