SERVICE PROCEDURE

**G-12524
OCTOBER 2012**

SUBJECT: SAFETY RECALL
Piston spring brakes on certain DuraStar®, ProStar®, TranStar®, and WorkStar® models built 29 November, 2010 thru 2 April, 2012 with feature code 04EVP.

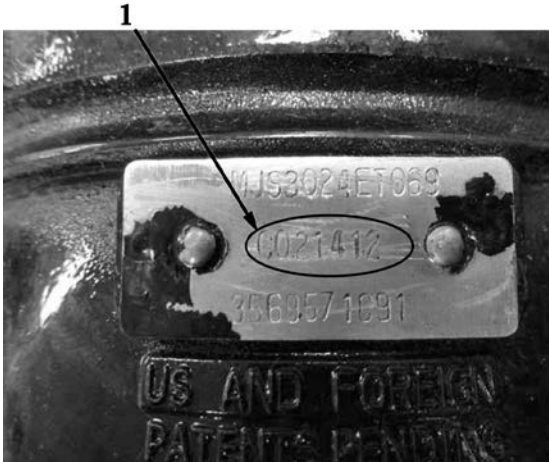
Figure 1. Spring Brake Label

1. Spring brake build date code

5. Inspect the build date code on both spring brake chambers (Figure 1). If the date codes on the spring brake chambers are 11/03/2010 through 04/01/2012, proceed with Step 6 for each chamber to be replaced. If the date codes on the spring brake chambers fall outside these dates, no further action is required. Proceed to Step 26.

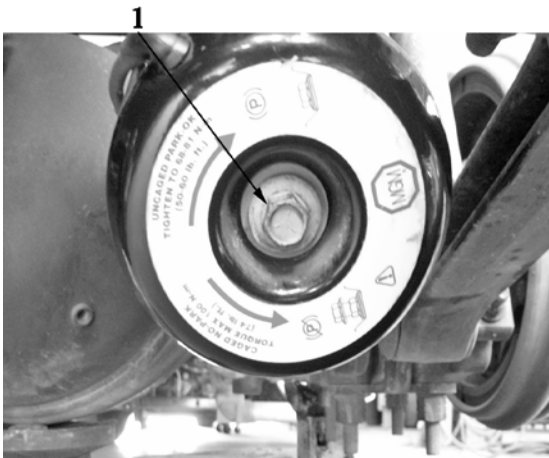
Figure 2. Spring Brake Chamber

1. Integral release bolt

6. Locate integral release bolt on back of spring brake chamber (Figure 2).

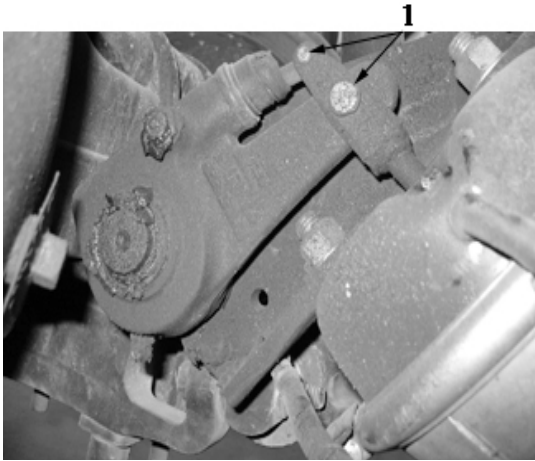
Figure 5. Slack Adjuster

1. Slack adjuster clevis pins (2)

10. Remove cotter pins from clevis pins. Remove clevis pins from yoke. Discard cotter pins and retain clevis pins for reuse.
11. Adjust slack adjuster nut until slack adjuster is free from spring brake chamber welded yoke.

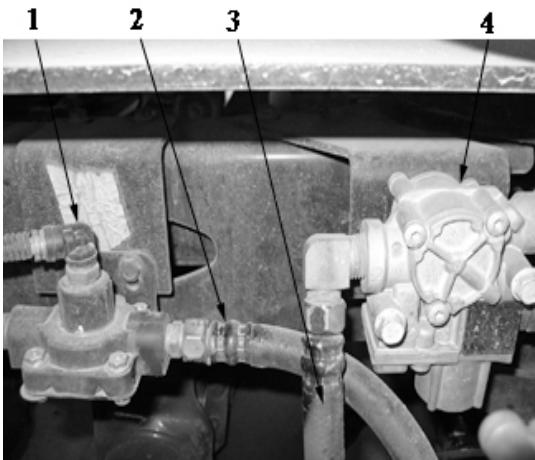
Figure 6. Brake System Valves

1. Quick release valve
2. Spring brake hose
3. Service brake hose
4. ABS modulator valve

12. Disconnect spring brake chamber hose from quick release valve (Figure 6, Items 1 and 2).
13. Disconnect spring brake chamber hose from ABS modulator valve (Figure 6, Items 3 and 4).
14. Remove two spring brake chamber mounting hex nuts from spring brake assembly and remove spring brake chamber assembly from chassis. Discard hex nuts.

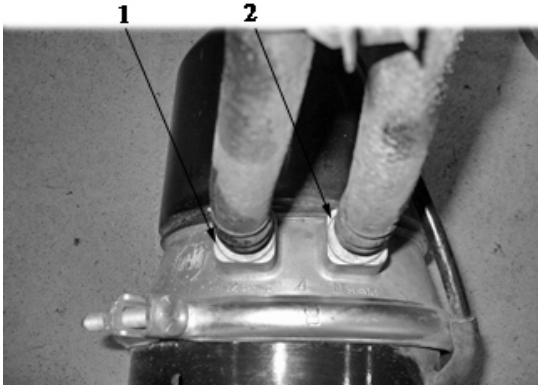
Figure 7. Spring Brake Chamber

1. Spring brake air inlet port
2. Service brake air inlet port

15. Remove spring brake chamber hose and service brake hose from spring brake chamber (Figure 7).
16. Apply thread sealant to brake hose threads before installation.
install spring brake chamber hose and service brake hose onto new spring brake chamber assembly.
