Local Campaign Request Form

<i>Title</i>	<input type="text" value="Replace Drive axle radius rod bushings and caps to improve reliability"/>		
<i>Customer (s) involved</i>	<input type="text" value="NYCT Only"/>		
<i>Comments</i>	<input type="text" value="Premature failure of drive axle radius rod bushings, cap was redesign to improve reliability of this installation and extend the bushing life"/>		
<i>Ref to procedure</i>	<input type="text" value="Procedure to come from maintenance manual Service will take care of it."/>		
	<input type="text" value="Pièce jointe"/>	<input type="text" value="Pièce jointe"/>	<input type="text" value="Pièce jointe"/>
<i>Time Allocated (hr)</i>	<input type="text" value="3hrs per coach"/>		
<i>Parts involved</i>	<input type="text" value="110807 (6) new plate, 5001896 (12) new bolt, 110788 (6) locking tab, 630021 (6) bushings"/>		
<i>Causal p/n</i>	<input type="text" value="110681 current bushing cap"/>

DRIVE AXLE RADIUS ROD BUSHING REPLACEMENT CAMPAIGN # 63

DRIVE AXLE RADIUS ROD BUSHING REPLACEMENT

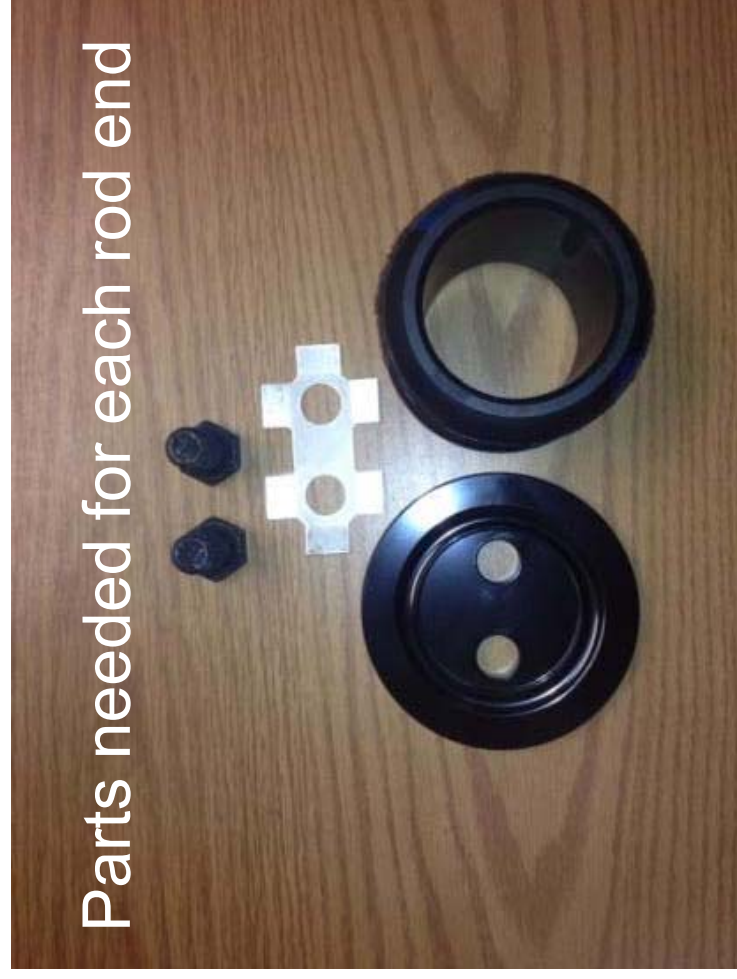
Parts needed:

(6) 110807 plate

(6) 110788 tab

(6) 630021 bushing

(12) 5001896 M16-2.0 X 35

G500 10.9 bolt

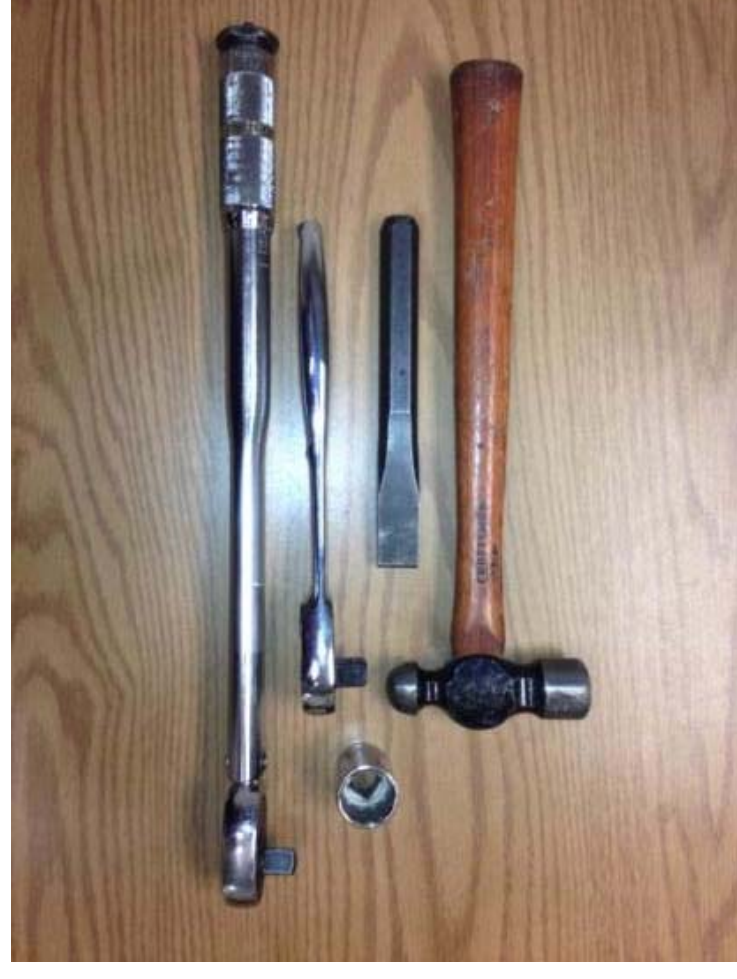
Tools needed:

1/2 dr Ratchet

24mm socket

Ball peen hammer

Cold chisel

Torque wrench

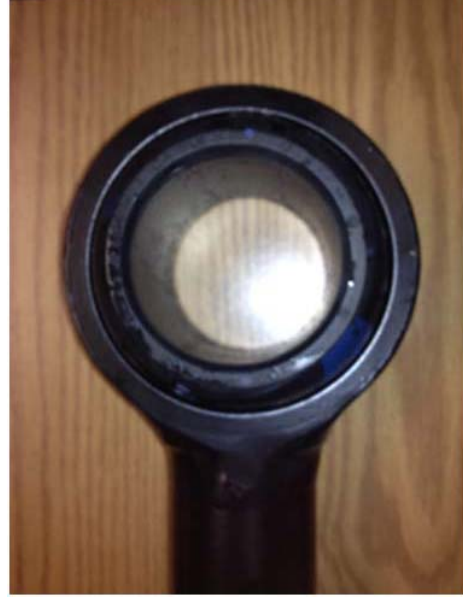
Bushing installation

1. Lightly spray the inner and outer surfaces of radius rod bushing with water.

No assembly lubricant whatsoever is to be used on the rubber bushing other than water.

Place radius rod bushing on a flat surface. Spray a light coat of water on the inner and outer surfaces of radius rod bushing. Take the radius rod, align the bushing. Tap the rod onto the bushing or using a block of wood tap the bushing into the rod until the bushing is positioned correctly.

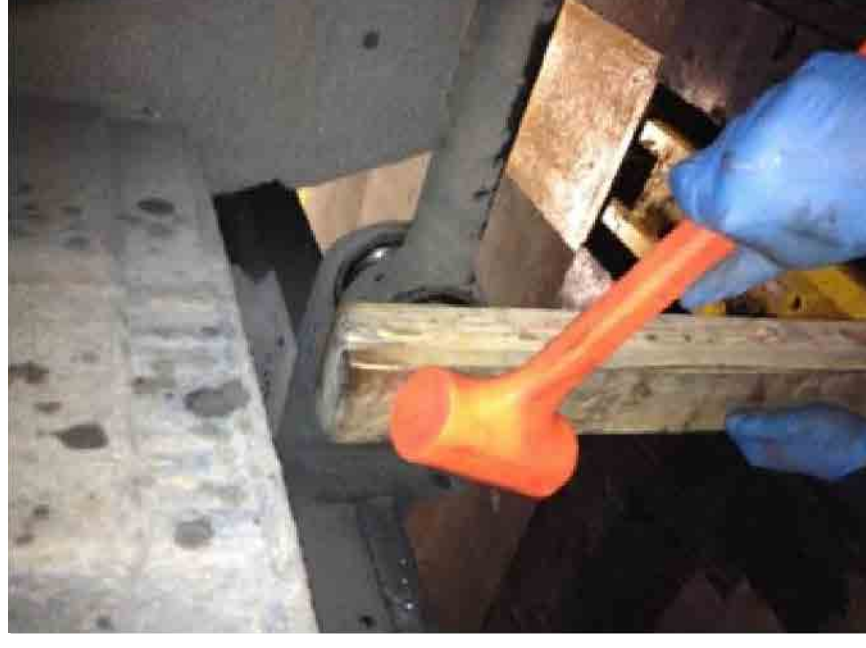
Radius Rod Installation

Lightly spray the radius rod support with water. Place the radius rod end over the radius rod support. Alternating from one end of the rod to the other use a block of wood to drive the rod and bushing fully onto the pins.

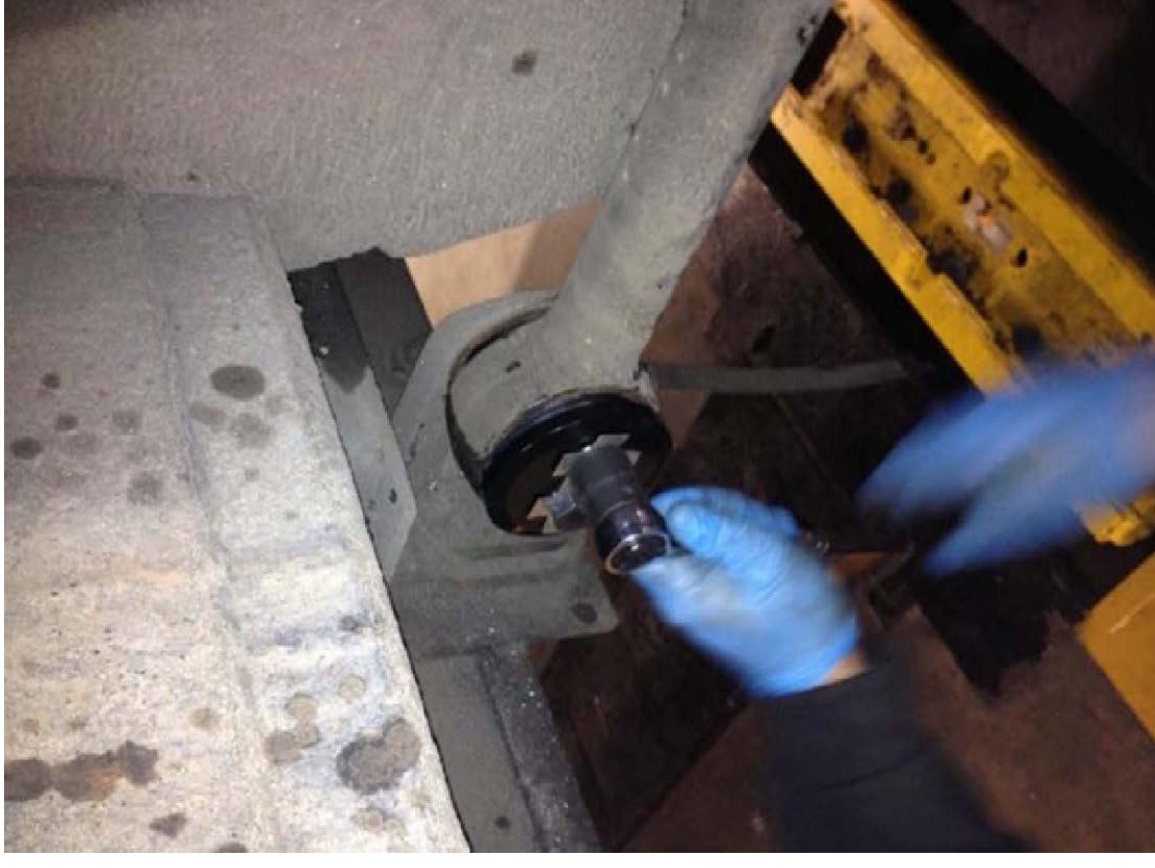
Position the retaining plate, add blue loctite to the length of the bolt threads and install the lock tabs and bolts. Using a ratchet tighten the bolts alternately and equally, and repeat until both bolts are tight.

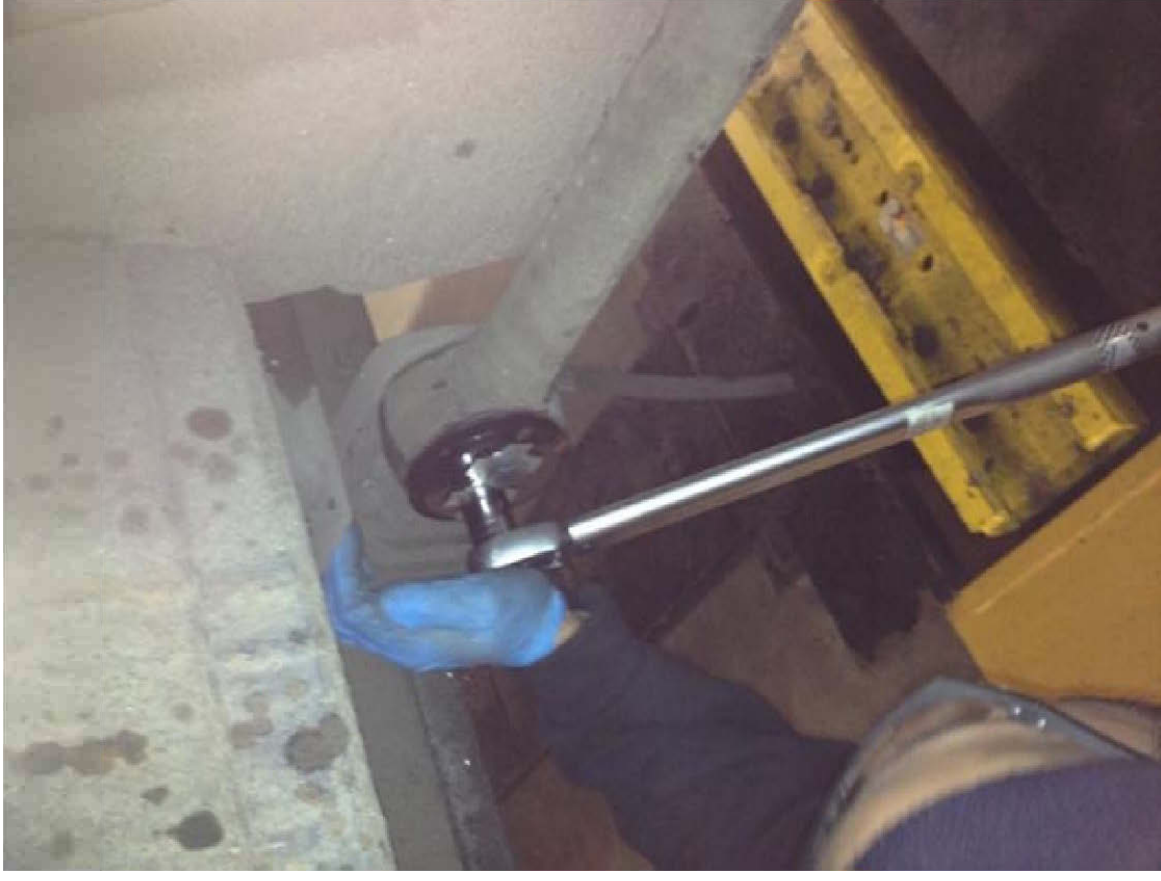
Using a suitable torque wrench, tighten the bolts alternately and equally, and repeat until both bolts are tightened to 130 lb ft. Confirm torque using an alternating sequence at least 3 times or until no rotation of the bolt is present.

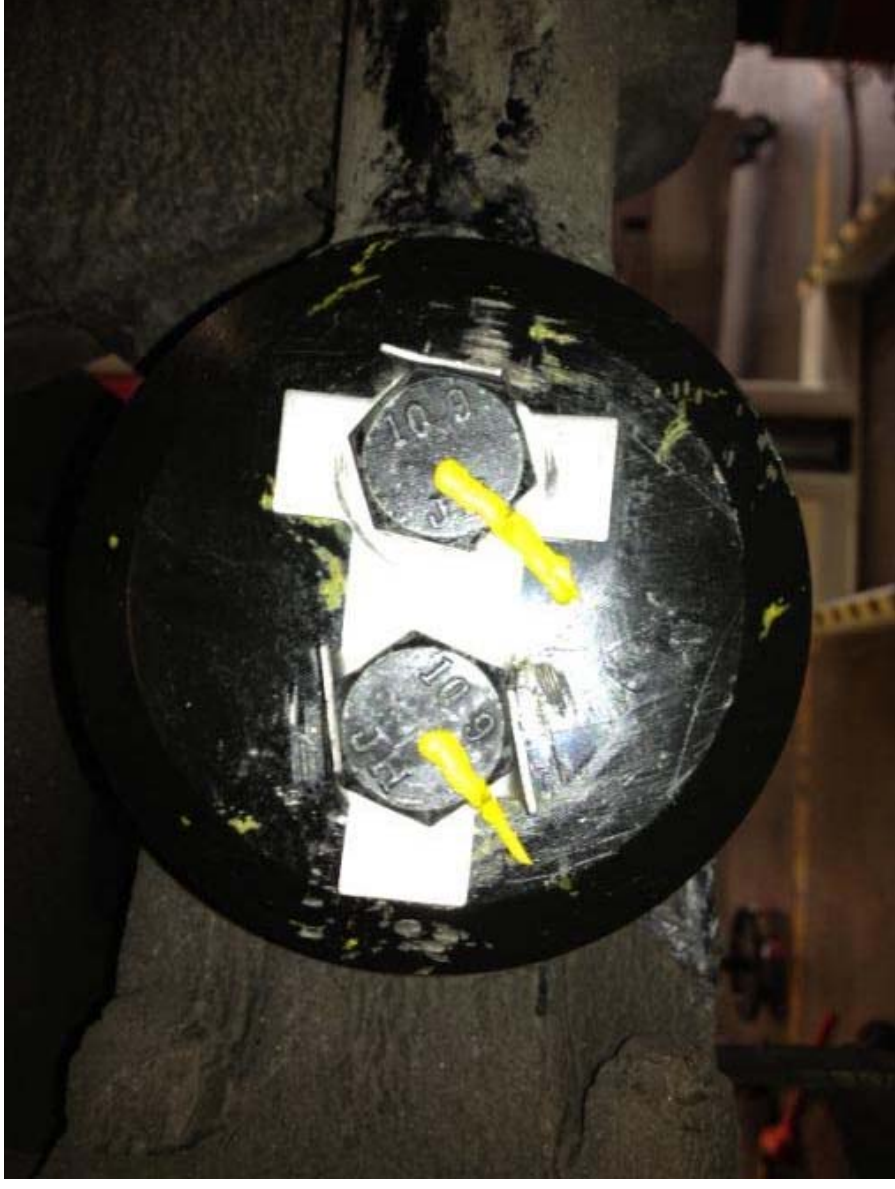
Once the proper torque has been obtained, bend the lock tabs tightly against the flat of the bolt head, be sure that the tab is firmly seated against the flat of the bolt head. If necessary, bend two tabs against the bolt head to achieve sufficient contact area.
