TITLE: ADDITION OF A POWER RELAY TO THE INVERTER SYSTEM WIRING  
Prevost vehicles

On the vehicles affected by this bulletin, addition of a power relay to the inverter system wiring is required.

| NOTICE TO SERVICE CENTERS | |
|---|---|
| X3-45 Commuter<br>Model Year : 2012 | 2PCG33495CC735053 up to, including<br>2PCG33495CC735232 |

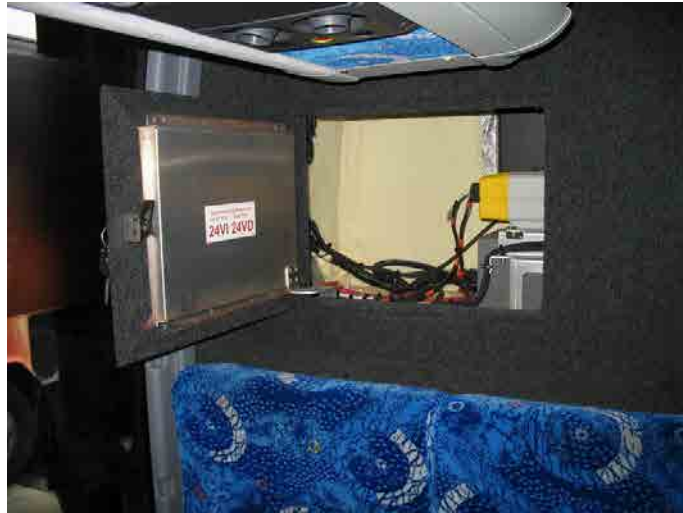
1. Disconnect batteries.
2. Open the access door located in the vehicle on the back wall.

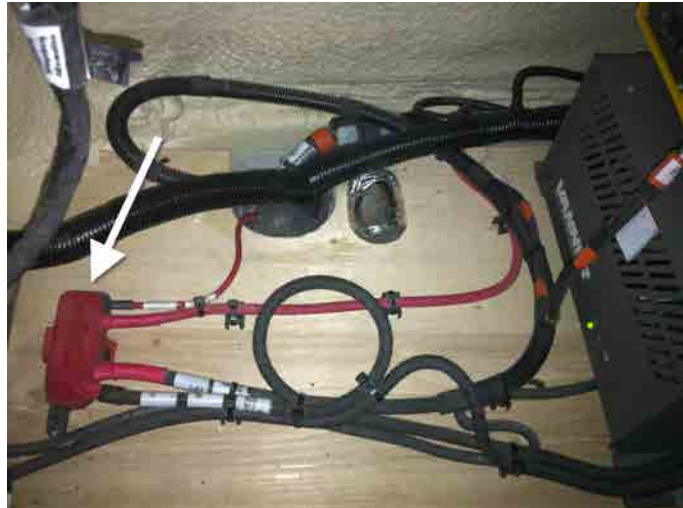
3. Verify there is no power on the 24VD post.

Lift the rubber boot and test with an appropriate tool.

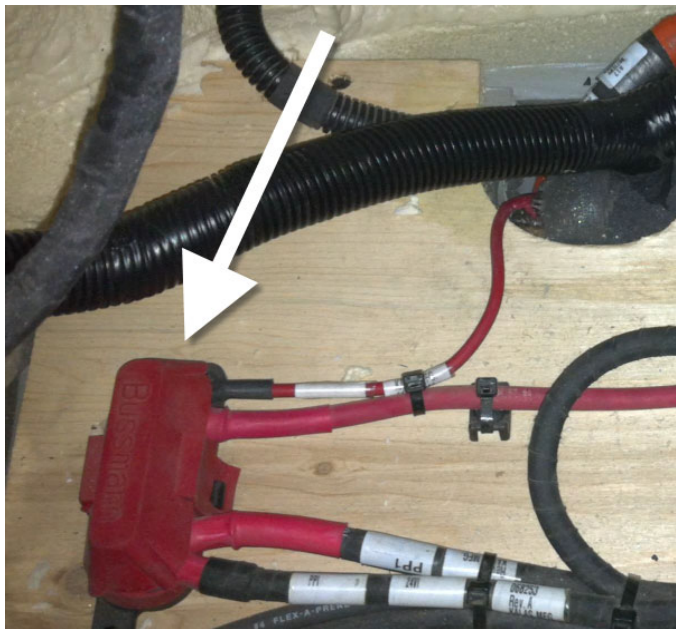
4. Remove the two 24VD wires connected to this post.

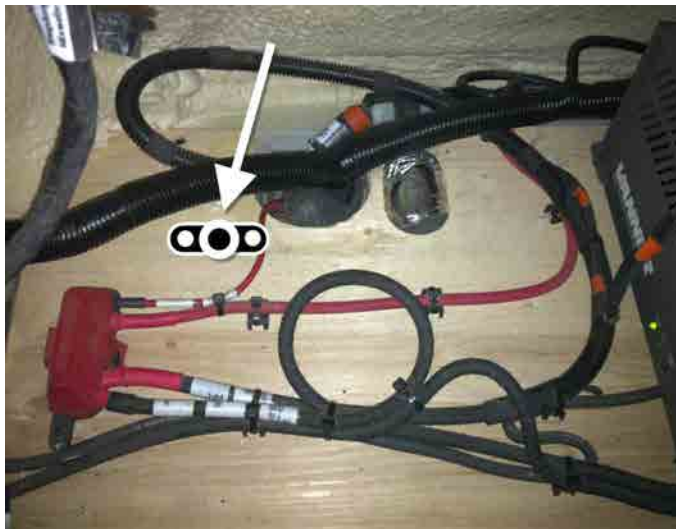
5. Install single junction block #560422. In this location.  
Use tapping screws #500957.

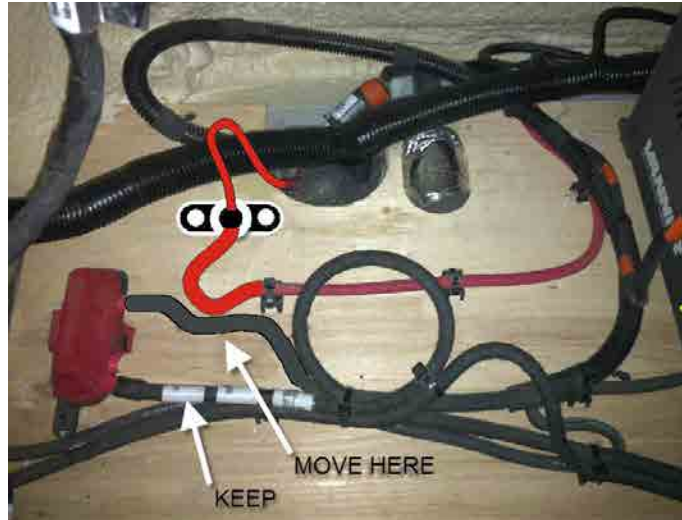
6. Connect the previously removed 24VD wires to the new post.
7. Move existing 24VI PP1 wire #068136 to 24VD post.
8. Keep 24VI PP1 (#068253) on the post

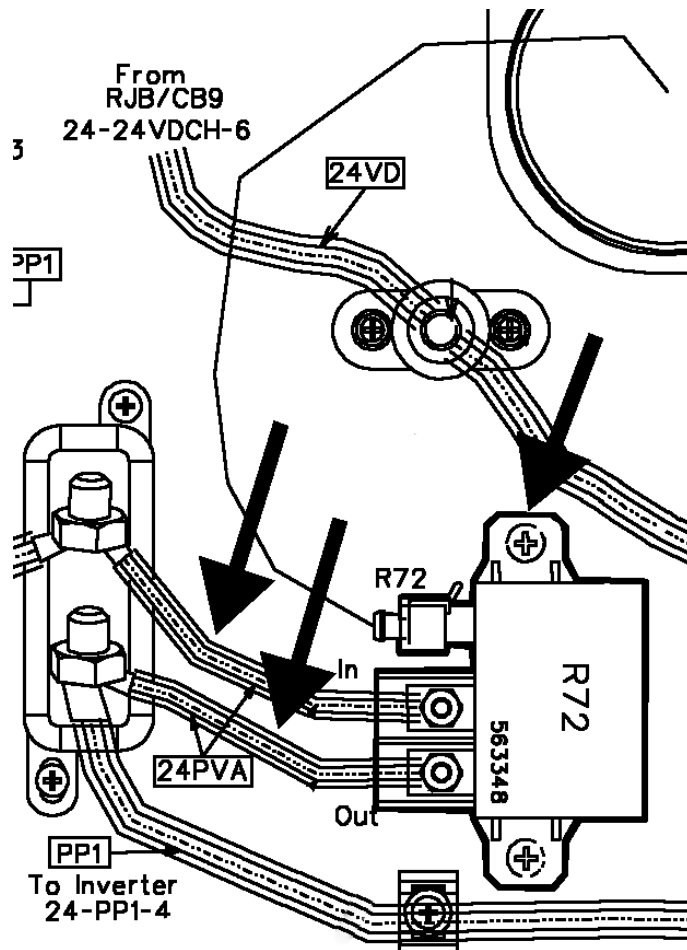
9. Install #563348 R72 power relay in battery charger / equalizer compartment.

*Place relay in front of the double post. Refer to image for orientation and approximate position.*

Install with tapping screws #500957.

10. Connect the two wires 24PVA #068494 provided with kit to the dual posts.
11. Connect other end of 24PVA to relay using washers #502573 and nuts #5001182.

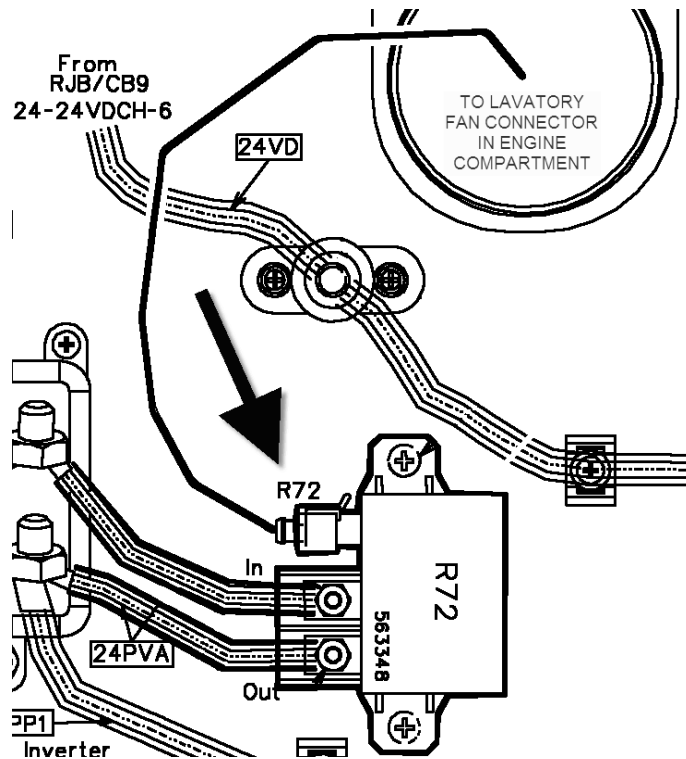
Cable #068655 will be routed from engine compartment up to the battery charger / equalizer compartment.

13. Slip R72 connector from the engine compartment through cuff bellows up to the battery charger / equalizer compartment.
14. Connect R72 connector to the relay
15. Route other end of cable #068655 through the engine compartment towards the lavatory fan.

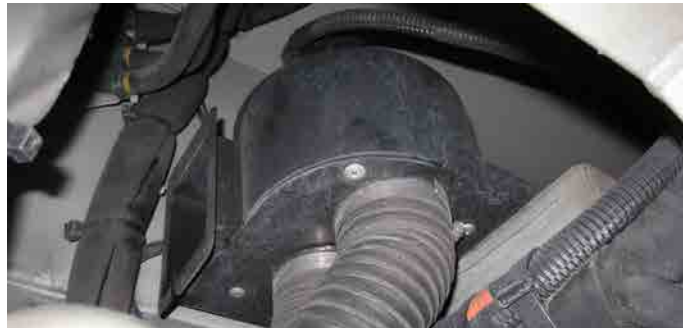
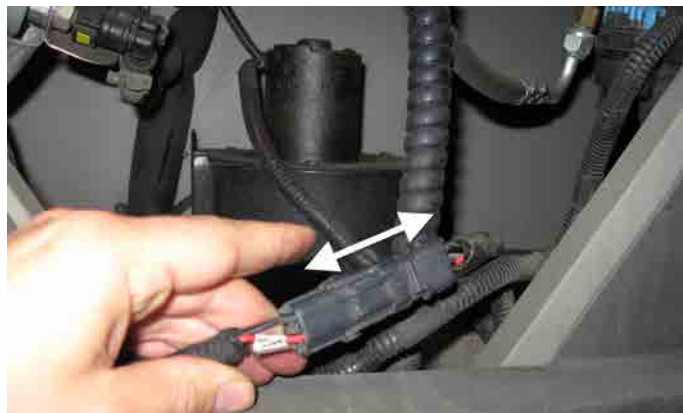
16. In the upper right corner of the engine compartment, locate the lavatory fan.
17. Follow fan power cable up to Mo14 connector. Unplug Mo14 lavatory exhaust fan connector.

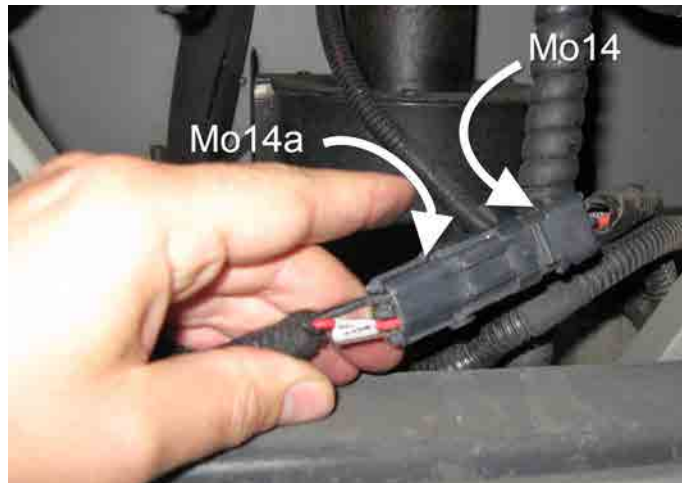
18. Connect Mo14 from #068655 cable to Mo14 from lavatory exhaust fan

Connect Mo14a from #068655 cable with Mo14 on vehicle side harness.

Support harness as required with cable ties.
