**PREVOST**

## WARRANTY BULLETIN

WB12-35

| SUBJECT : | PRE-HEAT EXHAUST TUBE CLEARANCE | |

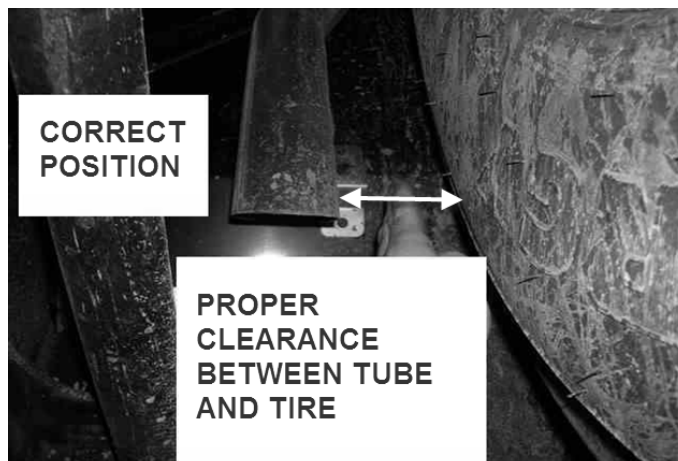
3. This is the correct position. Distance between tube and tire should be approximately 2 in.

*If the tube shows this position, end the procedure.*

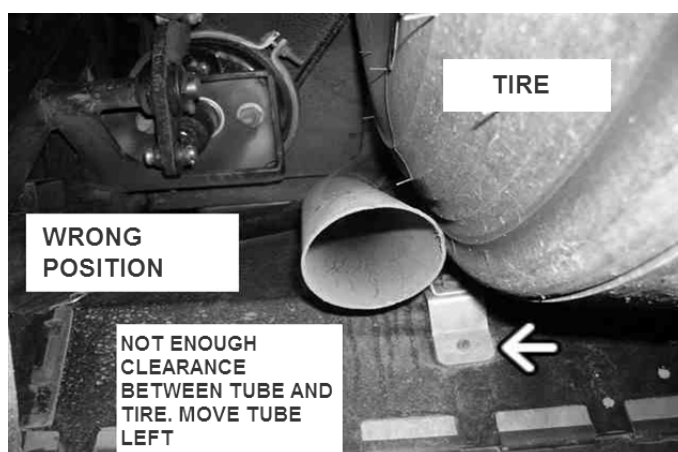
4. Any other position less than 2in between tube and tire is wrong. Proceed to the next steps.

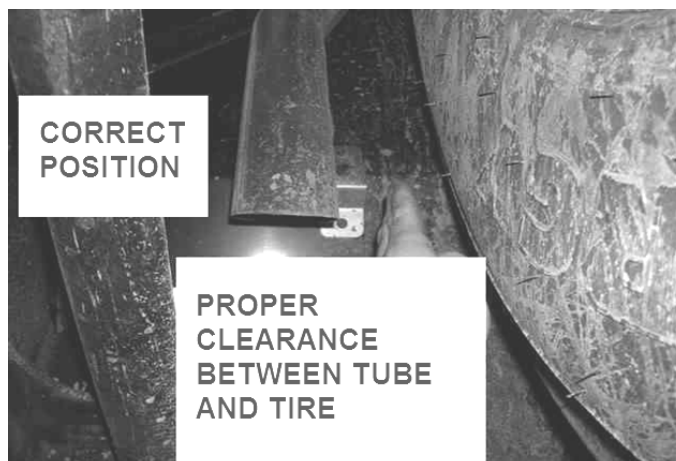
9. The final position should look like this.
