# Rear Combination Lamp Condensation

**Service Category** Vehicle Exterior

**Section** Lighting (ext)

YEAR(S)	MODEL(S)	ADDITIONAL INFORMATION
2012 – 2013	iQ

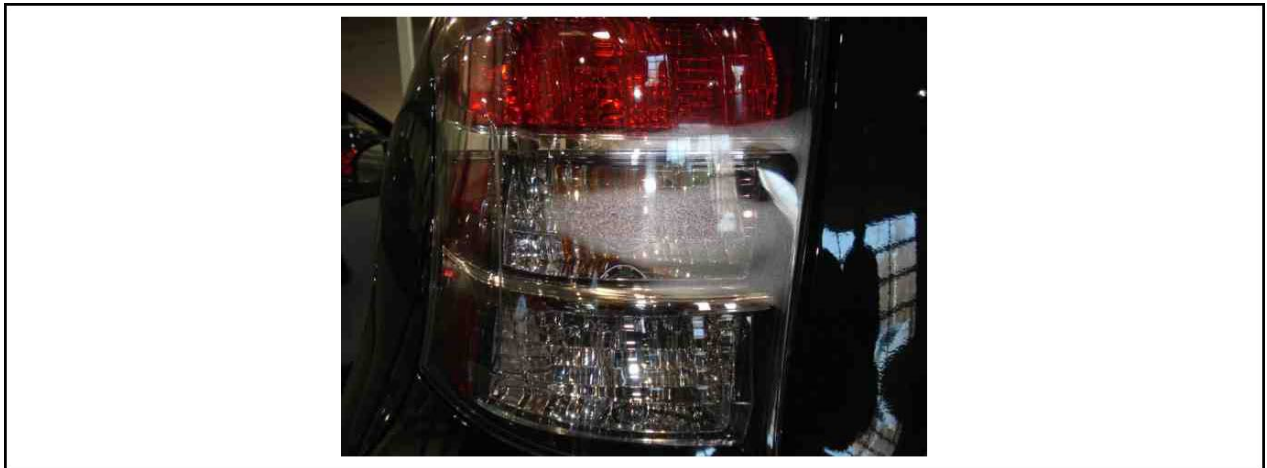
**Figure 1.**

Some vehicles may exhibit a condition where condensation builds up on the inside of the lens of the Rear Combination Lamp Assembly. A new Rear Combination Lamp is now available to address this condition.

1. Confirm condensation is present in Rear Combination Lamp Assembly.
2. Replace Rear Combination Lamp Assembly.
