Service Bulletin

Subject: Transmission Fluid Level Indicator Handle Broken

Models: 2007-2013 Cadillac Escalade Models
2007-2013 Chevrolet Avalanche, Silverado, Suburban, Tahoe
2007-2013 GMC Sierra, Yukon Models
Equipped with Automatic Transmission RPOs MYD, MYC

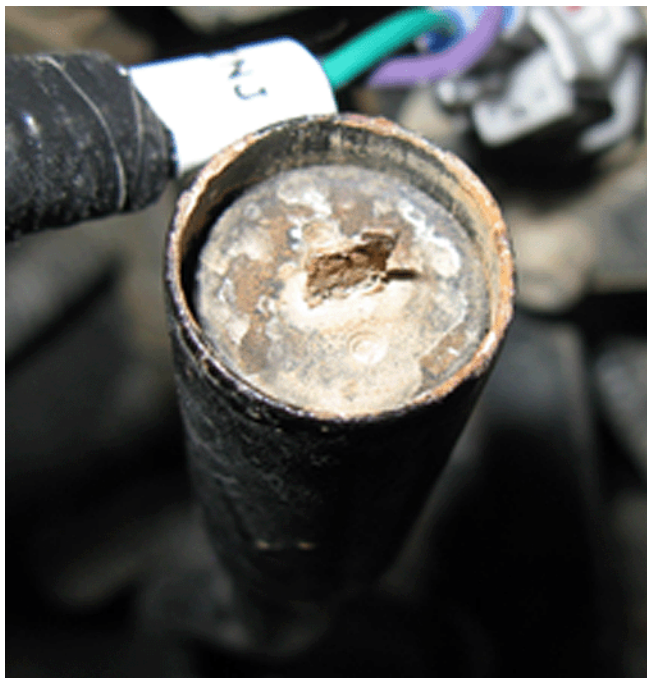
Some customers may comment that while attempting to remove the transmission fluid level indicator to check the fluid, the handle breaks off. Further investigation reveals that the metal indicator material was corroded and broke where the plastic handle is attached.

Technicians should replace the transmission fluid level indicator with the updated part number. The new part is darker in color as shown below.
