# Technical Bulletin

69 12 02 October 2, 2012 2029767 Supersedes T.B. V691201 dated June 21, 2012 to include additional model year.

Airbag Warning Lamp Illuminated in Instrument Cluster, DTC B101614 Stored in Airbag Control Module

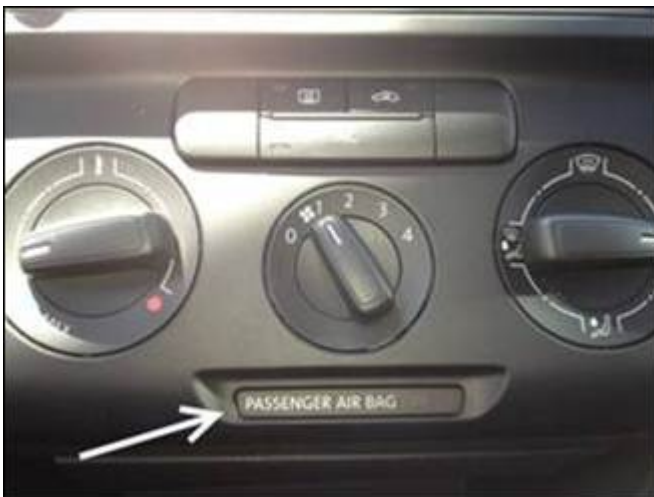
Figure 3

Airbag lamp in instrument cluster may illuminate due to unfastened connector for passenger airbag warning lamp.

- If fault clears, and the airbag indicator in the instrument cluster does not illuminate, no repairs necessary.
- If DTC reoccurs, remove center console cover using wedge tool 3409, inspect wiring connections to "PASSENGER AIR BAG WARNING LAMP" (see figures 3 and 4), for loose connection.
- Secure wiring connections as necessary.
- If connection is secure, further diagnosis is needed. This technical bulletin does not apply.
- Clear DTCs again and retest operation to verify airbag lamp is OFF in instrument cluster.
