## SERVICE CAMPAIGN BULLETIN

**CAMPAIGN REF:** 01H  
**TITLE :** HVAC Drain tube modification  
**DOCUMENT # :** 11 A 030

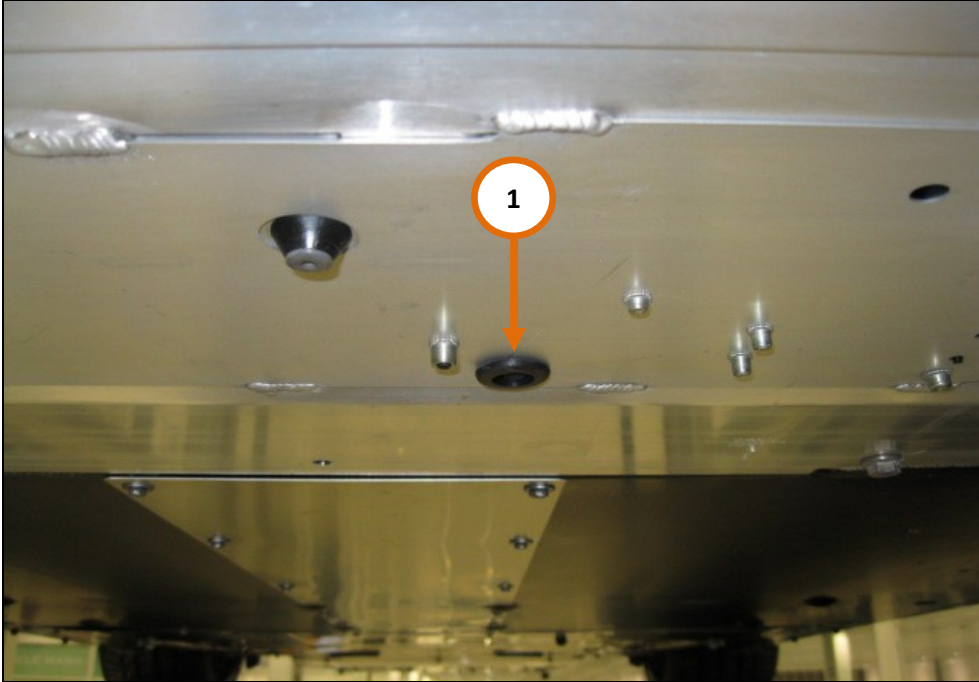
1. Locate the HVAC drain tube in the front subframe (1).

**Care Point:** It is not necessary to remove the drain tube to perform the modification.

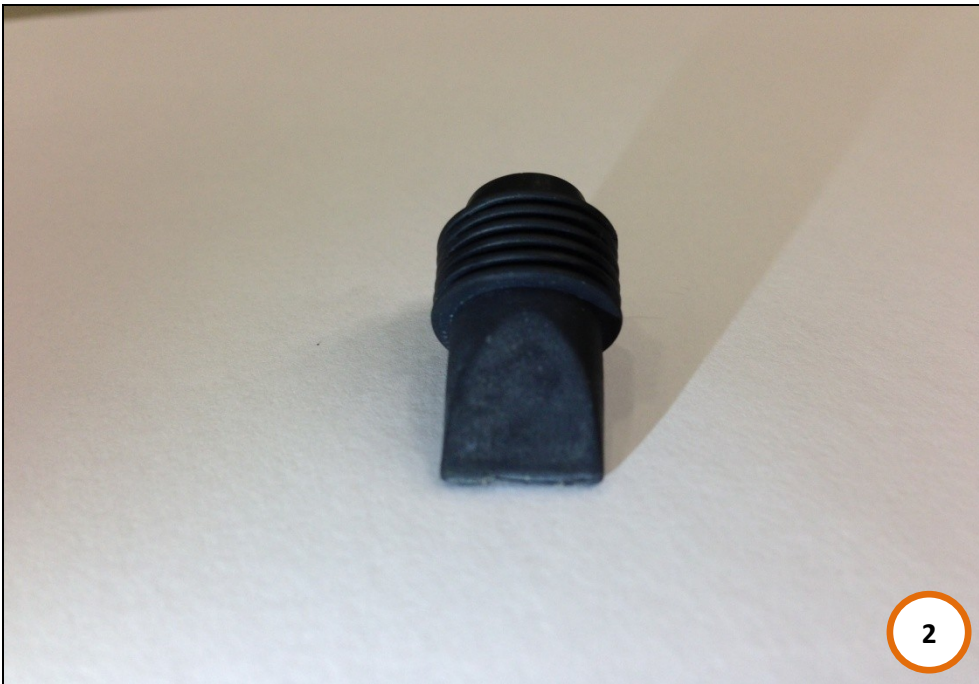
2. Remove the valve from the drain tube using a pair of long nose pliers (2).

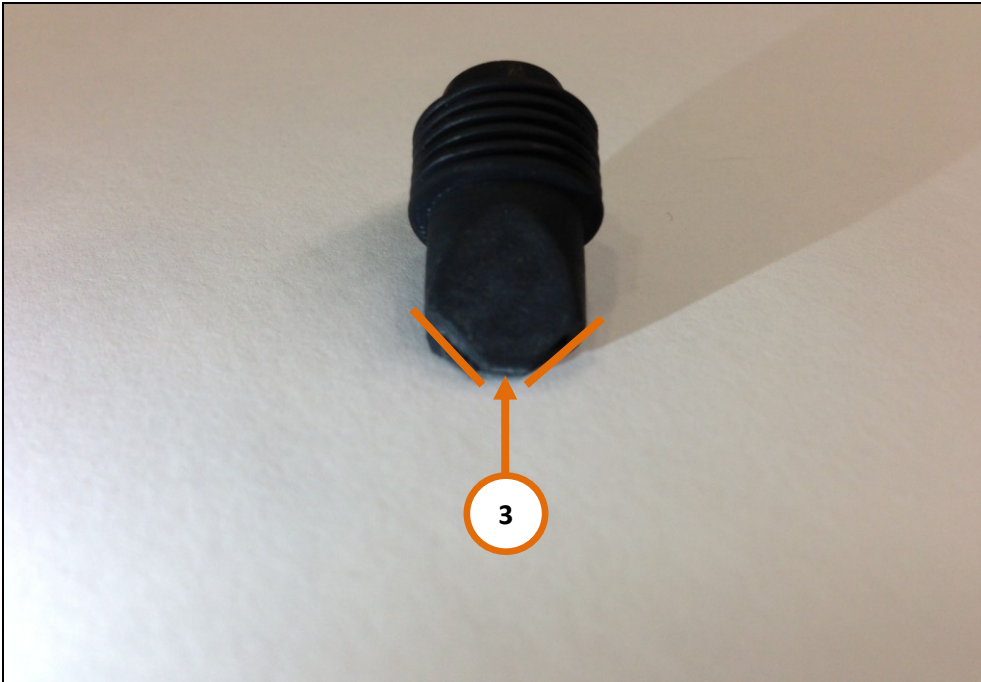
3. Cut the two edges (3) to create a constant drain path.

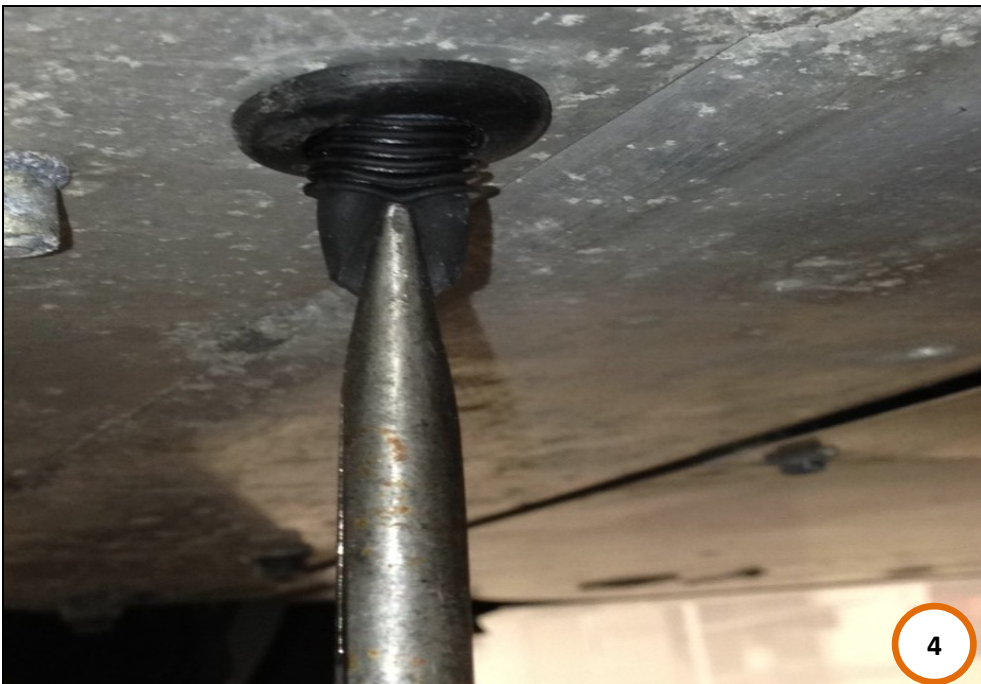
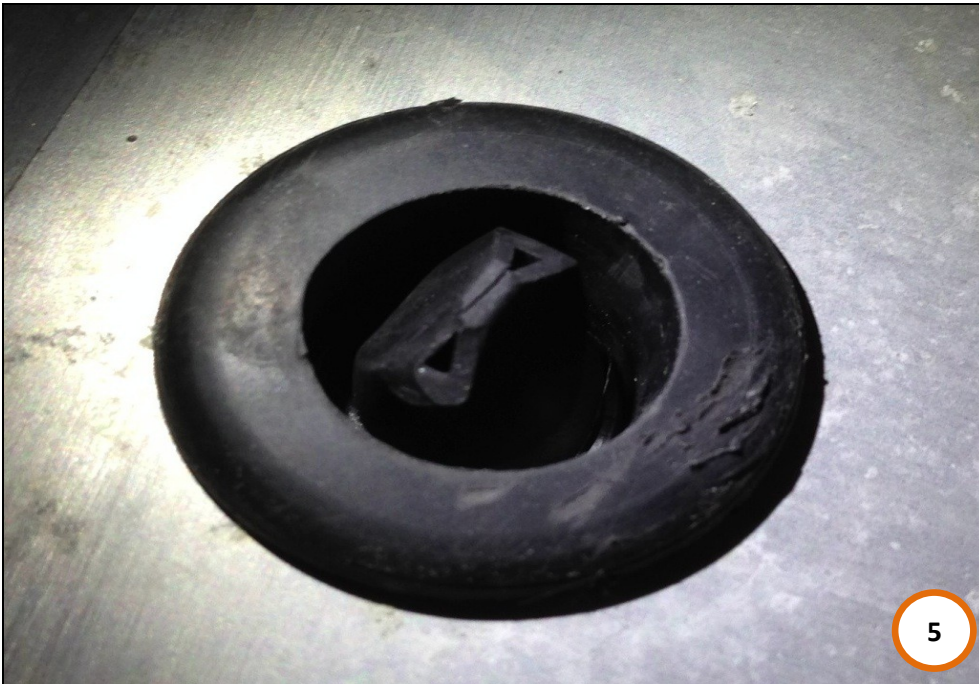
4. Reinstall the valve into the drain tube (4), ensuring that it is correctly located (5).
