## Service Campaign 62-02

**AFFECTED:** Certain 2013 Model E26HE Winnebago Vista and Itasca Sunstar Motor Homes

**SUBJECT:** House Batteries Not Receiving a Charge When The Engine is Running

## 2013 Vista/Sunstar Model E26HE Battery Boost Switch Wiring Procedure

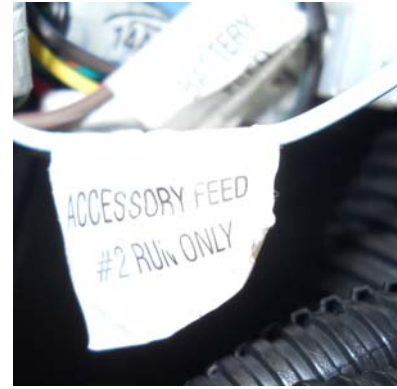
1. Locate Ford accessory feed #2 run only wire (white/light blue) under left side of dash or locate KE wire in harness under dash area.

2. Run 14 gauge wire from accessory # 2 run only feed wire or connect to KE wire from harness under dash to # 4 terminal on battery boost switch.

Add this wire.

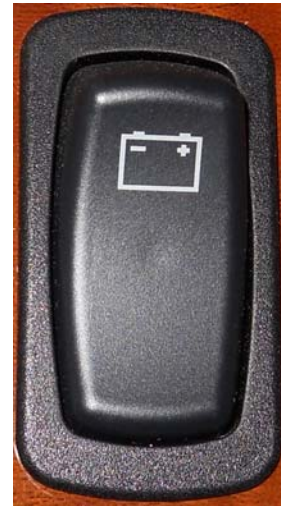
Battery Boost Switch

# 4 terminal KE wire

#2 terminal LR wire

#1 terminal LS wire

Terminal p/n 129236-02-000  
Female, M/P, 630, 14-16 gauge

Note: This will allow house batteries to charge from engine battery when engine is operating.
