EL12-041

ITB12-065

## 2013 JX35; DOME LIGHTS ILLUMINATE AND/OR FLICKER WHILE DOORS ARE CLOSED.

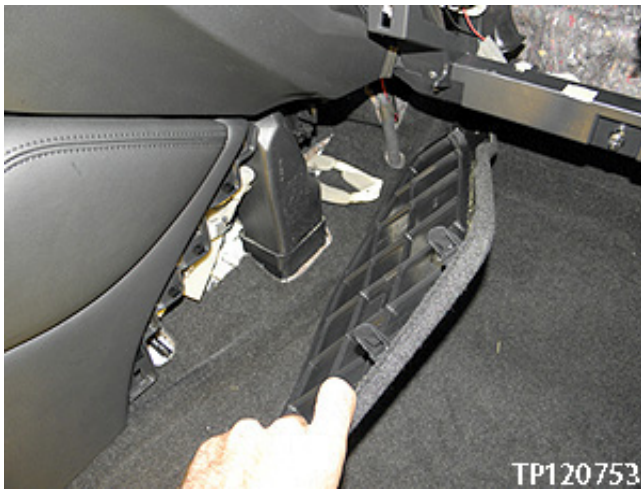
Figure 1

1. Remove front Kick Plates and Center Consol Side finishers from both drivers and passenger floor areas.

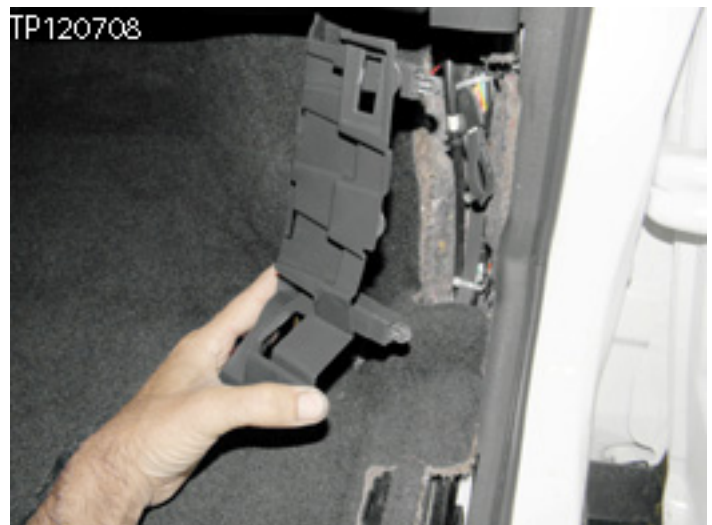
Figure 3

2. Remove Glove box to allow correct harness routing (See ESM for procedure to remove).
3. Remove both drivers and passenger front Foot Well Trim Panels.
4. Remove floor mats.

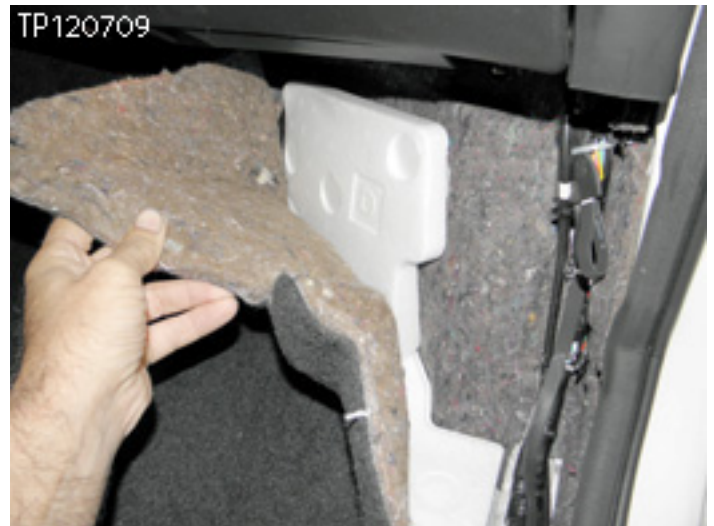
Figure 4

5. Lift both left and right front carpet to expose foam floor finishers.

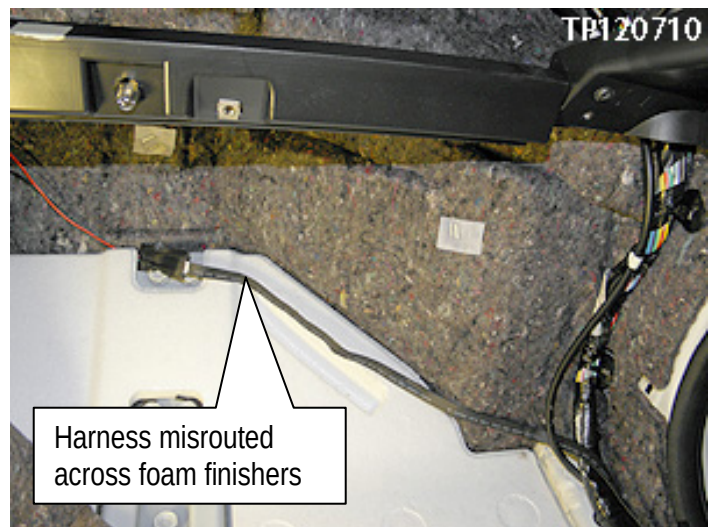
Figure 5

4. Remove left and right foam floor finisher extensions to expose misrouted harnesses.

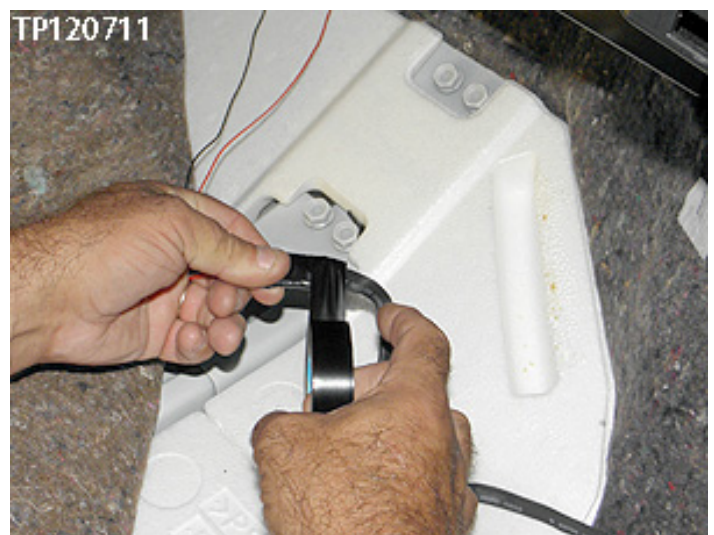
Figure 6

5. Wrap both kick plate light control units with several layers of electrical tape around pre-existing foam covering.

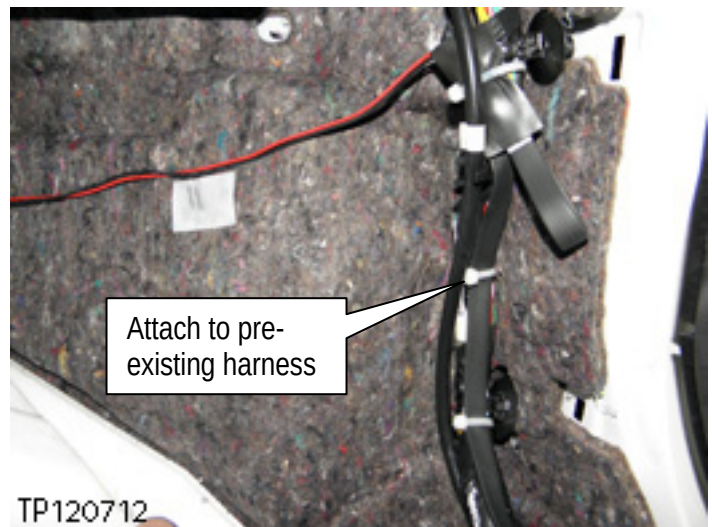
Figure 7

6. Harness should be routed along pre-existing body harnesses and held in place with wire ties.

- Behind glove box on passenger side.
- Behind brake and throttle peddles on driver's side.

7. Then route harness to upper driver's and passenger foot wells, above foam floor finishers. (Figure 7 shows passenger front floor. Drivers side routing is similar.)

- Use foam tape from Squeak and Rattle Kit to hold harness in place.
- Roll up and zip tie any unused harness length and secure out of the way.

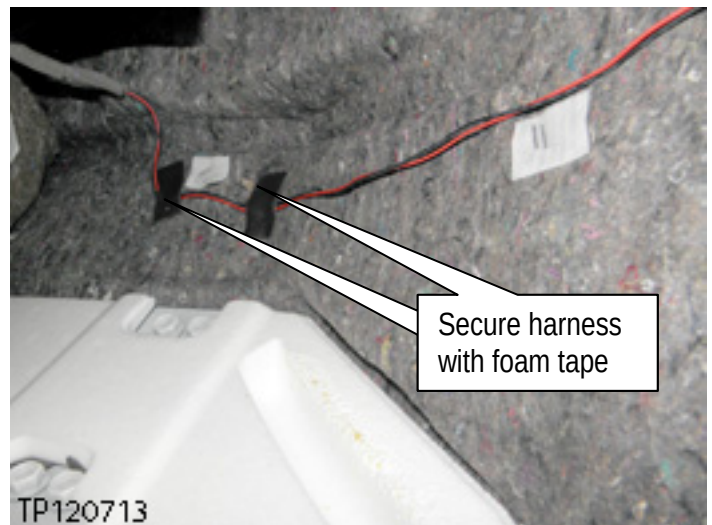
Figure 8

8. Re-install foam finishers, carpet and Kick Panels for left and right front floors.

NOTE: Harness now should no longer be routed under foam finishers.
