BT12-017

## 2013 JX35; RUBBING NOISE WHEN OPENING THE REAR HATCH

**APPLIED VEHICLES:** 2013 JX35 (L50)

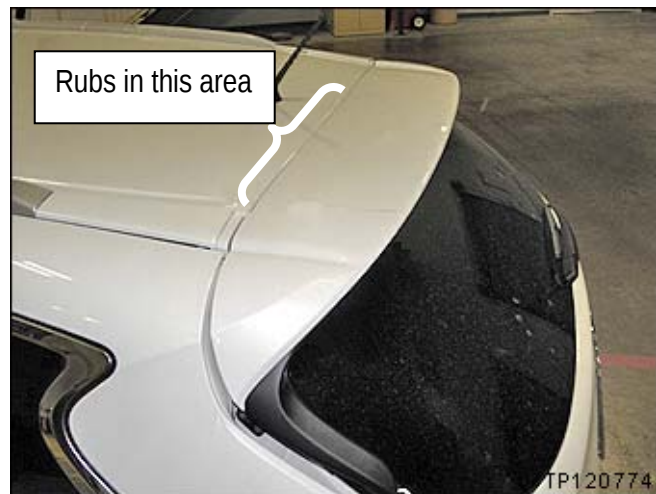
Figure 1

The back door (hatch) or rear spoiler rubs on the roof (driver side or center) when the hatch is opened.

- The customer may report there is a noise (rubbing, scraping, or popping) when the rear hatch is opened.
- The issue may occur intermittently. Ambient temperature may affect when the issue occurs (only when hot, or only when cold).
- There may be small witness/contact marks on the roof, hatch, or spoiler at the contact points.

Adjust the rear hatch as shown in the Service Procedure of this bulletin.

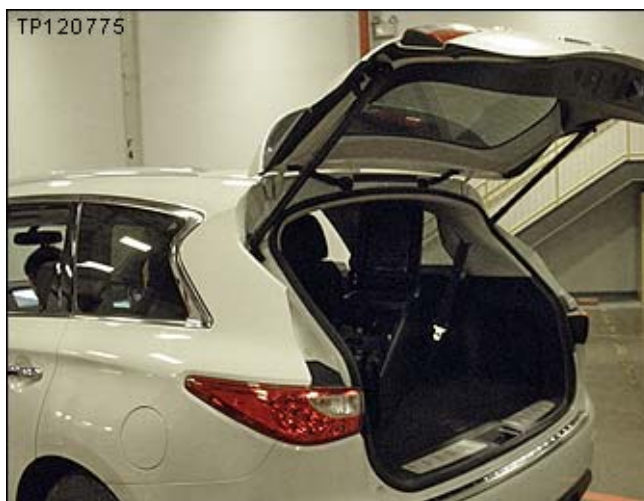
Figure 2

1. Fully open the rear hatch.

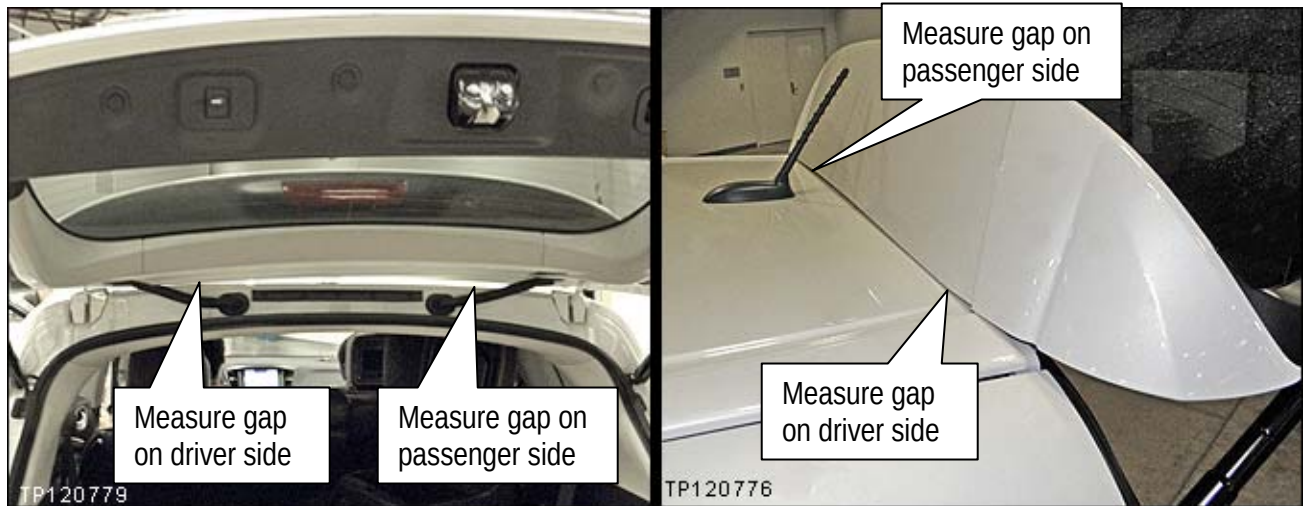
Figure 3

2. Measure the gap between the rear hatch/spoiler and the roof on the driver and passenger side (see Figure 3).

**NOTE:** Gap can be measured from the front side or the back side of the hatch.

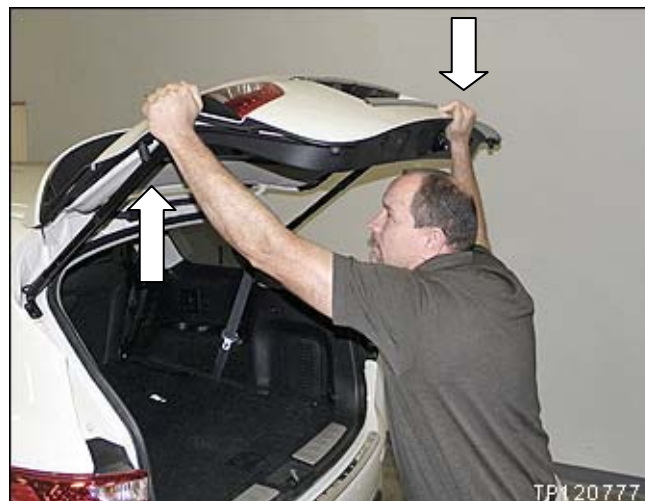
Figure 4

- a. Position your hands as shown in Figure 4.
  - b. Hold down in the center of the hatch (right hand).
  - c. Push up on the driver side outer edge of the hatch (left hand).
- Adjust only a small amount and then recheck the hatch movement and gap measurement. Adjust more if needed.
  - If the hatch is adjusted too much it can be pulled back. See Figure 5 on the next page.

3. Adjust the driver side of the rear hatch so the driver side gap measured in step 2 matches the passenger side gap.

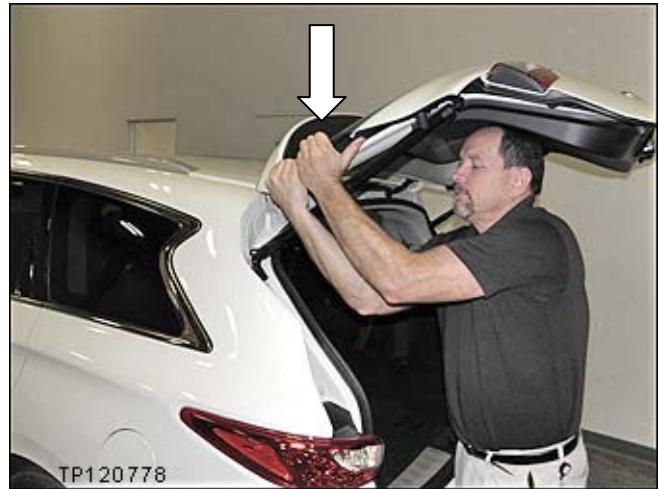
Figure 5

**NOTE:** If the hatch is adjusted too much, pull it back as follows:

- a. Hold the edge of the hatch as shown in Figure 5.
- b. Pull straight down to adjust.
- c. Adjust only a small amount and then recheck the hatch movement and gap measurement.

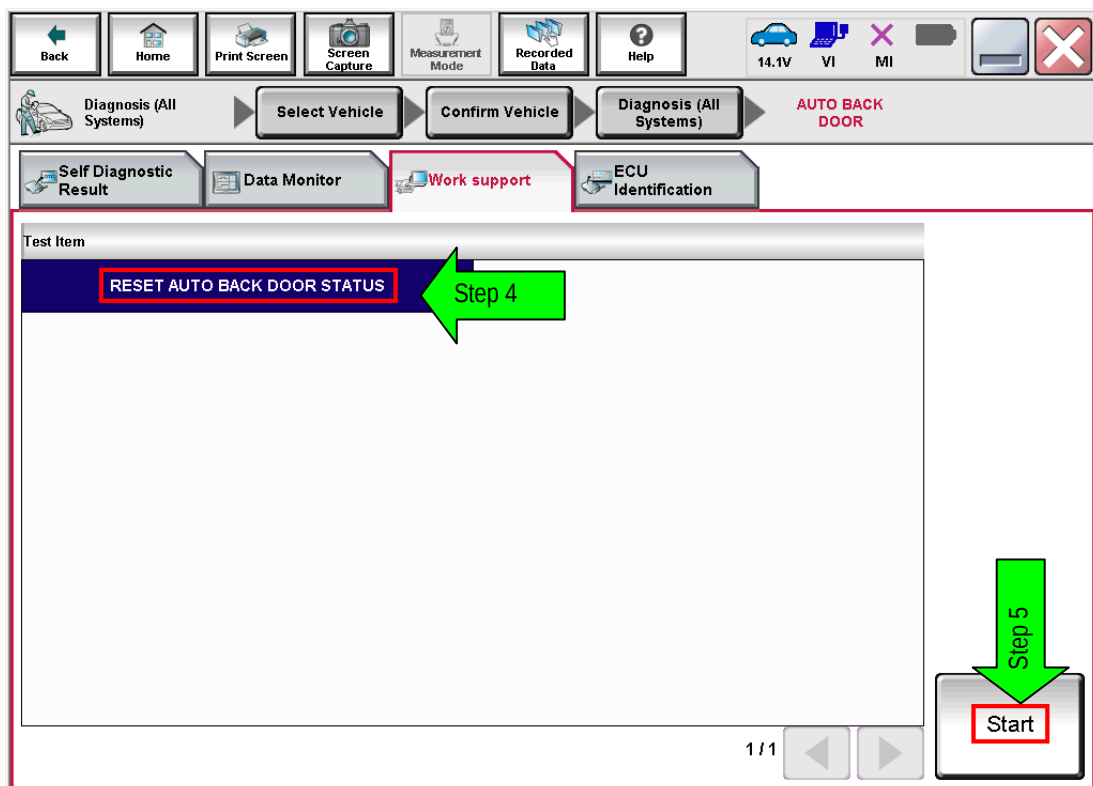
Figure 6

1. Make sure the hatch (back door) is fully closed.
  - If needed, manually close the back door.
2. Connect CONSULT-III plus (C-III plus) to the vehicle.
3. Navigate C-III plus to:

**Diagnosis (All Systems) > AUTO BACK DOOR > Work Support**

4. Select **RESET AUTO BACK DOOR STATUS**.
5. Select **Start**.

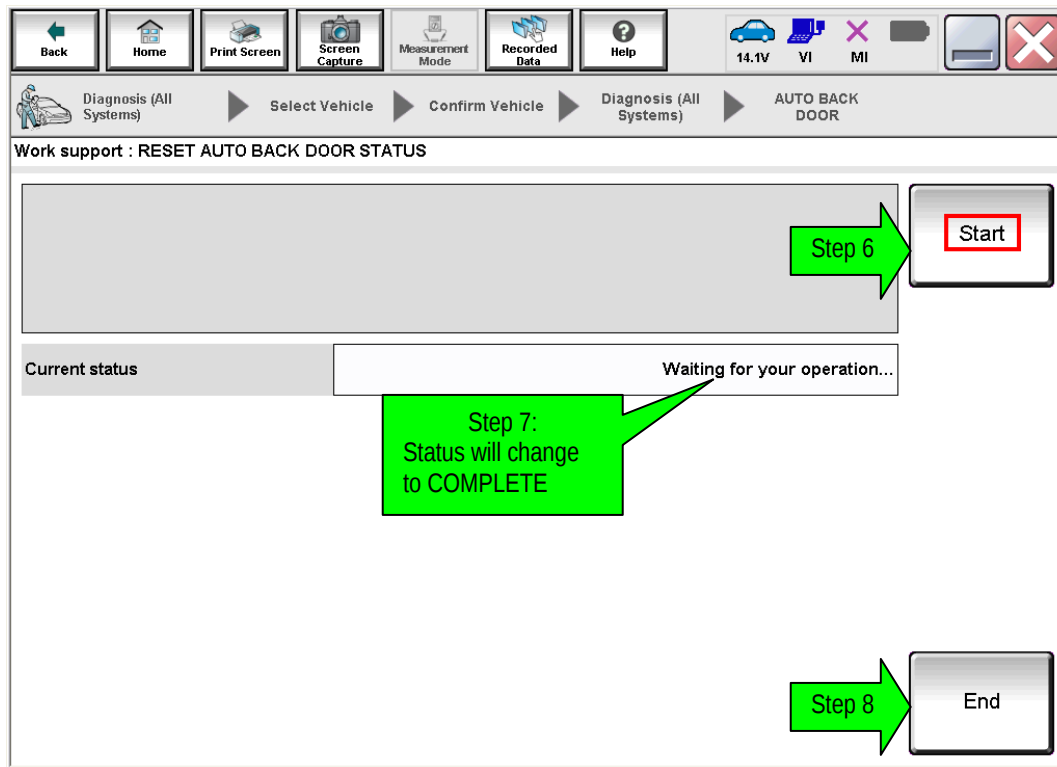
Figure 7

6. Select **Start**.
7. Wait for Current status to change to COMPLETE.
8. Select **End**.
