Bombardier Recreational Products Inc.

Date: December 3, 2012

Re: Model Year 2013 Can-Am™ Spyder - Special Repair Needed at PDI

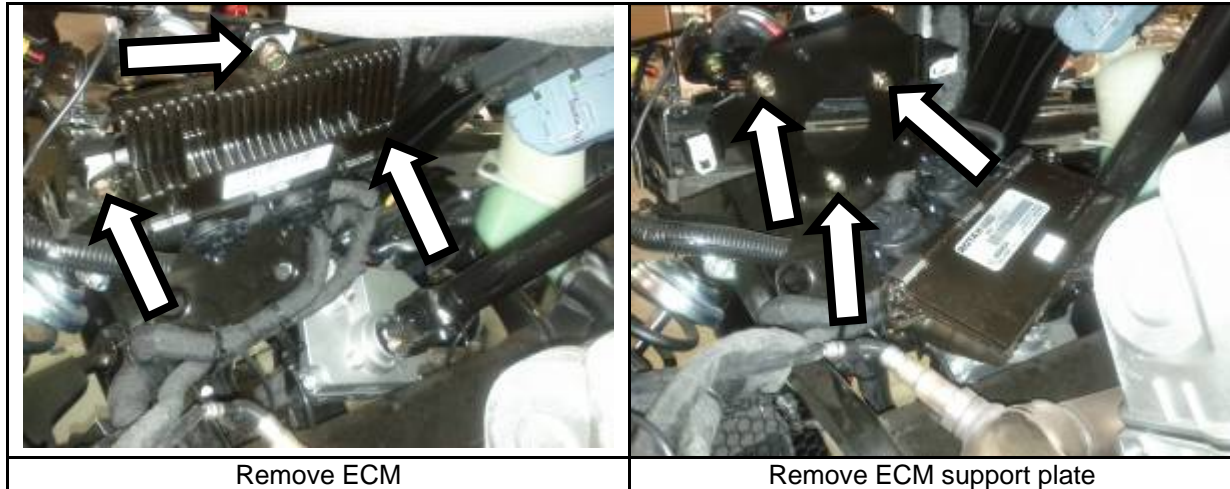
Use the appropriate Shop Manual to reach and remove the air box, and to access the wires area. Until the final Shop Manuals are available through the normal channel, some temporary Shop Manual sections were attached to each VIN on BRP Knowledge Base.

Replace any pinched/damaged wire(s).

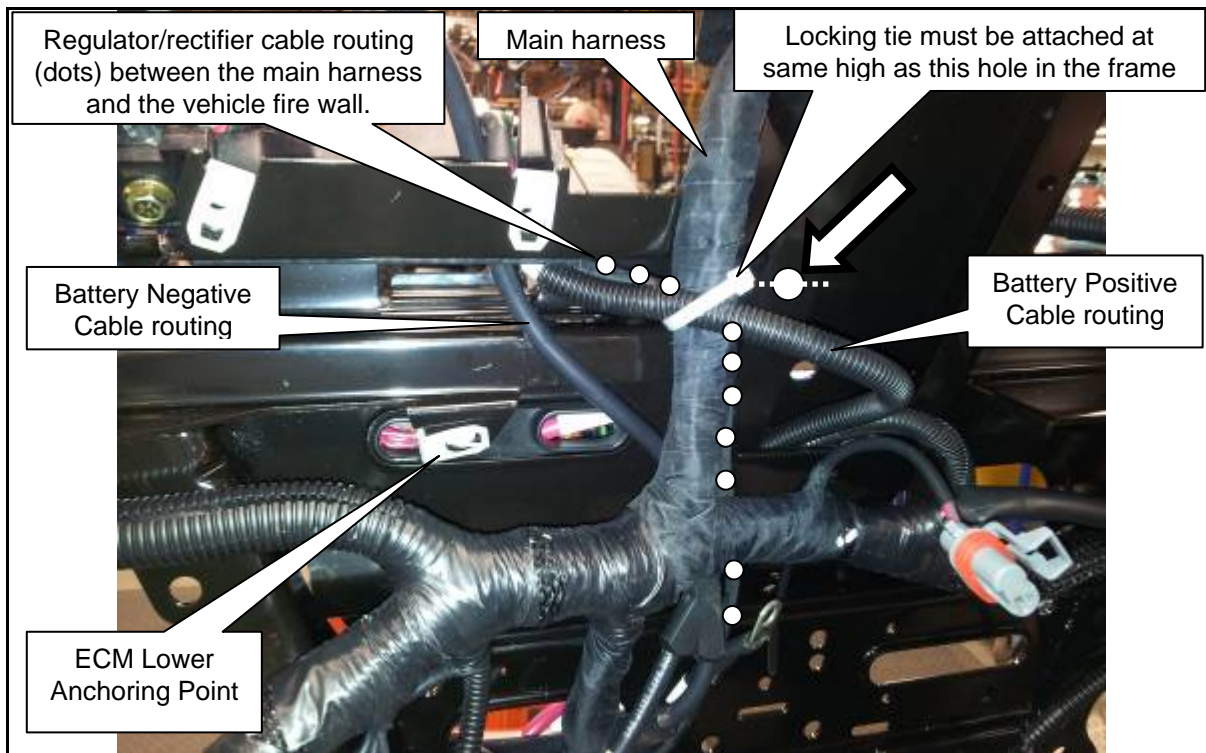
Modify routing as per following pictures for (view is from inside of vehicle, looking towards the front):

- Red positive cable with corrugated over it (P/N 710 002 373)
- Regulator/rectifier wires (2) protected by harness tape (P/N 710 002 716)
- Large black ground cable (P/N 710 002 378)

Make sure that all wires are not pinched and routed away from any sharp edge.
Reassemble all components on vehicle.
