NUMBER: 23-035-12

Liftgate Emblem Paint Peeling

2012 FF 500 (Abarth Only)

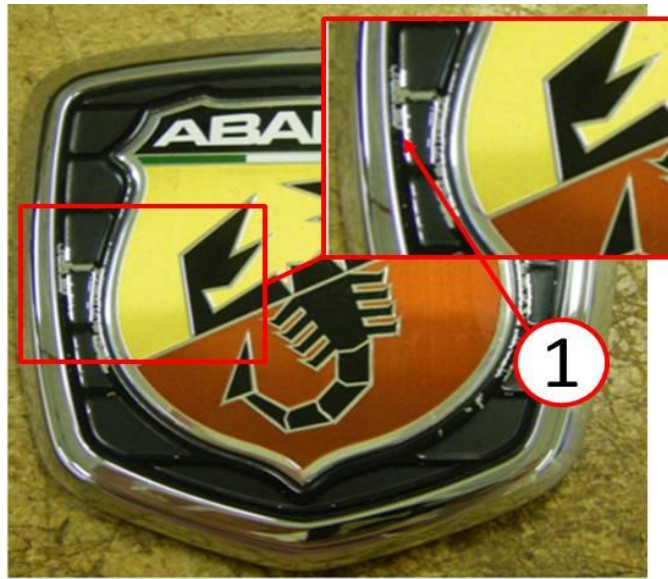
Fig. 1 Abarth Liftgate Emblem

1. Inspect the abarth liftgate emblem as shown in (Fig. 1). Was the paint delaminating and/or peeling?
 - a. Yes>>> Proceed to [Step #2](#).
 - b. No>>> Return the vehicle to the customer or dealer inventory.

1 - Black Enamel Paint Peeling

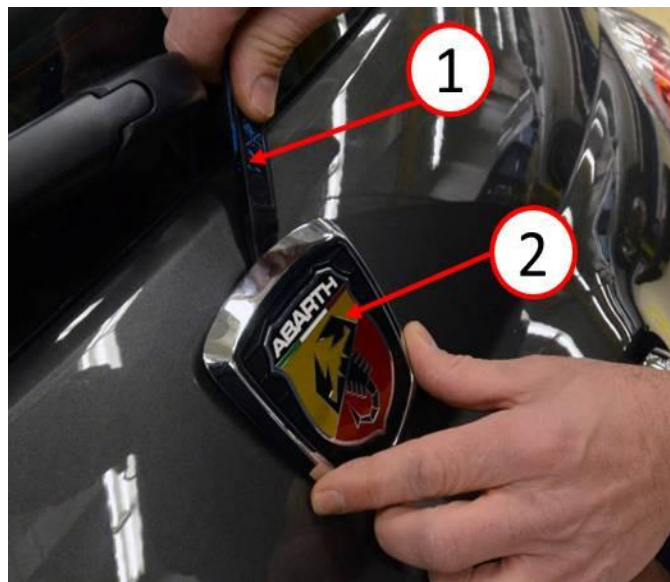
Fig. 2 Emblem Removal

1 - Trim Stick

2 - Abarth Emblem

2. Remove the liftgate abarth emblem using a trim stick as shown in (Fig. 2) and discard.

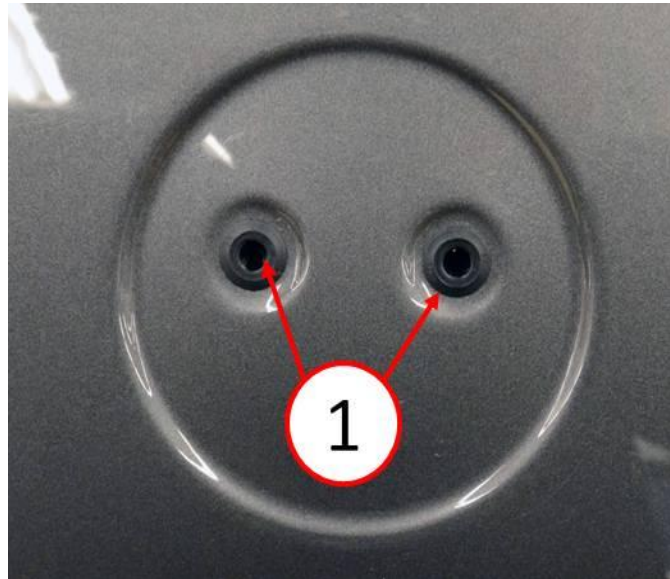
Fig. 3 Plastic Retainers

1 - Plastic Emblem Retainers

3. Verify the plastic retainers p/n 68073915AA shown in (Fig. 3) are fully seated in the liftgate. If they do not fully seat and/or remained on the emblem during removal, they must be replaced.

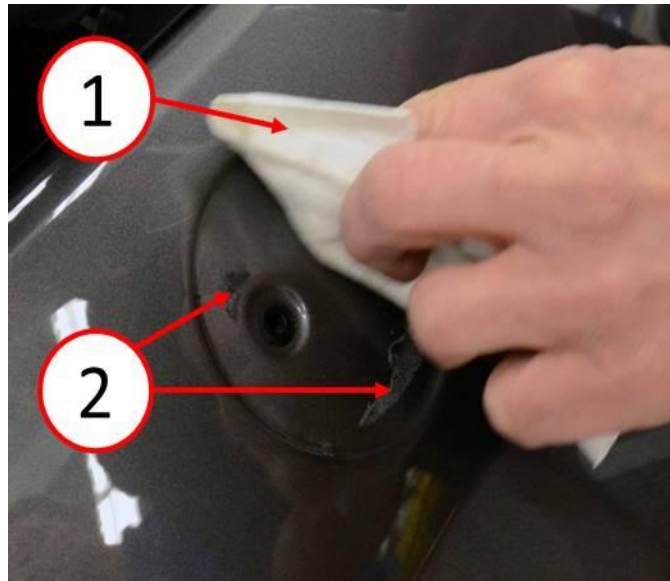
Fig. 4 Adhesive Removal

- 1 - Lint Free Towel
- 2 - Adhesive Residue

-
4. Remove adhesive residue from the liftgate where the abarth emblem has been removed with 3M 08984 general purpose adhesive cleaner or equivalent in conjunction with a lint free towel (Fig. 4).

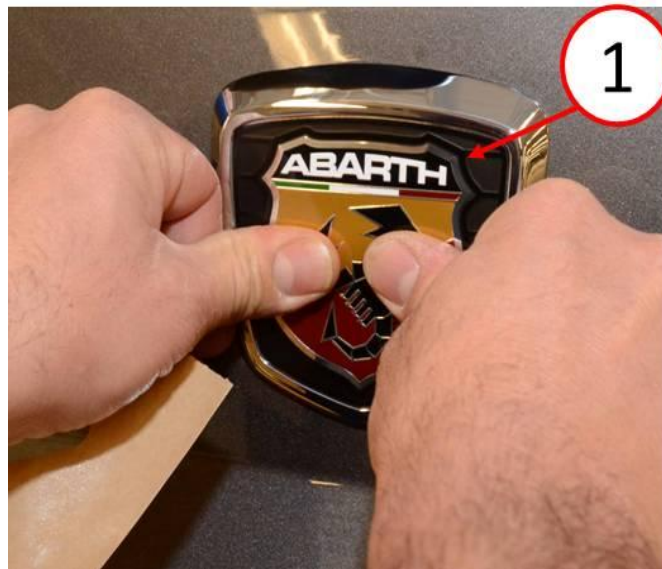
Fig. 5 Emblem Installation

- 1 - Abarth emblem
-

-
5. Clean the surface area where the emblem will be installed with isopropyl alcohol and a lint free towel.
 6. Remove the adhesive liner on the new abarth emblem and install on the liftgate as shown in (Fig. 5).

NOTE: Apply firm pressure to the emblem to ensure the adhesive is properly wetted out.
