iKNOW International® Knowledge Now	IK2200060 Revision: 1.00 Created: 01/24/08 Major System: BUS BODY IFB
--	---

Bus, Passenger Window Plastic Guide

BE, CE, FE and RE Bus Models

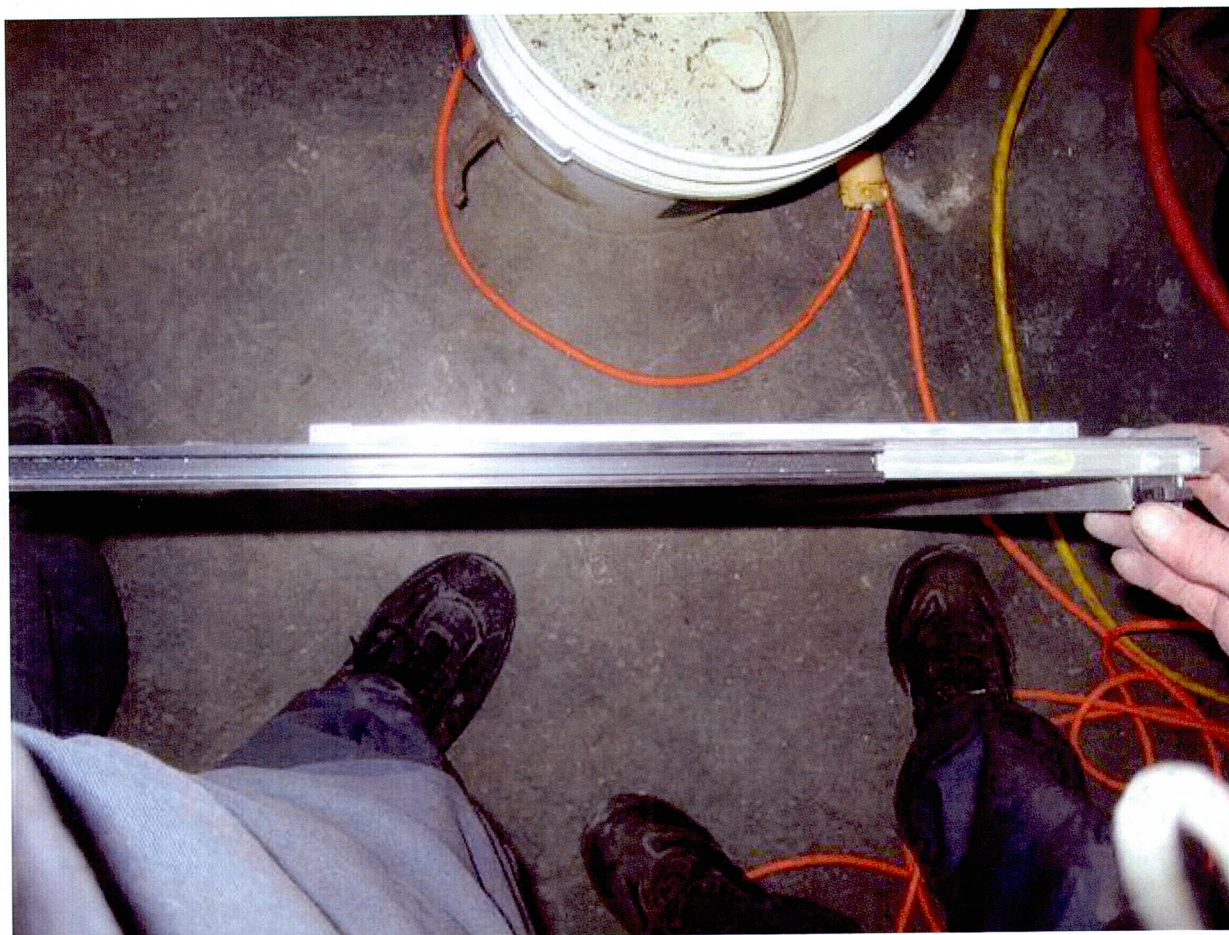
SB-10032287-1855

Above photo shows the plastic guide loose and out of position.

The plastic guide is bonded to the side extrusion using a resin formula during the extrusion production. Replacement of the extrusion is recommended to ensure proper window clearance. In the diagram below, the side extrusion is item 7 as shown in the International Parts Catalog Online.
