SB-10032287-9046

Title: Bus, Passenger Window Plastic Guide

Applies To: BE, CE, FE and RE Bus Models Built Prior to August 18, 2011

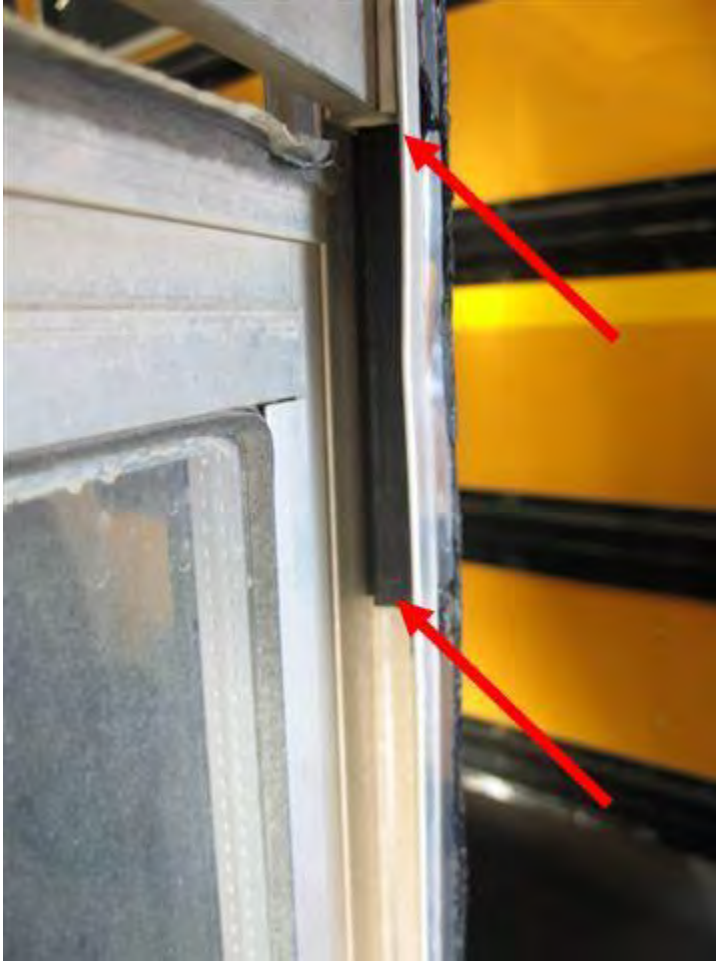
In some cases, visual inspection of the split sash track will allow you to see the plastic guide protruding out past the bottom of the split sash.

Above photo shows the plastic guide protruding out the bottom of the sliding sash.

To repair windows with the plastic guide visible as shown above, remove the window assembly and disassemble window frame to remove the sliding sash.

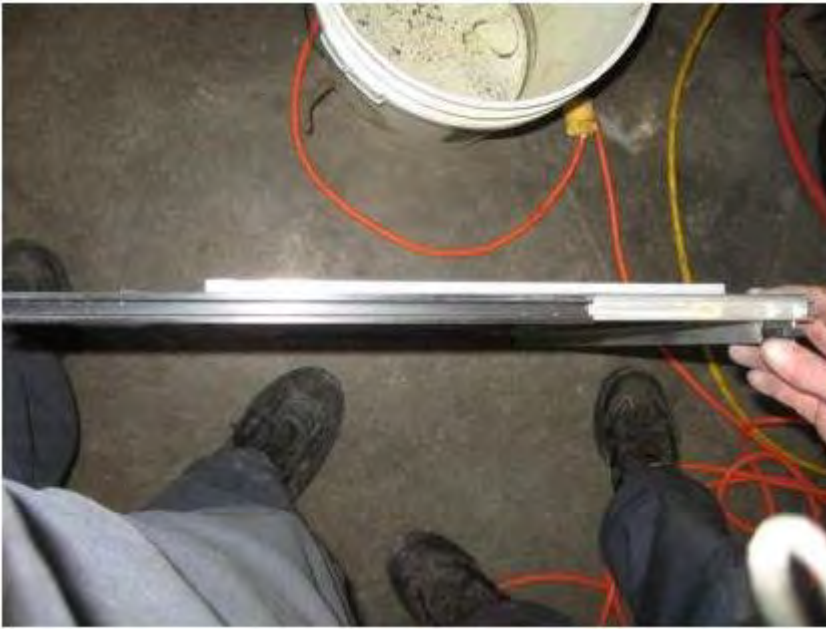
Above photo shows the plastic guide loose and out of position.

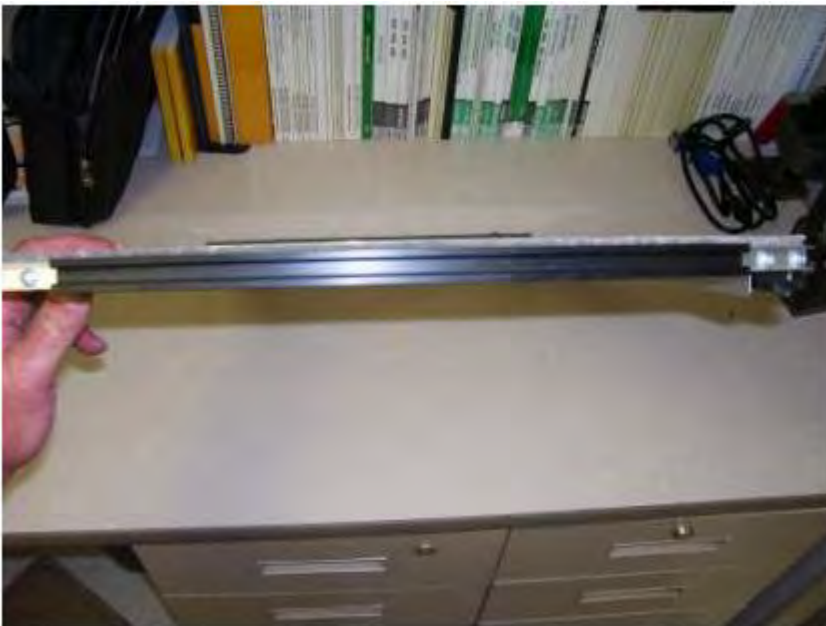
Above photo shows the plastic guide in the original position.
