**Product Update: Audio Unit Software Update for Security Code, Clock Reset, HFL, and Other Listed Issues**

(Supersedes 10-081, dated April 6, 2011, to revise the information marked by the black bars)

**2011 Odyssey LX, EX, EX-L, and EX-L with RES –**  
 Do an iN VIN status inquiry to check which vehicles are affected.

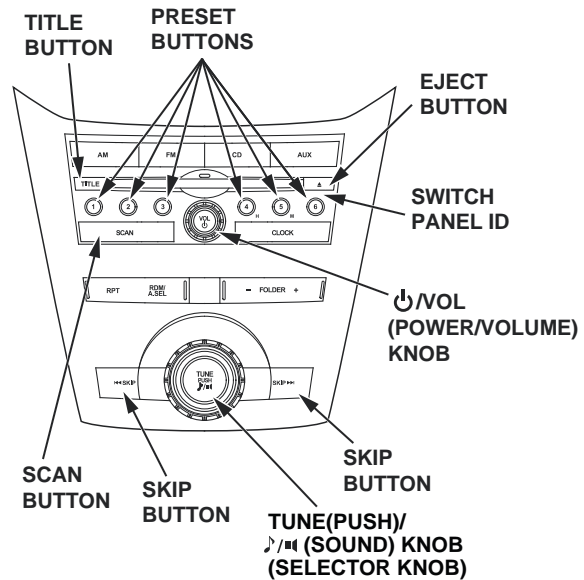
1. Verify that the vehicle is an LX model by making sure the audio unit switch panel ID starts with 1BU0.

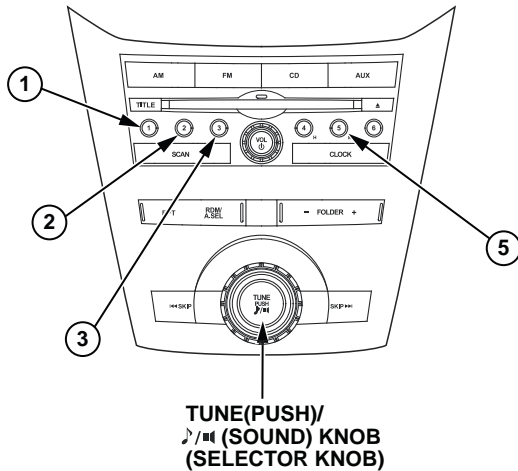
- Press and hold audio preset buttons No. 1, No. 2, No. 3, and No. 5.

- While holding the preset buttons, press and hold the TUNE(PUSH)/ SOUND KNOB (selector knob) until the audio unit turns off; you will also hear a thump sound from the speakers. Release all the buttons.

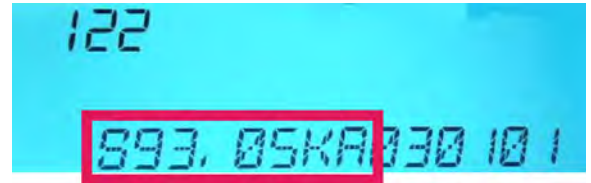
- To display the region, press and hold audio preset buttons No. 1, No. 3, and No. 5. While holding the preset buttons, press the VOL/POWER knob. The region should be **S93.05KA**.

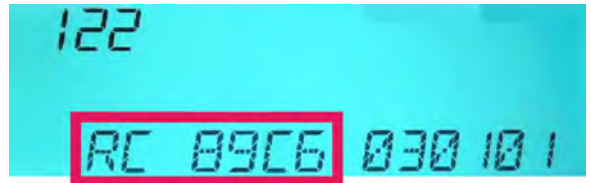
- To display the software version, press and hold the SCAN and the TITLE buttons until the software version appears. The software version should be **RC 89C6**.

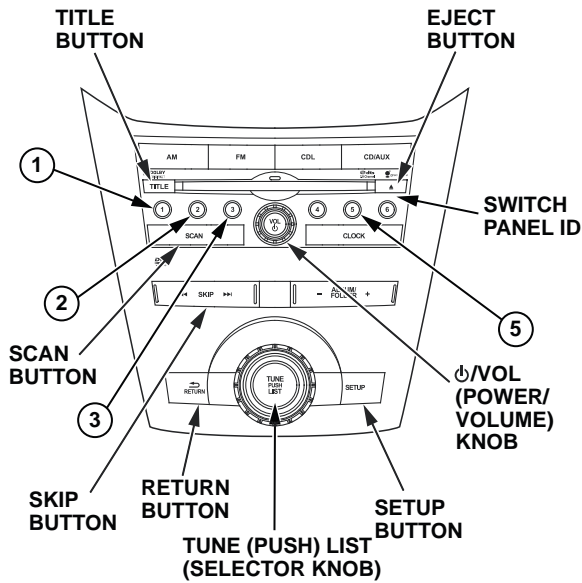
1. Verify that the vehicle is an EX model by making sure the audio unit switch panel ID starts with 1XU0.

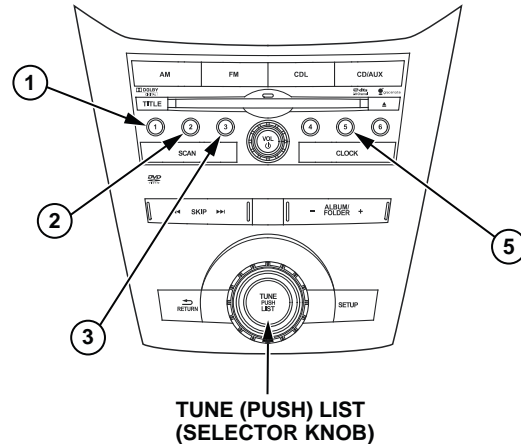
6. Apply the software update:
  - Press and hold audio preset buttons No. 1, No. 2, No. 3, and No. 5.

- While holding the preset buttons, press and hold the TUNE (PUSH) LIST knob (selector knob) until the audio unit turns off; you will also hear a thump sound from the speakers. Release all the buttons.
7. Verify the update by checking the region and the software version:
    - To display the region, press and hold audio preset buttons No. 1, No. 3, and No. 5. While holding the preset buttons, push the POWER/VOLUME knob. The region should be **SA3.05KA**.

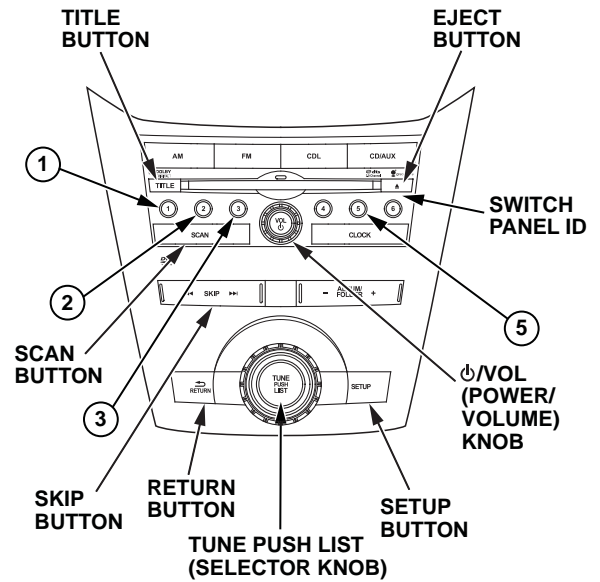
1. Verify that the vehicle is an EX model by making sure the audio unit switch panel ID starts with 1XU0.

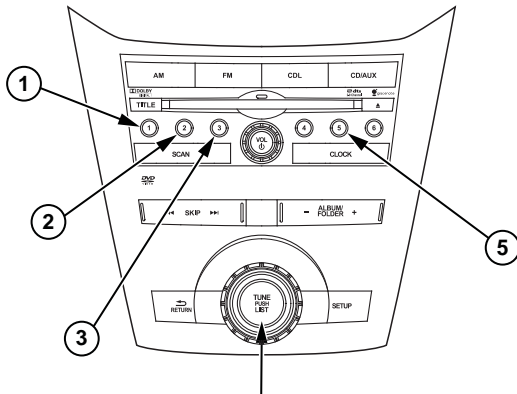
TUNE PUSH LIST  
(SELECTOR KNOB)

- Press and hold audio preset buttons No. 1, No. 2, No. 3, and No. 5.

- While holding the preset buttons, press and hold the TUNE (PUSH) LIST knob (selector knob) until the audio unit turns off; you will also hear a thump sound from the speakers. Release all the buttons.

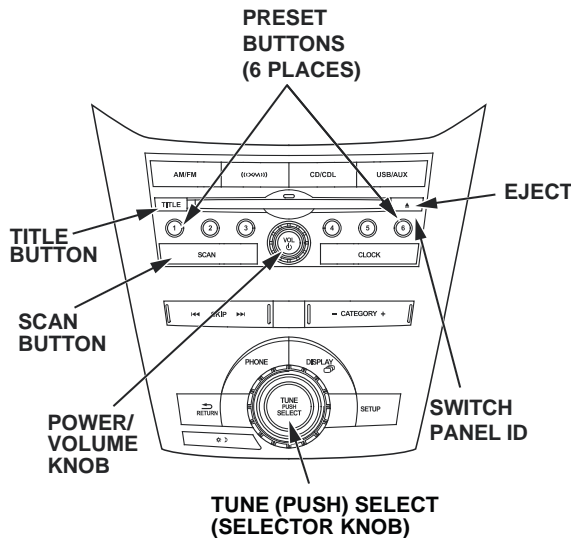
1. Verify that the vehicle is an EX-L model by making sure the audio unit switch panel ID starts with 1PU0.

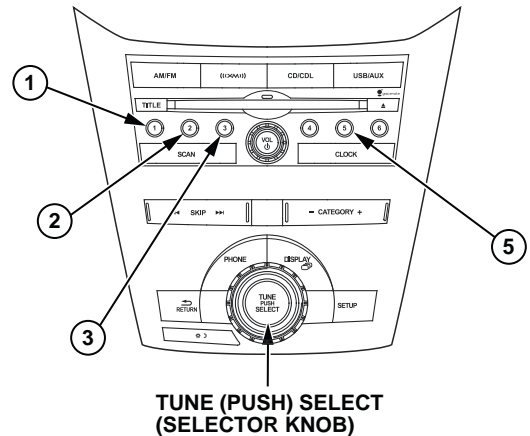
6. Apply the software update:
  - Press and hold audio preset buttons No. 1, No. 2, No. 3, and No. 5.

- While holding the preset buttons, press and hold the TUNE (PUSH) SELECT knob (selector knob) until the audio unit turns off; you will also hear a thump sound from the speakers. Release all the buttons.
7. Verify the update by checking the region and the software version:
    - To display the region, press and hold audio preset buttons No. 1, No. 3, and No. 5. While holding the preset buttons, press the POWER/VOLUME knob. The region should be either **SB3.06KA** or **SB3.07KA**.

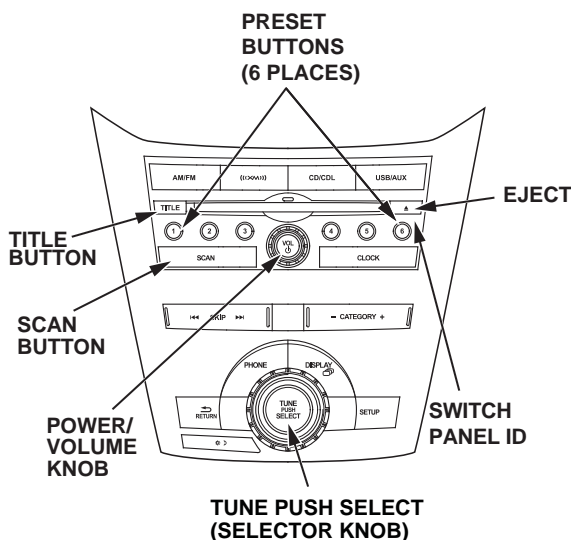
1. Verify that the vehicle is an EX-L model by making sure the audio unit switch panel ID starts with 1PU0.

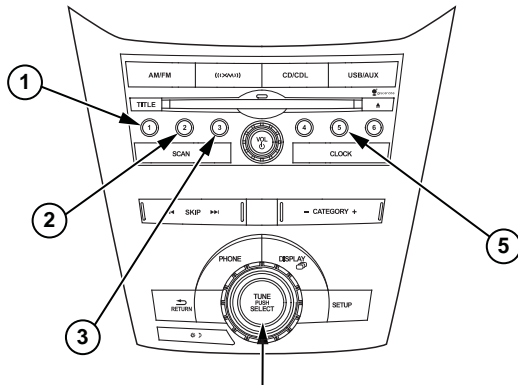
TUNE PUSH SELECT  
(SELECTOR KNOB)

- Press and hold audio preset buttons No. 1, No. 2, No. 3, and No. 5.

- While holding the preset buttons, press and hold the TUNE (PUSH) SELECT knob (selector knob) until the audio unit turns off; you will also hear a thump sound from the speakers. Release all the buttons.

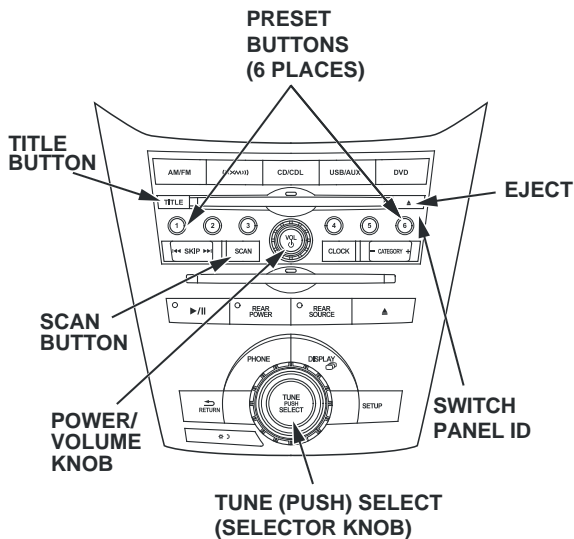
EX-L (WITH RES)

1. Verify that the vehicle is an EX-L with RES model by making sure the audio unit switch panel ID starts with 1PU5.

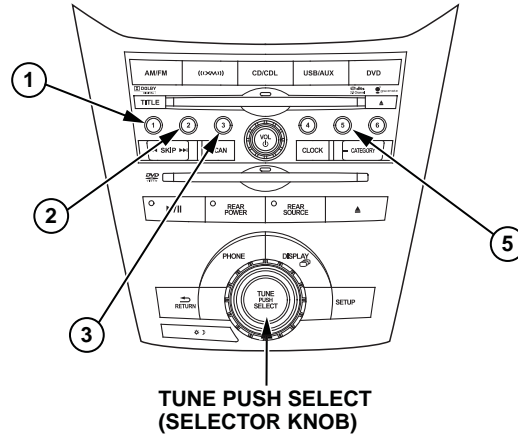
- Press and hold audio preset buttons No. 1, No. 2, No. 3, and No. 5.

- While holding the preset buttons, press and hold the TUNE (PUSH) SELECT knob (selector knob) until the audio unit turns off; you will also hear a thump sound from the speakers. Release all the buttons.
7. Verify the update by checking the region and the software version:

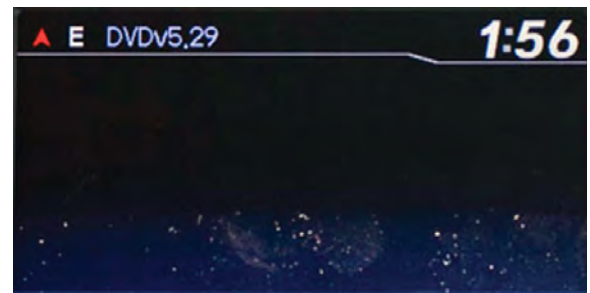
23. Check the RES version software to see if it needs an update:
  - Turn off the audio unit, then press and hold audio preset buttons No. 1, No. 3, and No. 5.
  - While holding the preset buttons, press and hold the POWER/VOLUME knob. Release all the buttons when the audio unit software appears on the display.
  - Press and hold the CD/CDL button for about 5 seconds until the CDL version appears.
  - Press the TITLE button. The RES version appears on the display.
    - If the current version is not at least **DVDv5.29**, go to step 24 and do the update procedure.
    - If the version is **DVDv5.29** or higher, the RES is updated. Go to step 28 to center-punch the VIN.

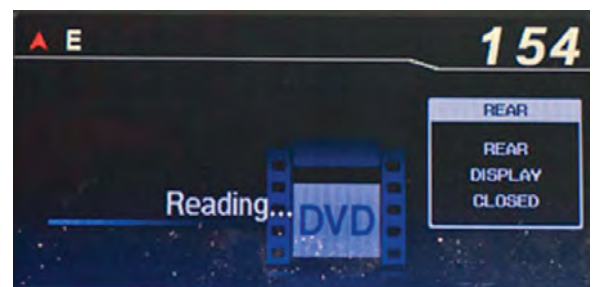
NOTE: Do not update the audio unit and RES unit at the same time. Do the audio unit first, then the RES unit.
25. Allow the RES to download the update CD. A reading message appears for about 2 minutes while the system updates.

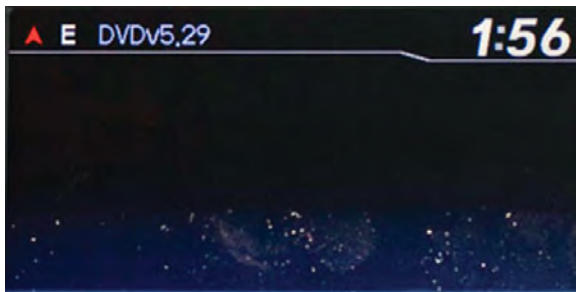
28. Verify the update by checking that the RES software is **DVDv5.29** or later. To check the software, do this:

- Turn off the audio unit, then press and hold audio preset buttons No. 1, No. 3, and No. 5.
- While holding the preset buttons, press and hold the VOL/Power button. Release all the buttons when the audio unit software appears on the display.
- Press and hold the CD/CDL button for about 5 seconds until the CDL version appears.
- Press the TITLE button. The RES version appears on the display. If the current version is not at least **DVDv5.29**, go to step 21 and repeat the update procedure.

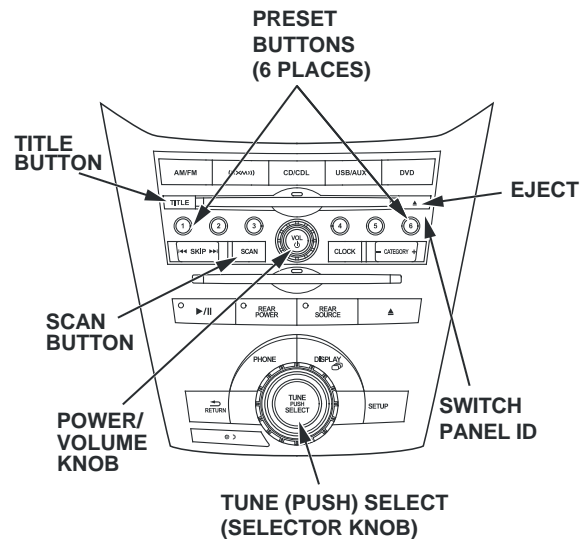
EX-L (WITH RES)

1. Verify that the vehicle is an EX-L with RES model by making sure the audio unit switch panel ID starts with 1PU5.

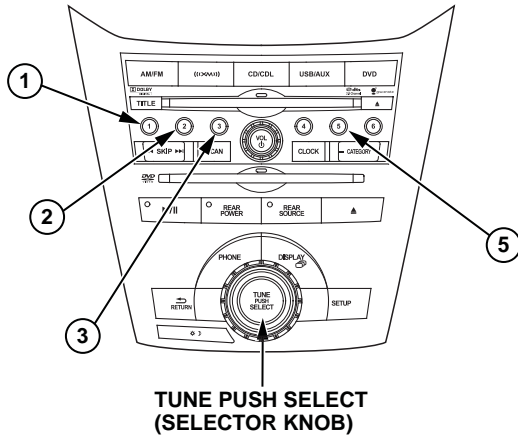
- Press and hold audio preset buttons No. 1, No. 2, No. 3, and No. 5.

- While holding the preset buttons, press and hold the TUNE (PUSH) SELECT knob (selector knob) until the audio unit turns off; you will also hear a thump sound from the speakers. Release all the buttons.

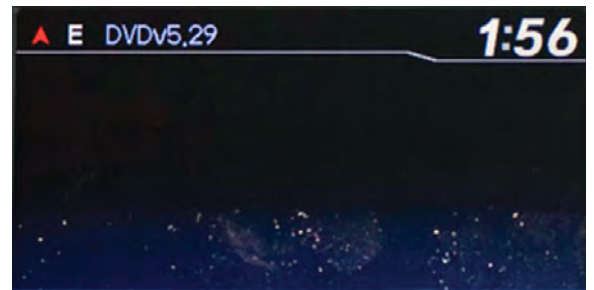
17. Check the RES version software to see if it needs an update:

- Turn off the audio unit, then press and hold audio preset buttons No. 1, No. 3, and No. 5.
- While holding the preset buttons, press and hold the VOL/Power button. Release all the buttons when the audio unit software appears on the display.
- Press and hold the CD/CDL button for about 5 seconds until the CDL version appears.
- Press the TITLE button. The RES version appears on the display.
  - If the current version is not at least **DVDv5.29**, go to step 18 and do the update procedure.
  - If the version is **DVDv5.29** or higher, the RES is updated. Go to step 23 to center-punch the VIN.

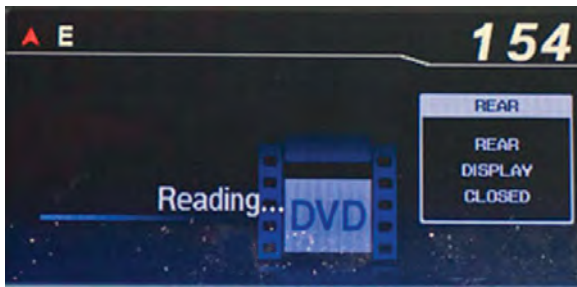
18. Start the engine.
19. Insert T/N 07AAZ-TK8A100 into the lower (RES) slot.
20. Allow the RES to download the update CD. A reading message appears for about 2 minutes while the system updates.

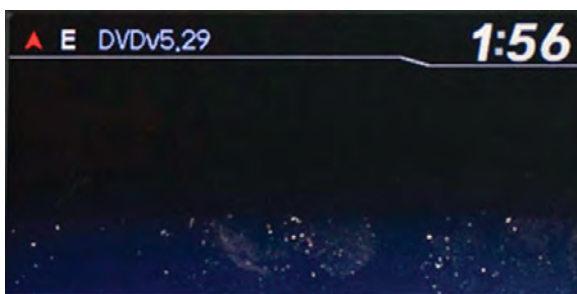
21. When the update is done, the RES automatically ejects the update CD.
22. Turn the ignition switch to LOCK (0), and wait at least 15 seconds.
23. Verify the update by checking that the RES software is **DVDv5.29** or later. To check the software, do this:
  - Turn off the audio unit, then press and hold audio preset buttons No. 1, No. 3, and No. 5.
  - While holding the preset buttons, press and hold the POWER/VOLUME knob. Release all the buttons when the audio unit software appears on the display.
  - Press and hold the CD/CDL button for about 5 seconds until the CDL version appears.
  - Press the TITLE button. The RES version appears on the display. If the current version is not at least **DVDv5.29**, go to step 16 and repeat the update procedure.

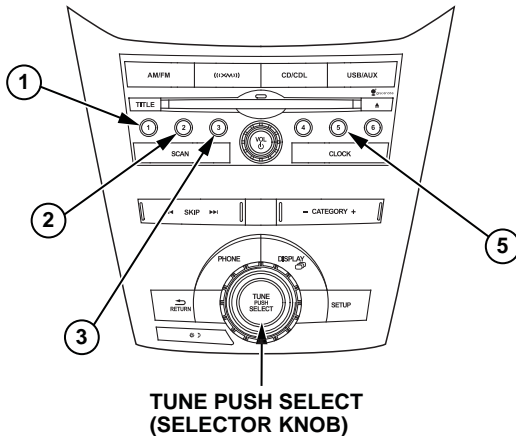
7. To verify that the recovery was successful:
  - Press and hold audio preset buttons No. 1, No. 2, No. 3, and No. 5.

- While holding the preset buttons, press and hold the TUNE (PUSH) SELECT knob (selector knob) until the audio unit turns off. Release all the buttons.  
NOTE: The EX-L is shown. Other models are similar.
