SERVICE BULLETIN

TS35-U01

TS-35 EPA10 alternator charge system modification.

The Aim of this bulletin is to solve the Alternator low charge Voltage issue (while charging Alternator output Voltage around 25V). After applying this modification Alternator Charge Voltage must be around 27-28Volts level.

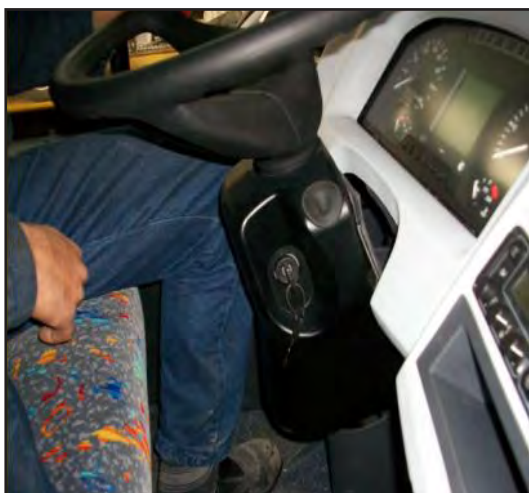
Photo 1

1. Turn the ignition off.

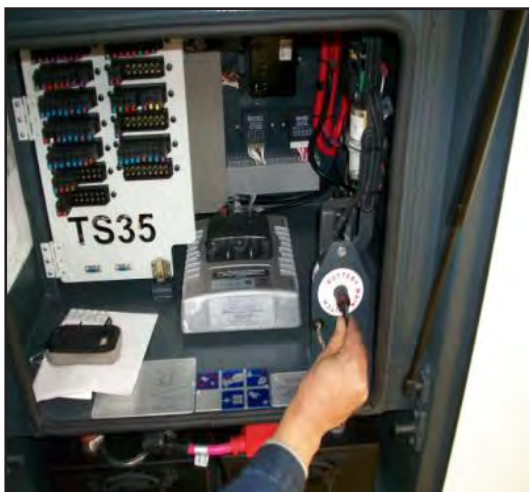
Photo 2

2. Turn the battery main switch off.

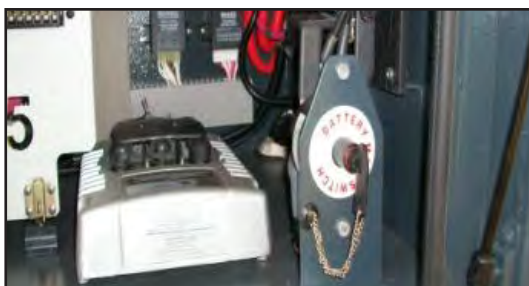
Photo 3

3. If you have six fuse blocks in your electric panel as shown Photo 4 follow Step 3a otherwise got Step 3b. (Six FuseBlocks , each has 20 fuses on it)

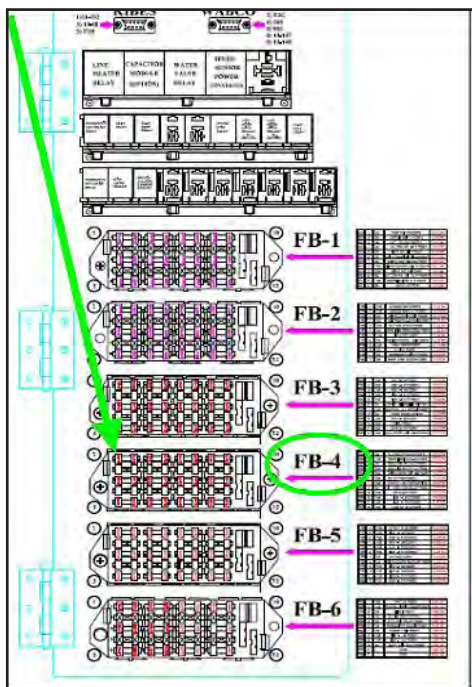
Photo 4

3a. Disconnect the 16-202 cable at the back of the FB4-1 fuse. (Photo 4, 5, 6)

TEMSA delivered the first 10 EPA10 TS35 buses with this type of FUSE BLOCKS as shown below , each FUSEBLOCK has 20 fuses on it

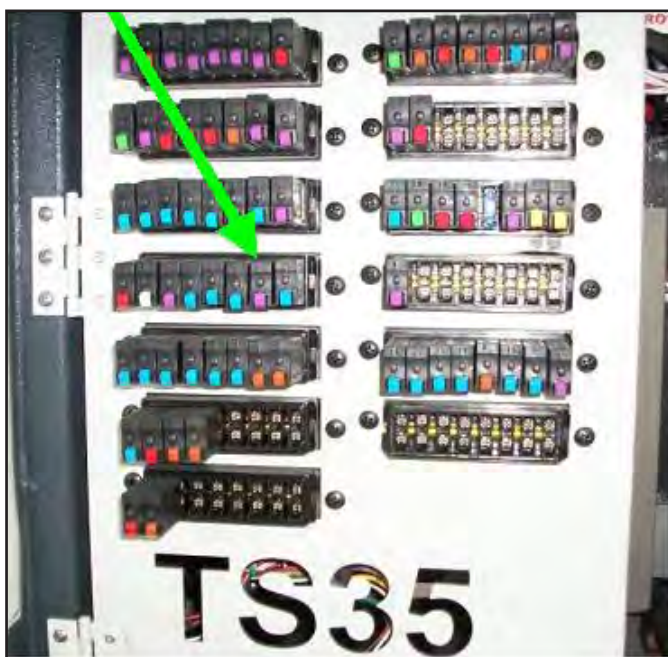
Photo 8

Except for the first ten buses TEMSA delivered the all other EPA10 TS35 buses with this type of fuse as shown below, each FUSEBLOCK has 8 fuses on it.

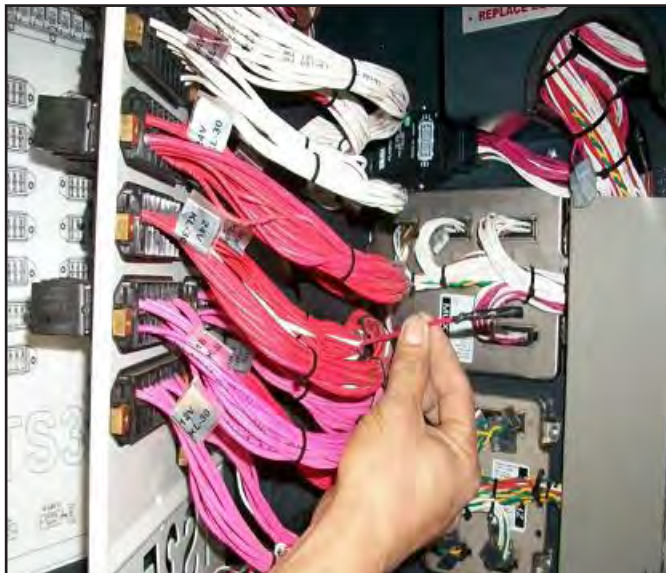
Photo 11

4. Isolate the cable with isolation tape.

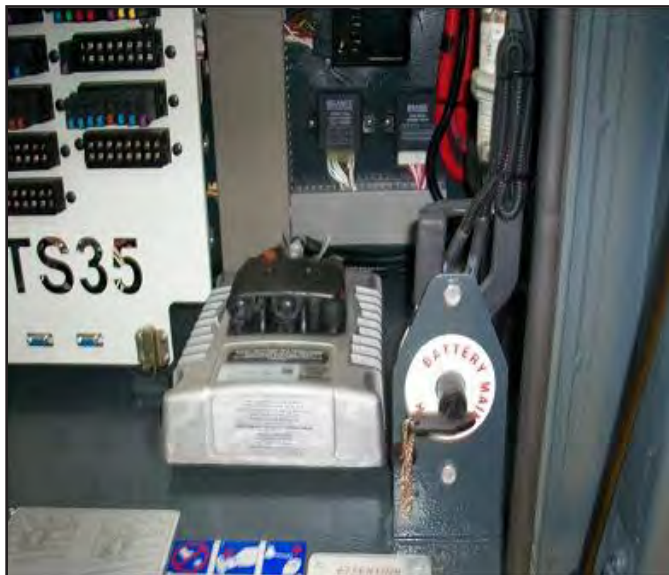
Photo 14

6. Turn the battery main switch on.

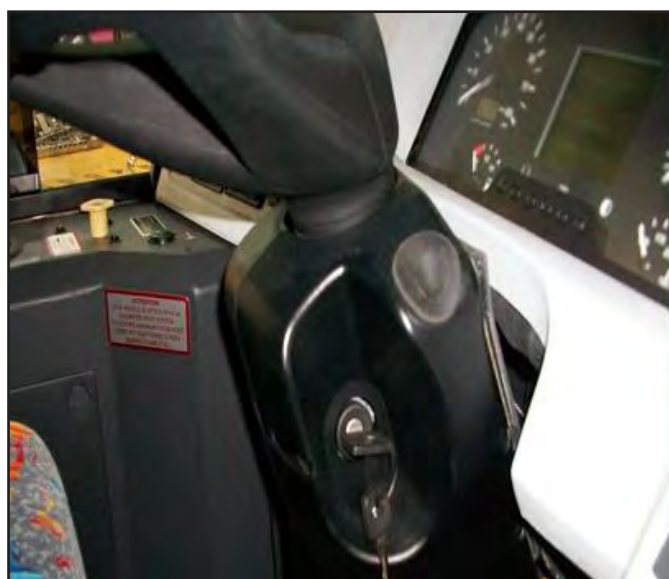
Photo 15

7. Turn the ignition on.

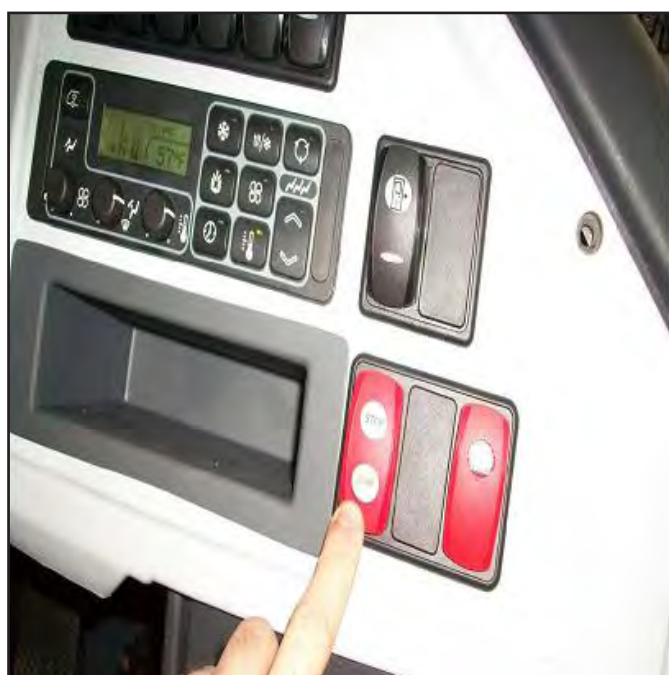
Photo 16

8. Start the engine and then check the battery voltage whether between 27-28V.
