**SB-10043468-2953**

Improved Transverse Torque Rod Bracket Workstar Severe Duty Models

Workstar-Severe Service Models - Latin America Markets

All models up to VIN: 672707

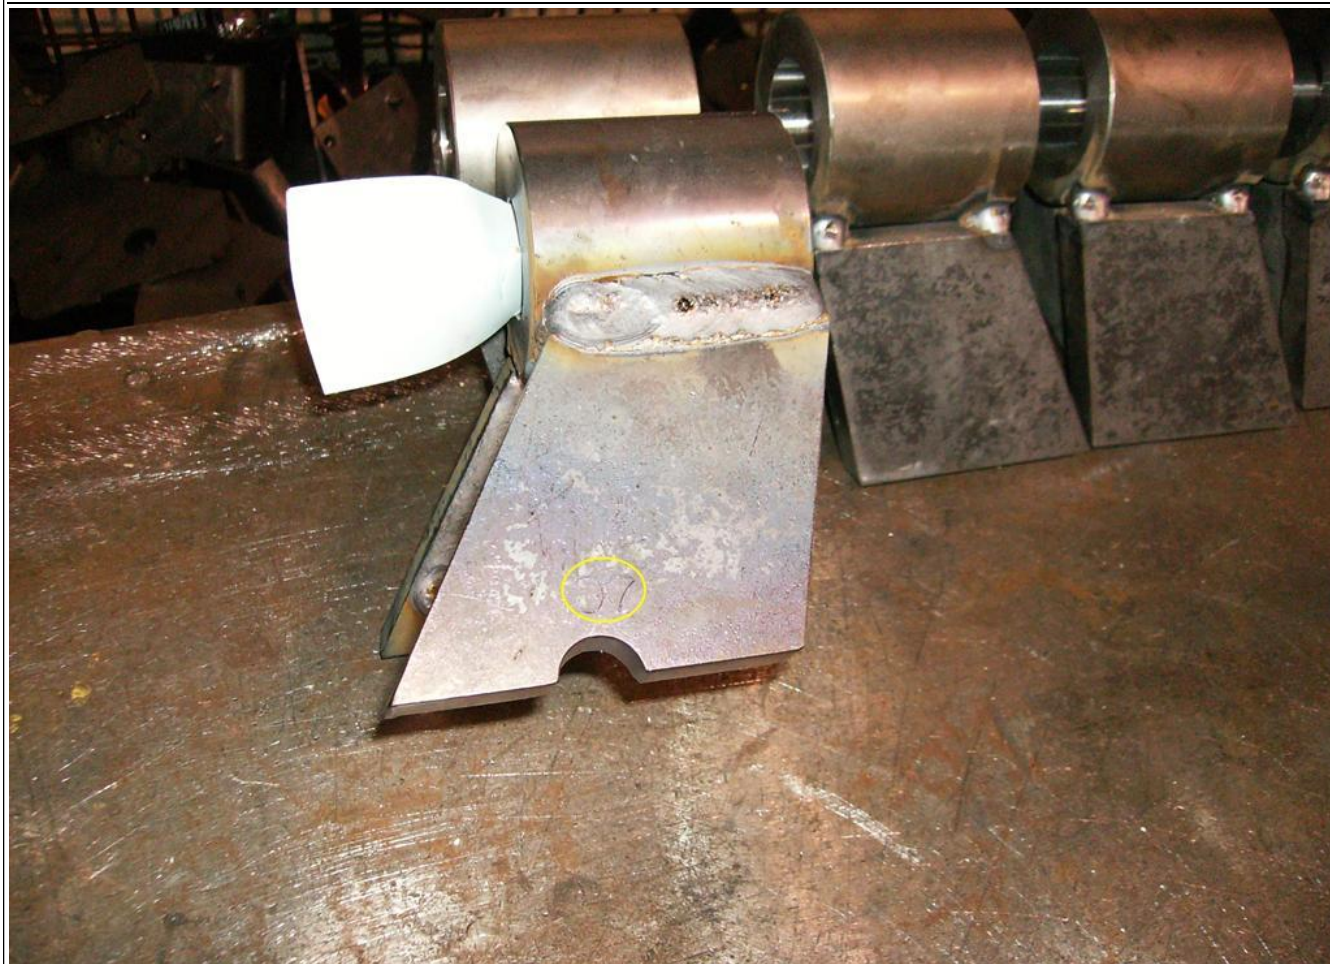
The transverse torque-rod tower bracket on rear axle(s) could fail under severe duty applications.

Modified/improved Bracket Identification marking (circled in yellow)

An improved and stronger transverse bracket has been released to address this concern. The improved part can be quickly identified by a marking on the side of the bracket (see picture).
