Subject: Service Action 72D9

2012 MY Volkswagen Passat – Passenger Seat Track Tab(s)

Service Action 72D9 – Passenger Seat Track Tab(s)

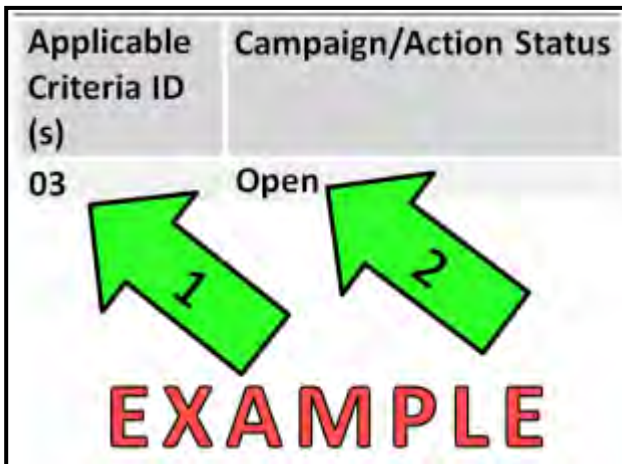
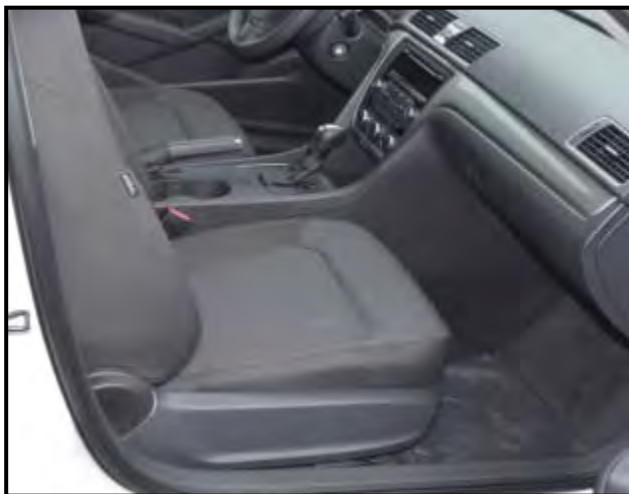
⇐ Enter the VIN in ElsaWeb and proceed to the “Campaign/Action” screen

⇐ Ensure that the Status is “Open” <arrow 2>

⇐ Note the Applicable Criteria ID <arrow 1> for use in determining the correct work to be done and corresponding parts associated

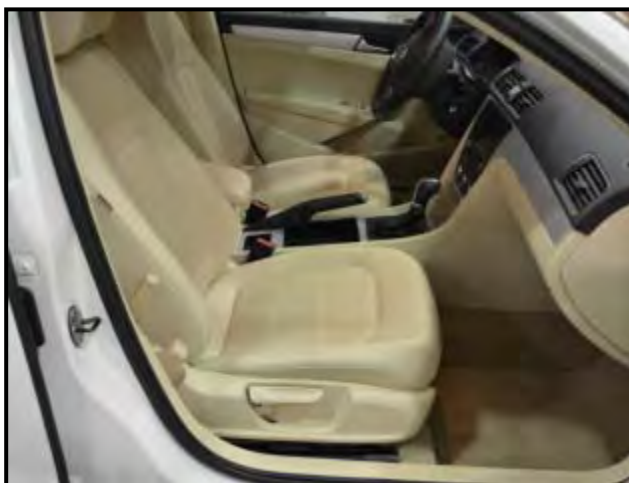
Tip: Criteria 01 – Manual seat without height adjustment <shown left>

⇐ If working on a vehicle tagged with Criteria 01 and containing a passenger-side manual seat without height adjustment <shown left>, **Continue to Section B**

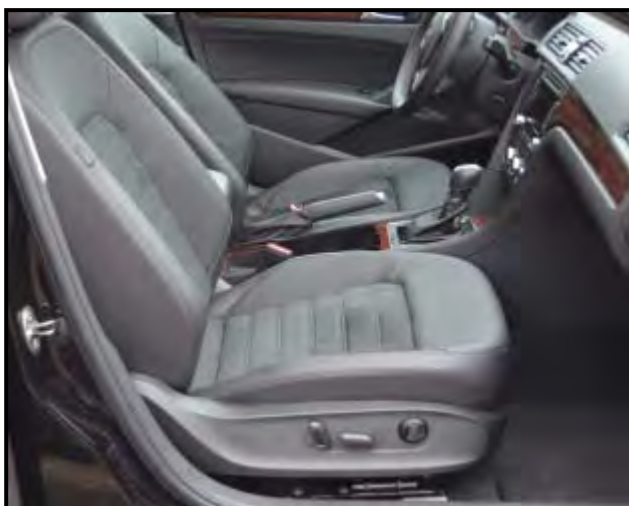
Tip: Criteria 02 – Manual seat with height adjustment <shown left>

⇐ If working on a vehicle tagged with Criteria 02 and containing a passenger-side manual seat with height adjustment <shown left>, **Continue to Section C**

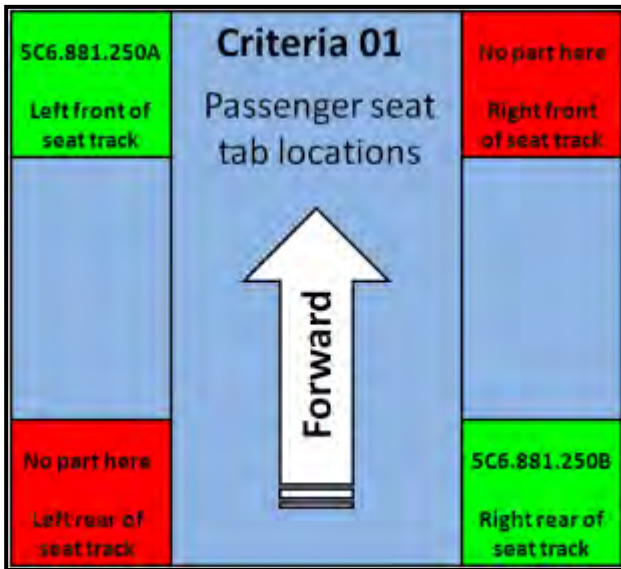
**Section B (Criteria 01 vehicles)
– Inspect for Missing Seat Track Tabs**

Tip: Illustration <left> shows Criteria 01 inspection points and part locations colored in green.

Tip: Criteria 01 vehicles contain a passenger side manual seat without height adjustment.

Tip: Criteria 01 vehicles DO NOT contain seat track tabs on the right front or left rear of the passenger side seat tracks. DO NOT install seat track tabs in these locations.

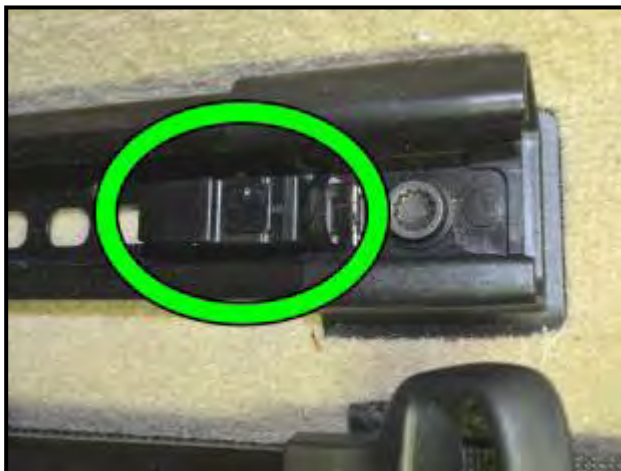
- Open passenger side front door
- Move passenger side front seat rearward
- ⇐ On the passenger side front seat, inspect left front seat of track to ensure the tab <circle> is installed in the seat track
- ⇐ If seat track tab is missing install part # **5C6 881 250A** <as shown>

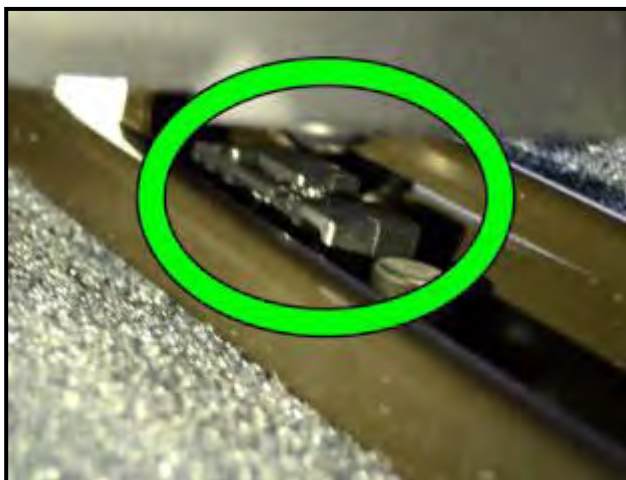
- Move passenger side front seat forward
- Open passenger side rear door
- ⇐ On the passenger side front seat, inspect right rear of seat track to ensure the tab <circle> is installed in the seat track
- ⇐ If seat track tab is missing from this location, install part number **5C6 881 250B** <as shown>
- Reposition seat to its original position
- Close passenger door(s)

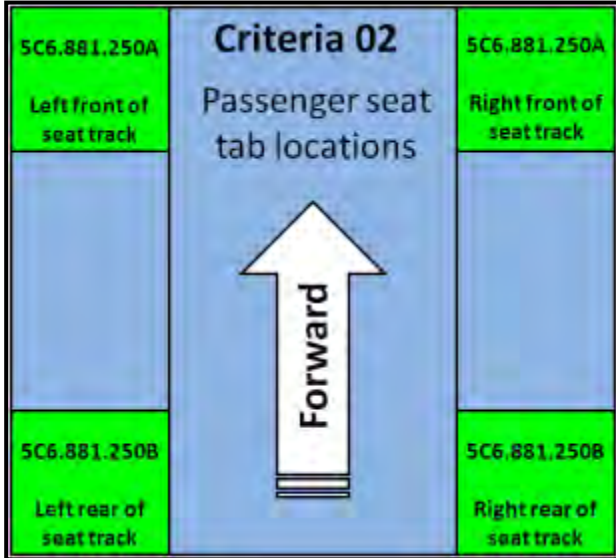
Section C (Criteria 02 vehicles) – Inspect for Missing Seat Track Tabs

Tip: Illustration <left> shows Criteria 02 inspection points and part locations colored in green.

Tip: Criteria 02 vehicles contain a passenger side manual seat with height adjustment.

Tip: Criteria 02 vehicles contain seat track tabs on all four inspection points of the seat track.

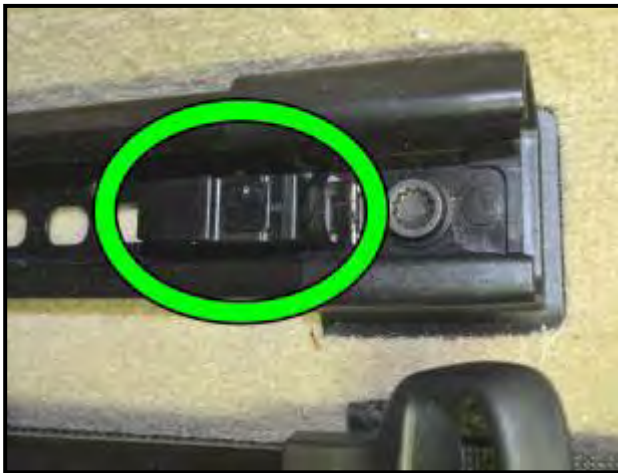
- Open passenger side front door
- Move passenger side front seat rearward and to its upper most height position
- ⇐ On the passenger side front seat, inspect left front of seat track to ensure the tab <circle> is installed in the seat track
- ⇐ If seat track tab is missing install part # **5C6 881 250A** <as shown>

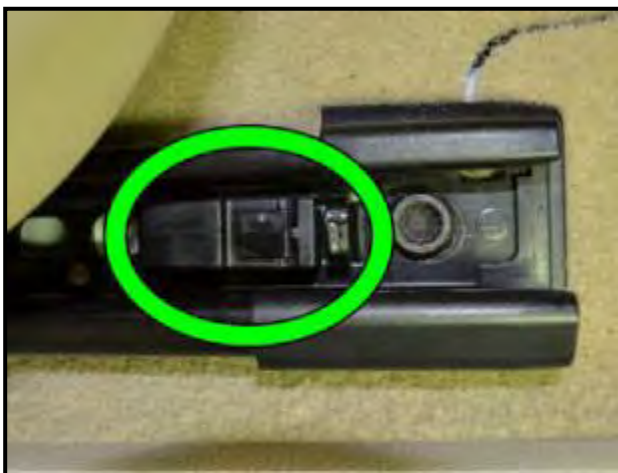
- ⇐ On the passenger side front seat, inspect right front of seat track to ensure the tab <circle> is installed in the seat track
- ⇐ If seat track tab is missing install part # **5C6 881 250A** <as shown>

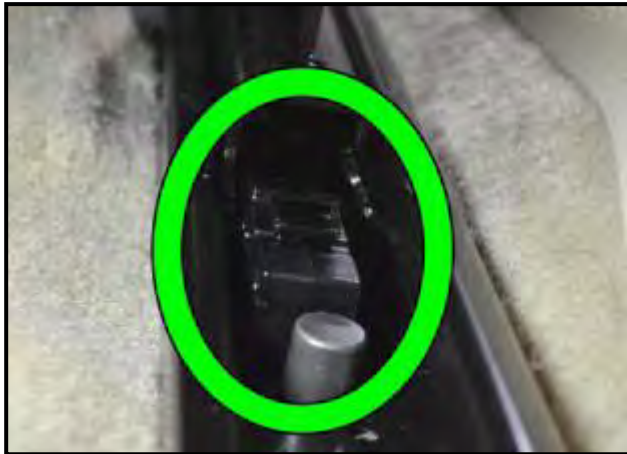
- Move passenger side front seat forward
- Open passenger side rear door
- ⇐ On the passenger side front seat, inspect right rear of seat track to ensure the tab <circle> is installed in the seat track
- ⇐ If seat track tab is missing from this location, install part number **5C6 881 250B** <as shown>

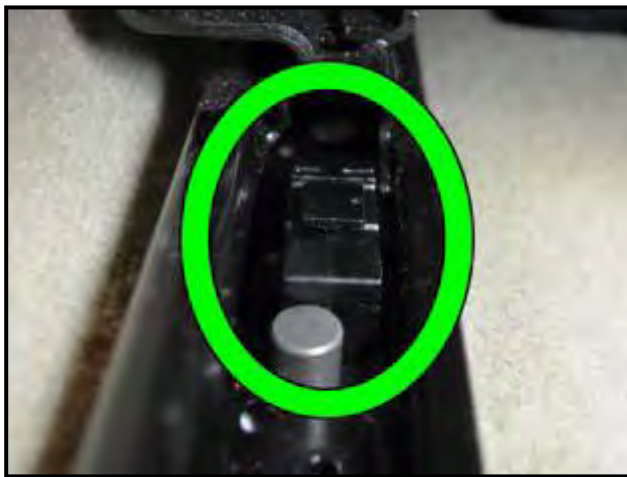
- ⇐ On the passenger side front seat, inspect left rear of seat track to ensure the tab <circle> is installed in the seat track
- ⇐ If seat track tab is missing from this location, install part number **5C6 881 250B** <as shown>
- Reposition seat to its original position
- Close passenger door(s)
- **Continue to Section E**

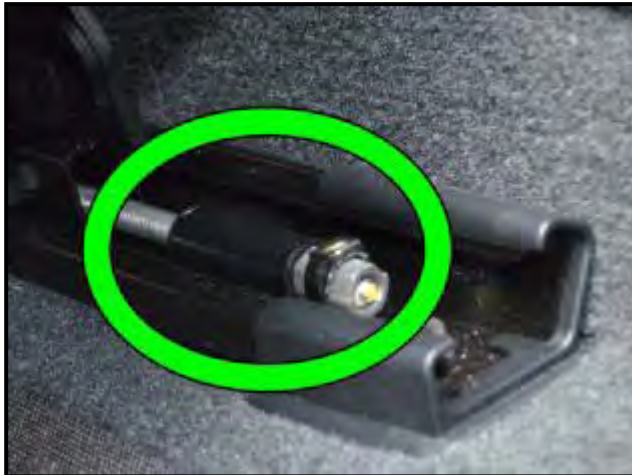
- Open passenger side front door
- Move passenger side front seat rearward and to its upper most height position
- ⇐ On the passenger side front seat, inspect left front of seat track to ensure the tab <circle> is installed in the seat track
- ⇐ If seat track tab is missing install part # **3D0 881 250** <as shown>

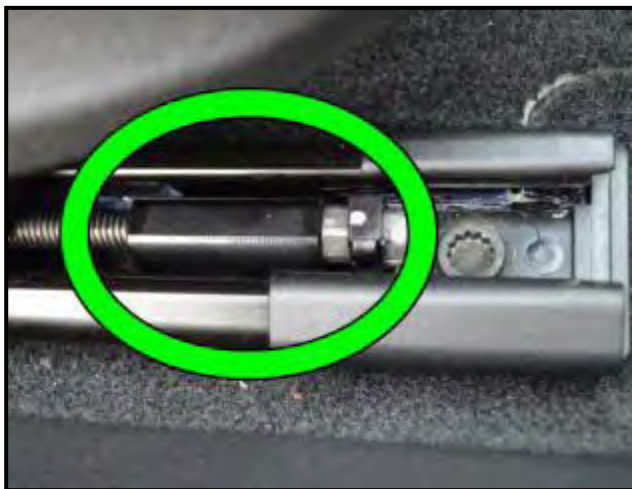
- ⇐ On the passenger side front seat, inspect right front of seat track to ensure the tab <circle> is installed in the seat track
- ⇐ If seat track tab is missing install part # **3D0 881 250** <as shown>

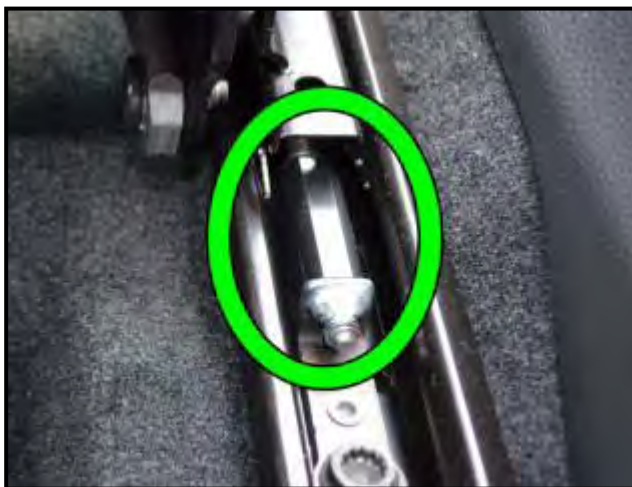
- Move passenger side front seat forward
- Open passenger side rear door
- ⇐ On the passenger side front seat, inspect right rear of seat track to ensure the tab <circle> is installed in the seat track
- ⇐ If seat track tab is missing from this location, install part number **3D0 881 250** <as shown>

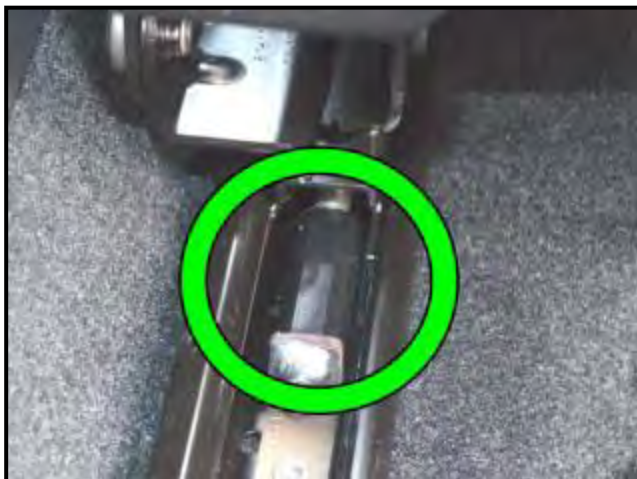
- ⇐ On the passenger side front seat, inspect left rear of seat track to ensure the tab <circle> is installed in the seat track
- ⇐ If seat track tab is missing from this location, install part number **3D0 881 250** <as shown>
- Reposition seat to its original position
- Close passenger door(s)
- **Continue to Section E**
