Authorized Field Change

AFC 11928

Subject: Heater Supply Pipe Change

Certain WorkStar® vehicles built with MaxxForce® 11 or 13 2010-emission engines may experience leaks in the single-piece water pipe. The purpose of this AFC is to replace the single-piece water pipe with the three-piece water pipe on WorkStar® models.

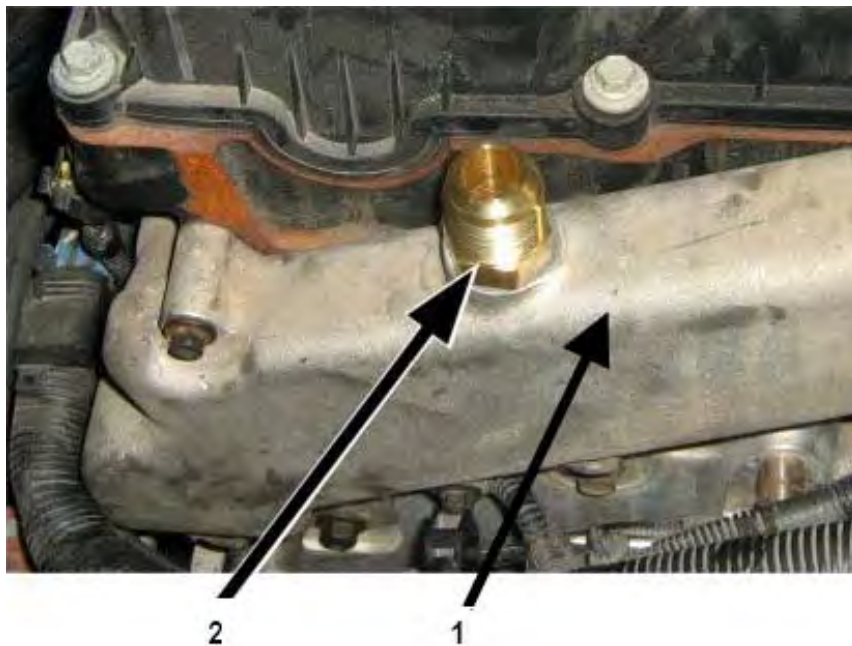
Figure 1 EGR Crossover Pipe (Rear of Engine)

1. EGR crossover pipe (coolant manifold)
2. M18 fitting

1. Park vehicle on a flat surface, shift transmission to park or neutral, set parking brake, and block wheels to prevent the vehicle from moving in both directions.
2. Raise hood assembly.
3. Drain the coolant using the Navistar Coolant Management tool.
4. Remove engine housing cover. (NOTE: It may be necessary to remove trim panels on some models and trim levels.) On ProStar® and TransStar® models with the deluxe interior, removal of the driver and passenger seat and floor mats is necessary.
5. From inside cab, locate EGR crossover pipe (coolant manifold) (See Figure 1, page 3) at the rear of the engine.

6. Remove the single-piece water pipe at the flare fitting end leaving the brass fitting in place in the EGR crossover. NOTE: Hold the brass fitting with a wrench when removing the flare fitting as this is an O-ring seal. The torque on the O-ring fitting should be maintained at 15-18 ft-lb (20-25 N•m). The torque on the flare nut should be 44-55 ft-lb (60-75 N•m). Remove the two fasteners holding the pipe to the EGR cooler housing. Disconnect the front end of the single-piece water pipe from the heater supply hose.

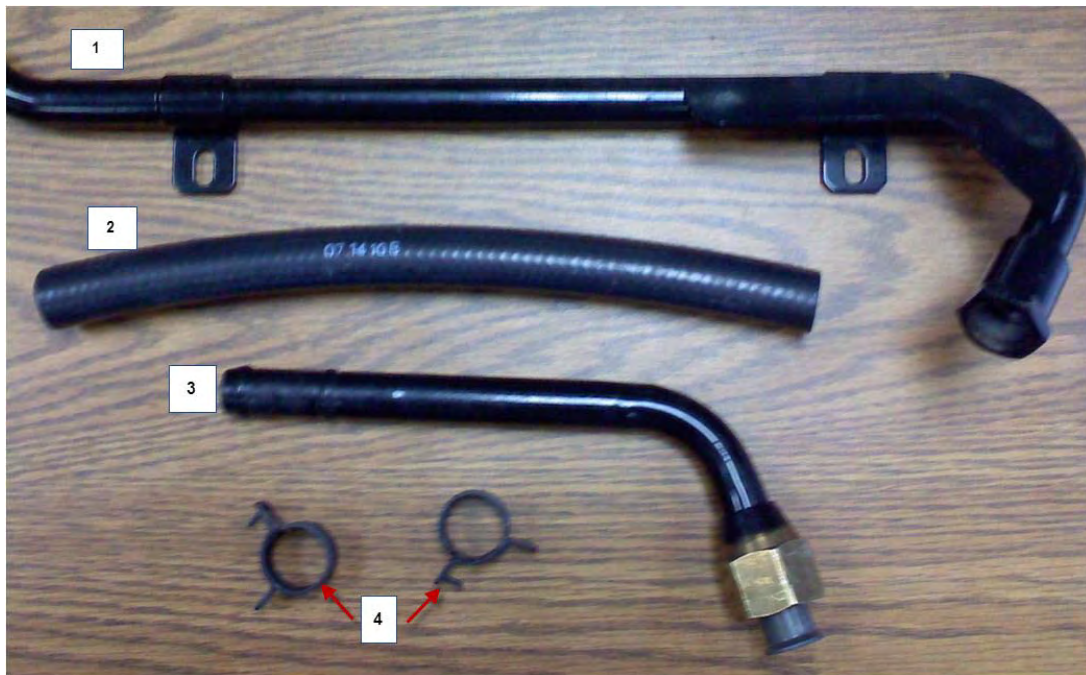
Figure 2 Three-Piece Heater Supply Hose

1. Top of engine-side of heater pipe
 2. 15 in. (380 mm) section of 0.75 in. (19 mm) heater hose (supplied hose may need to be cut to 15 in. length)
 3. Flare side of heater pipe
 4. 2 x Mubea #27 clamps
8. Remove the nipple or shut-off valve from the single-piece pipe and install the nipple or shut-off valve to the new heater supply pipe BEFORE installing on the engine (See Figure 3, page 5).

7. Install new heater supply hose as follows (See Figure 2, page 4).
