# Authorized Field Change

**AFC 11929**

**Subject:** HVAC Front Inside Module Drain Repair

Model: TranStar®, ProStar®, and LoneStar® equipped with Feature 0016WCT – Heater and Air Conditioner (Blend-Air)

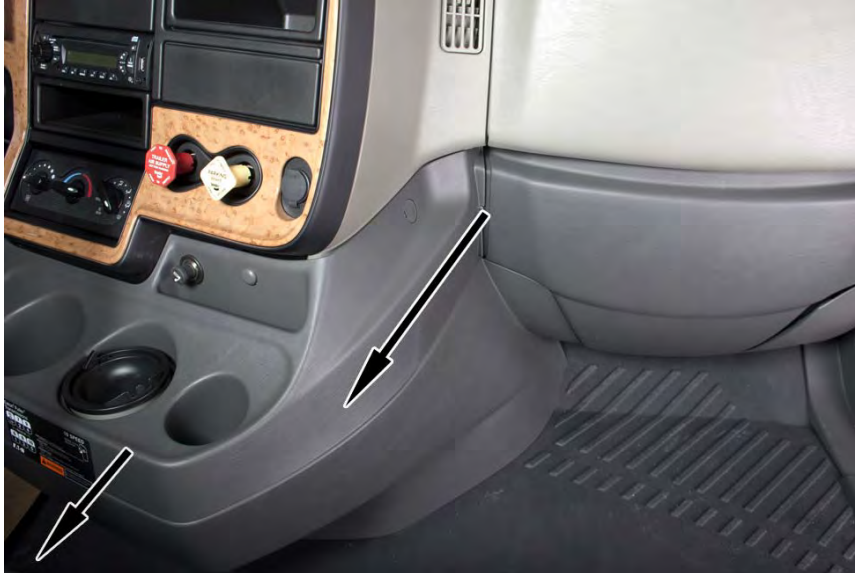
**Figure 2 Detaching Center Console**

2. Detach and pull back the center console to expose the floor mat (See Figure 2, page 3).

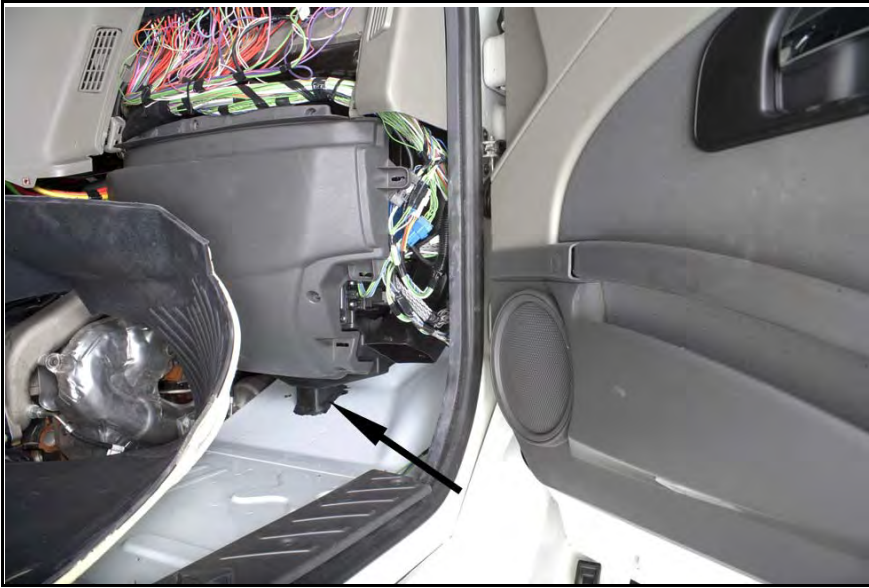
**Figure 3 Pulling Floor Mat away from Drain Area**

3. Pull the floor mat away from the drain area (See Figure 3, page 4).

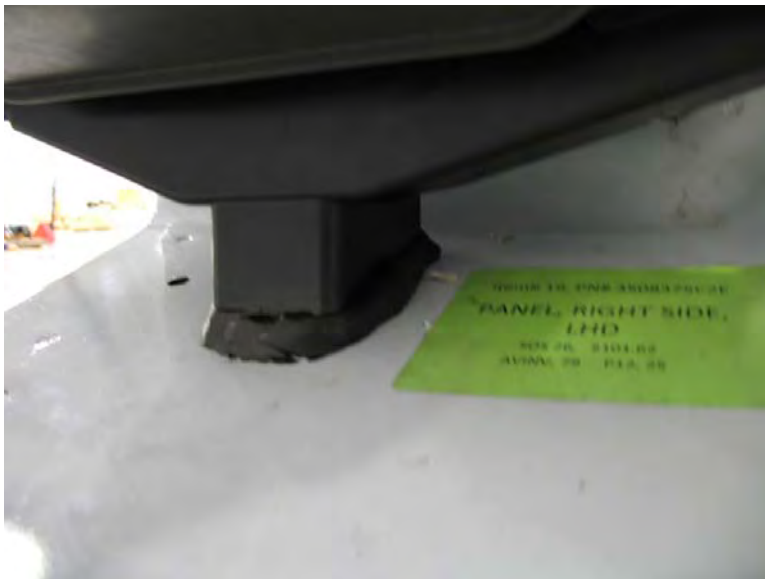
**Figure 9 Sealing HVAC Unit to the Floor**

7. Use sealant (p/n 8000934R91) to seal the HVAC unit to the floor. Make sure not to force excessive sealant into the gap (See Figure 9, page 7 ).
