Technical Service Bulletin

34, 37 Grinding or wheel bearing type noises from front when accelerating or at constant speed

34 12 08 2028650/1 February 21, 2012/

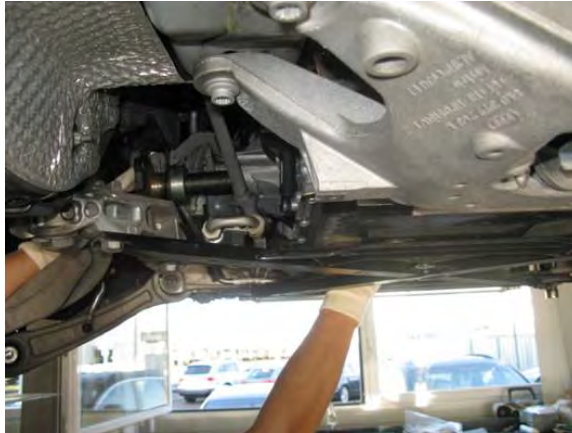
Figure 2. Supporting the flange shaft.

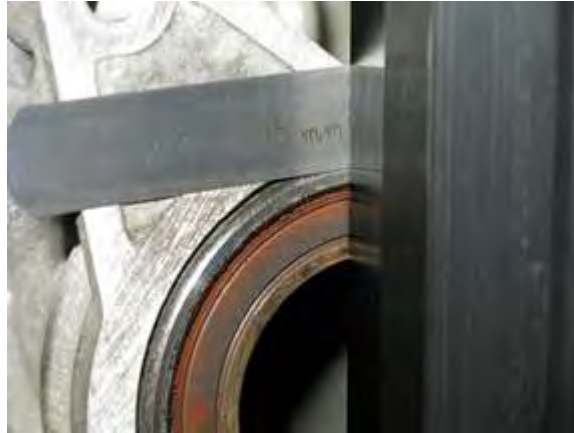
Figure 4. Bearing example.

Tip: Bearing in Figure 4 is only for demonstration purposes, ALWAYS measure using a new bearing.
