SB-10043572-6495**iKNOW**

ProStar™ and LoneStar™ HVAC system compressor and discharge hose failure diagnostics and repair procedures

2008 through pre-2010 emissions engine, equipped ProStar™ and LoneStar™ sleeper model vehicles

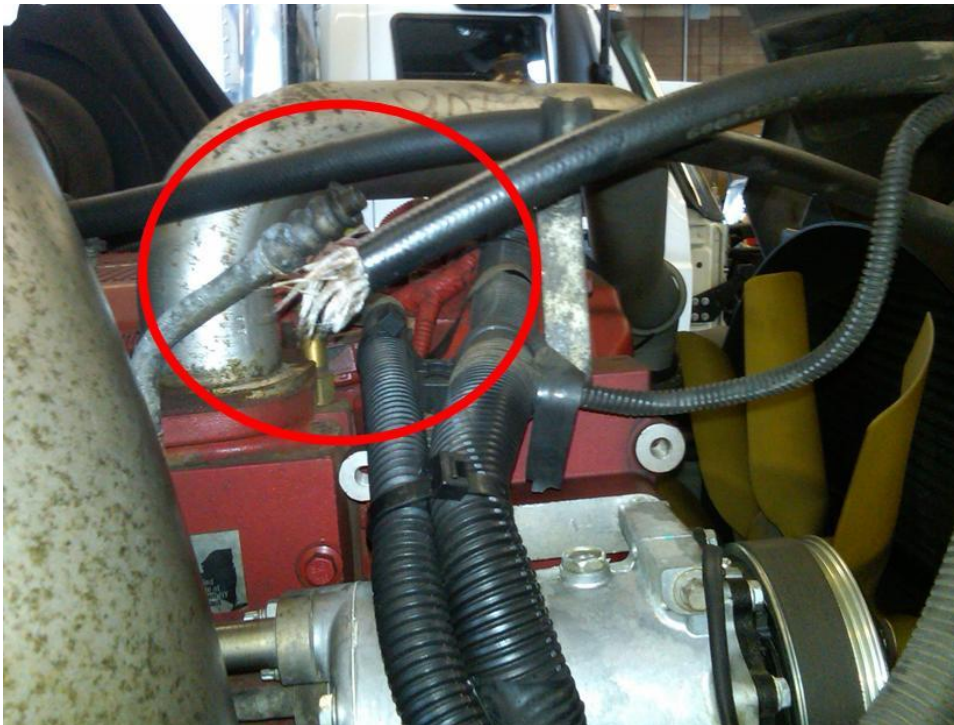
1. Ruptured and leaking A/C compressor discharge hoses, ("high side", compressor to condenser hose):

These ruptures and leaks have commonly occurred at the fitting closest to the compressor. The rupture causes damage to the A/C compressor from the sudden loss of refrigerant and lubricant, therefore replacement of the compressor and complete system flushing is necessary.

5. Do not flush the condenser, replace it. See [TSI1900001](#) "Air Conditioning (A/C) condenser replacement versus flushing" for additional details.

NOTE: If any metallic debris or residue is noted, indicated by metal shavings or black oily residue, after evacuation and disassembly, both TXVs (thermal expansion valves) and the condenser should be replaced. If the compressor discharge hose was ruptured or leaking, replace it also. Install these parts after the flushing and purging.

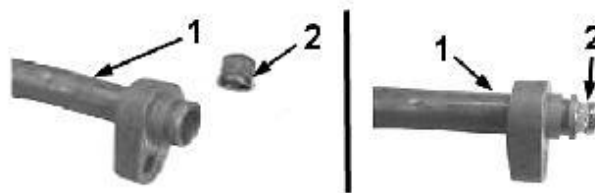
6. Install a HVAC Screen Kit 2607294C91 in the suction hose per [IK1900170](#)

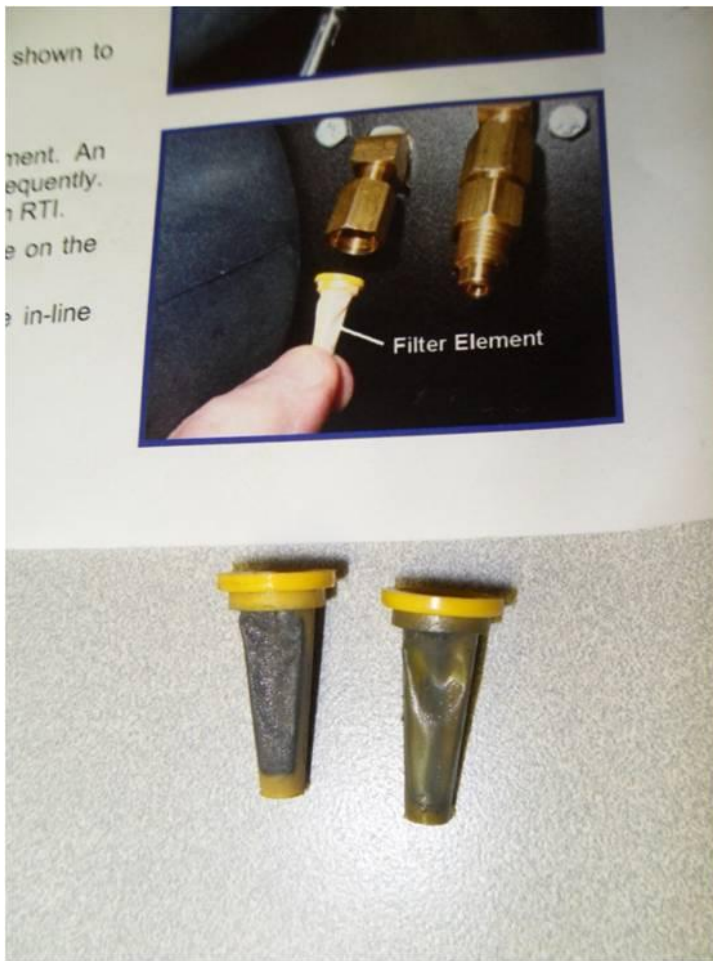
IF YOU RECOVER REFRIGERANT FROM A TRUCK AND THEN DETERMINE THAT THE A/C SYSTEM NEEDS FLUSHING, THE 2 HOSE FILTERS ON THE INTERNATIONAL A/C MACHINE (RTI) NEED TO BE CLEANED OR REPLACED AND BEFORE RECHARGING THE HVAC SYSTEM (Replacement filters listed below)
