**NUMBER: 390120002.02****MODEL: Karma****DATE: February 9, 2012****MODEL YEAR: 2012****TITLE: HV DC Power Cable Inspection****PRIORITY:**

HV DC Power Cable Connector Inspection – All Fisker Karma vehicles produced prior to VIN# YH4K16AA0CA001042 may have a damaged or improperly installed HV DC generator power cable connector.

Low Temperature Electronics Coolant Line Routing – Low temperature coolant lines for electronics may be incorrectly routed over the rear sway bar, causing unwanted tension and kink the hose.

Low Temperature HV Battery Coolant Line Clearance – HV Battery coolant lines may be coming into contact with shield under generator motor, which can damage the hose.

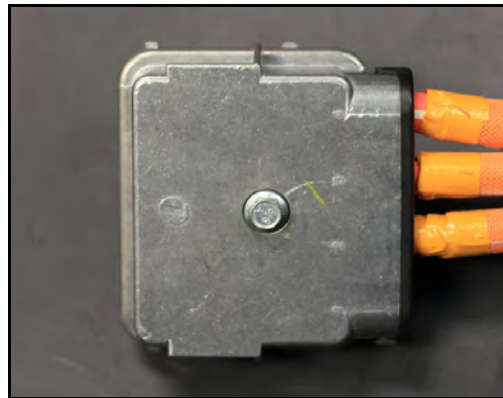
**NOTE:** Example A is an image of an HV generator battery connector with a properly seated seal retainer.

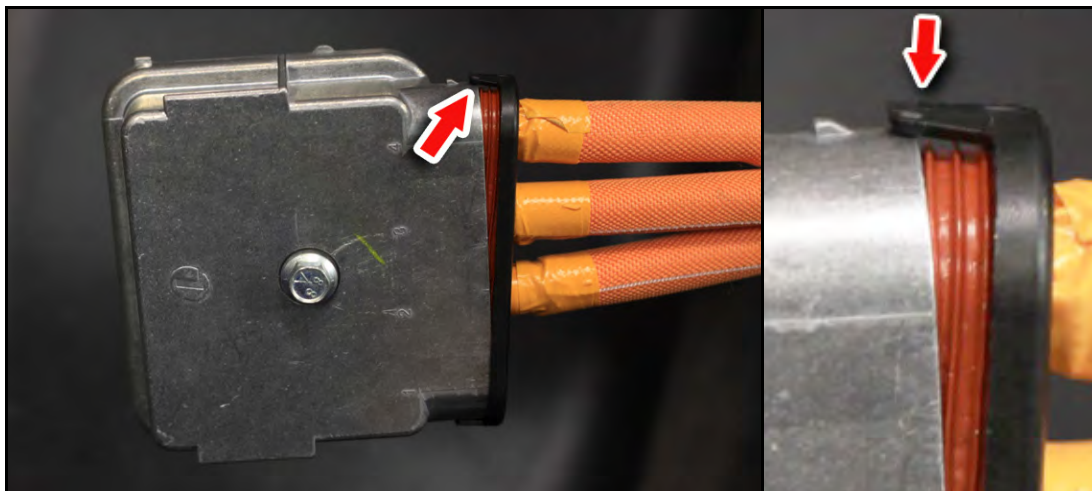
**NOTE:** Example B is an image of an HV generator battery connector with an improperly seated seal retainer, compromising the weatherproof seal.

- If the plastic locking tab (see **red arrow**) is not seated correctly, attempt to re-seat it on connector housing.
- If the plastic locking tab is broken/missing, contact Fisker TSS for further instructions.

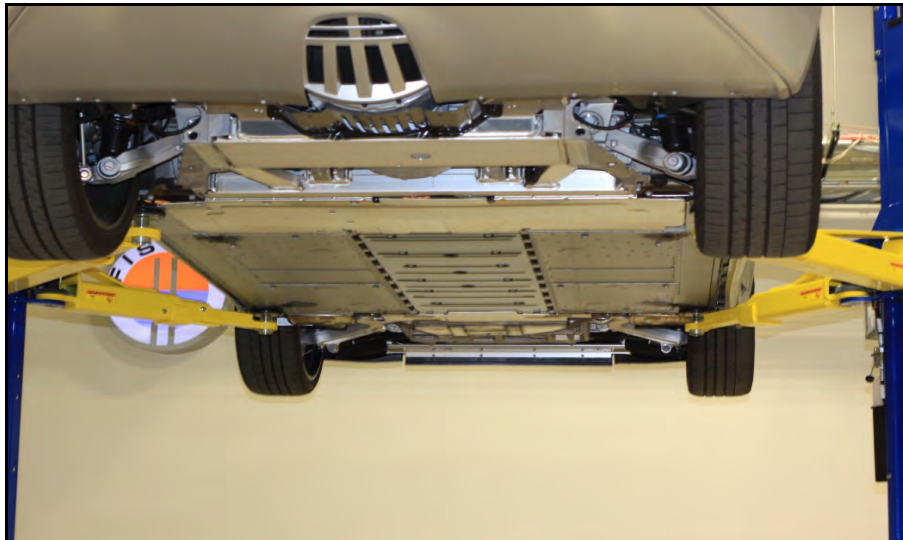
- 1a. Using a lift, elevate the vehicle so that there is full visual access to the HV battery cable connector attached to the generator.

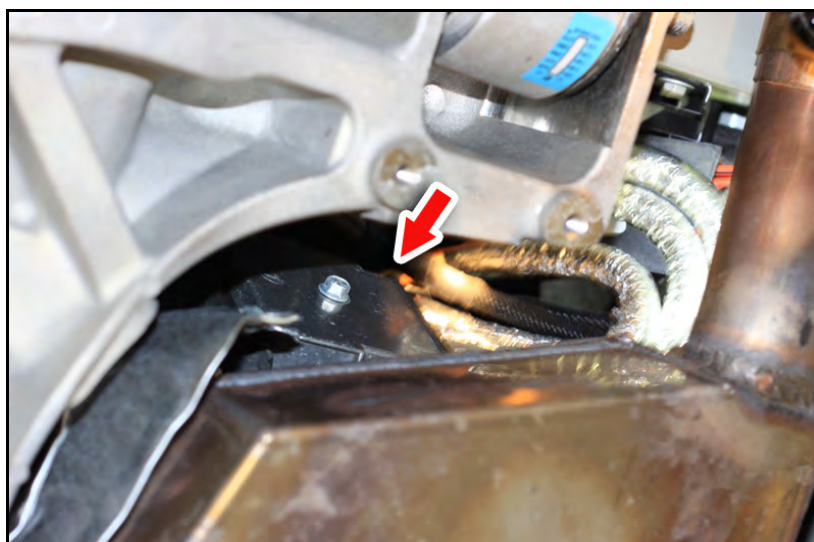
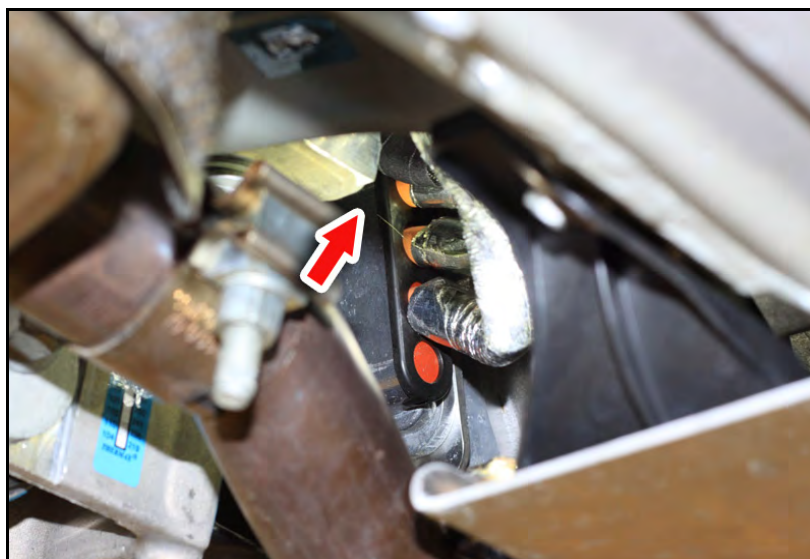
1b. Inspect the HV DC power cable connector (see arrow in images View 1 and 2). It can be viewed by looking between the exhaust system and front suspension sub-frame on driver's side of vehicle.

**NOTE:** If the plastic locking tab is broken/missing, contact Fisker TSS for further instructions.

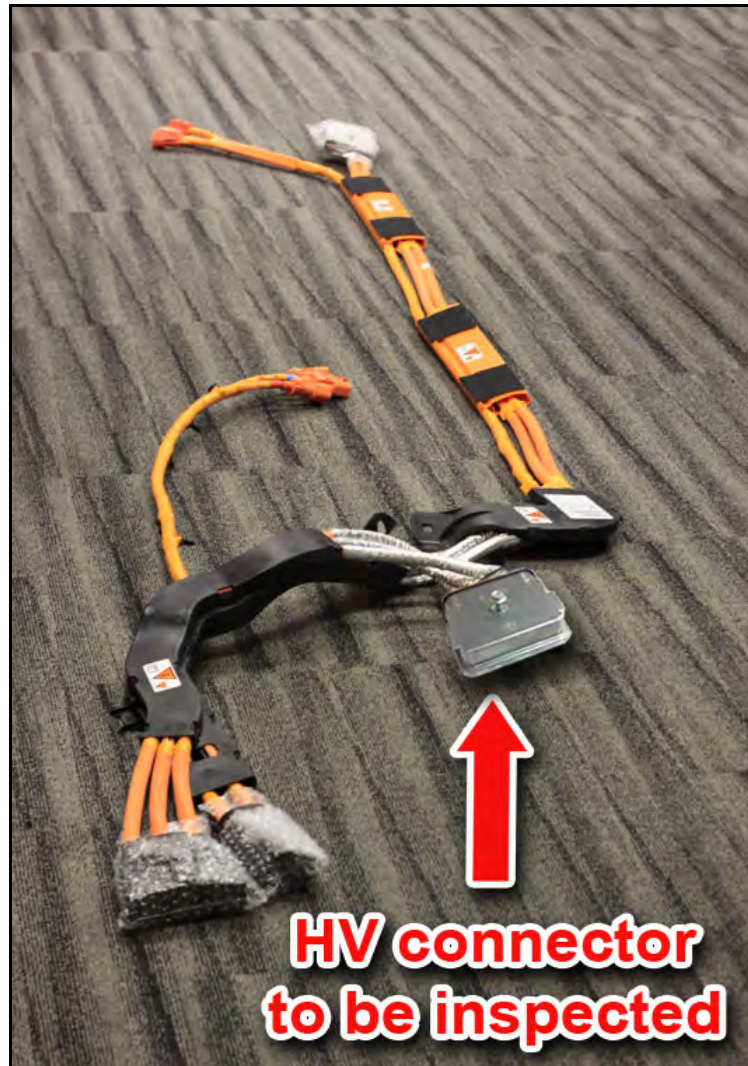
*For reference only: Complete HV Inverter 3 (Gen.) HV DC power cable harness*

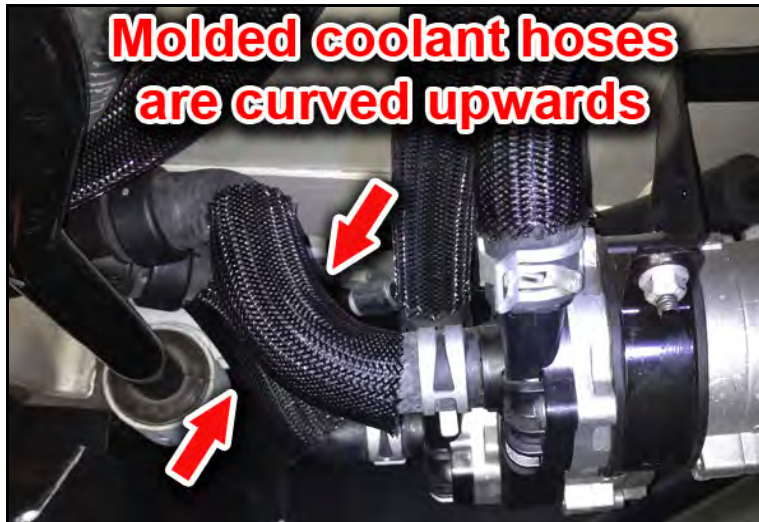
*Molded type (shown in image above with curved hoses connected to front of coolant pumps).*

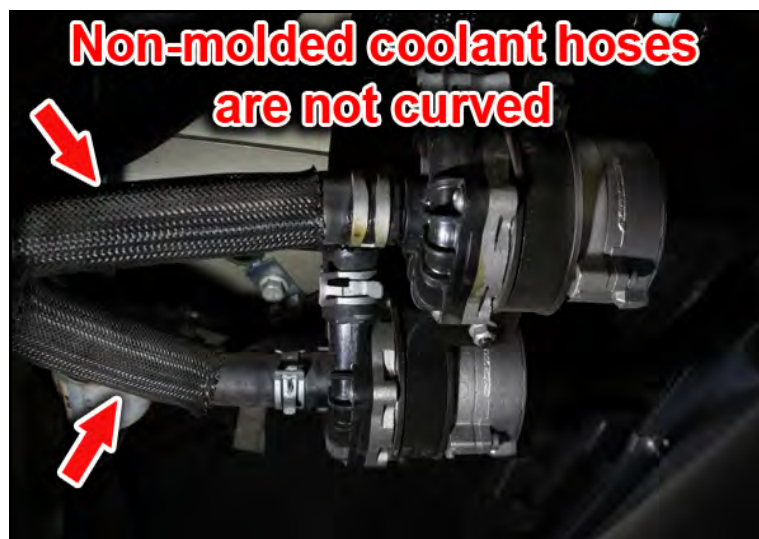
*Non-molded type (shown in image above with straight hoses connected to front of coolant pumps).*

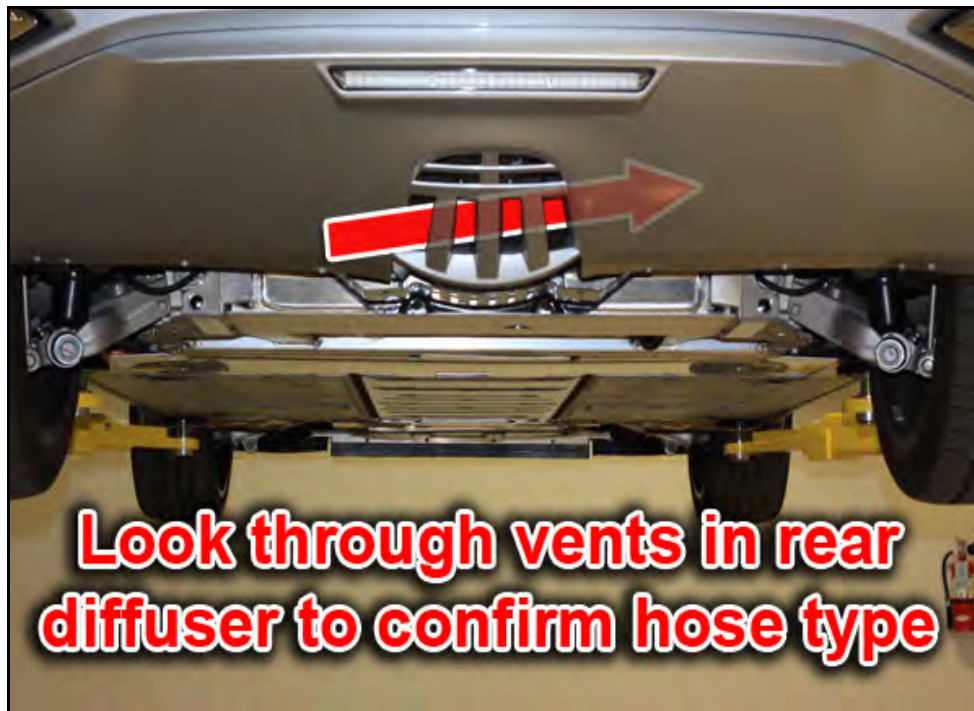
2a. Visually check to confirm hose type (molded or non-molded) by peering through the vents in the rear diffuser closing panel.

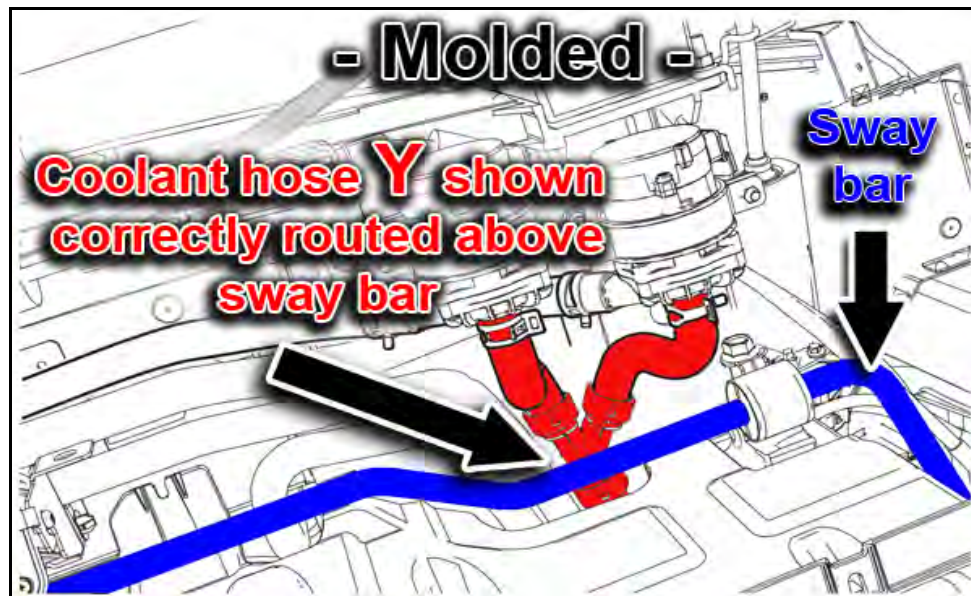
*Proper molded low temperature electronics coolant hose routing (see illustration above).*

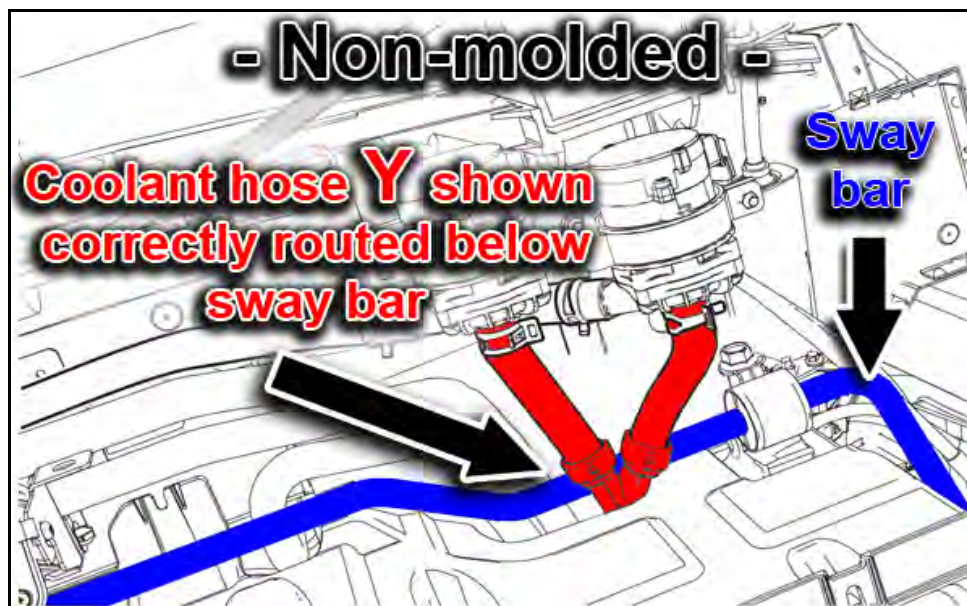
*Proper non-molded low temperature electronics coolant hose routing (see illustration above).*

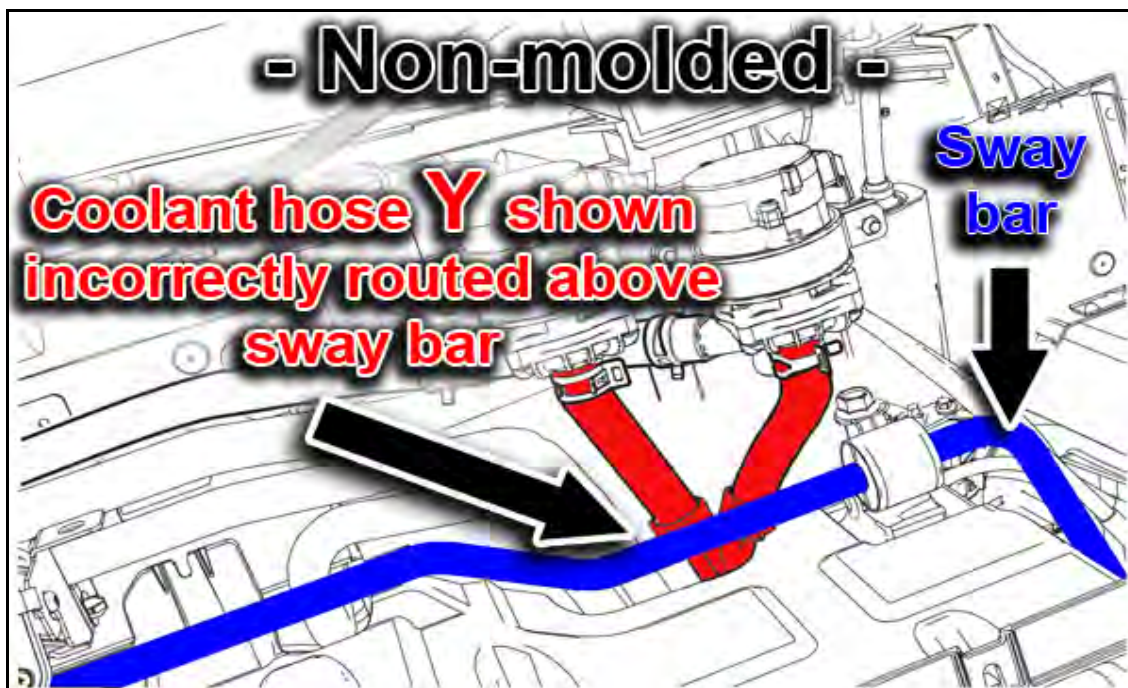
- If rear coolant hoses are non-molded and they are properly routed under the rear sway bar, go to step 10.
- If rear coolant hoses are non-molded and they are incorrectly installed over the top of the sway bar (as shown in illustration below), continue with following instructions to reroute coolant line.

7b. Reroute coolant hoses under the rear sway bar (see illustration below).

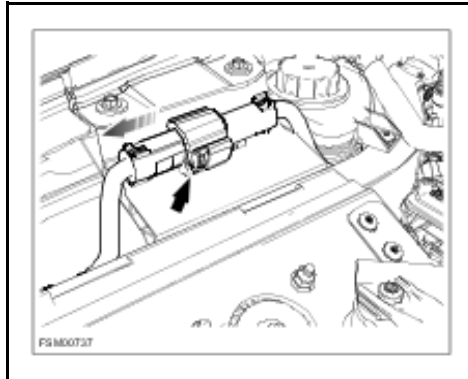
*12 Volt Battery Negative Connector C104*

3a. Power down the vehicle. Open the hood and disconnect the 12 Volt battery via connector C104.

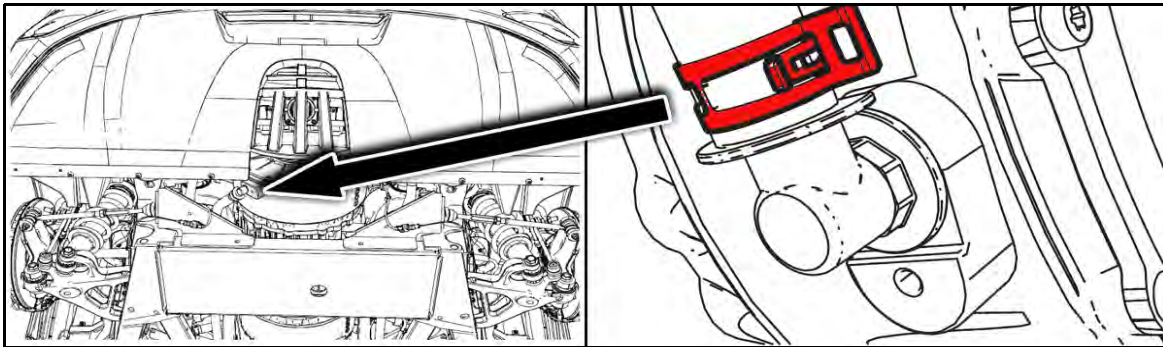
5a. Release hose clamp (red in illustration below) and disconnect rear drive motor coolant hose.

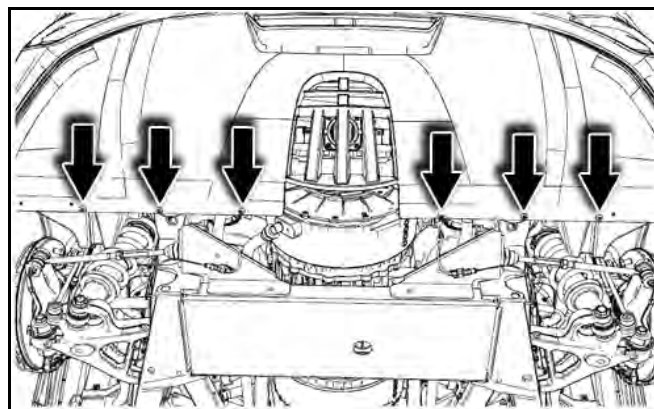
6a. Remove screws (x6) securing rear diffuser to closing panel (see illustration below).

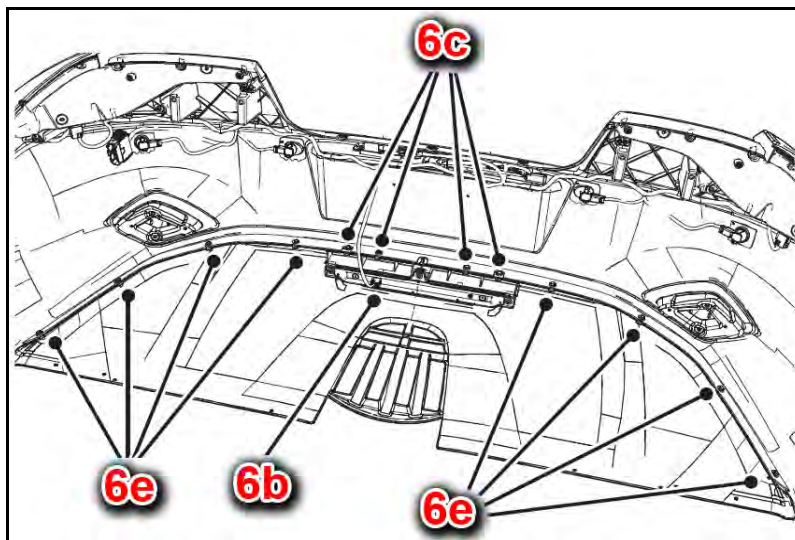
6b. Disconnect bumper harness connector from fog/reverse lamp (see illustration below).

6c. Remove bolts (x4) securing fog/reverse lamp bracket to rear bumper cover and diffuser (torque 3 Nm) (see illustration below).

6e. Remove bolts (x8) securing diffuser to rear bumper (torque 3 Nm) (see illustration below).

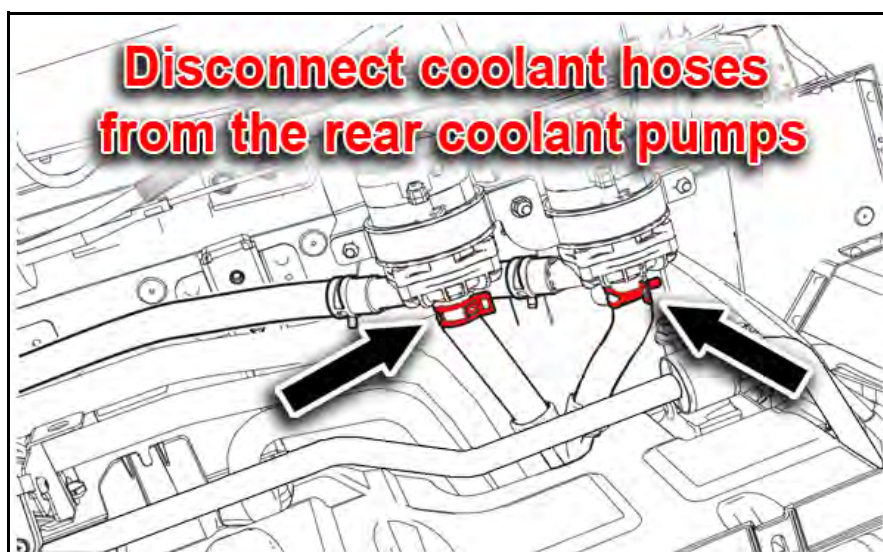
7a. Release clamps (see illustration below) and disconnect coolant hoses from rear pumps.

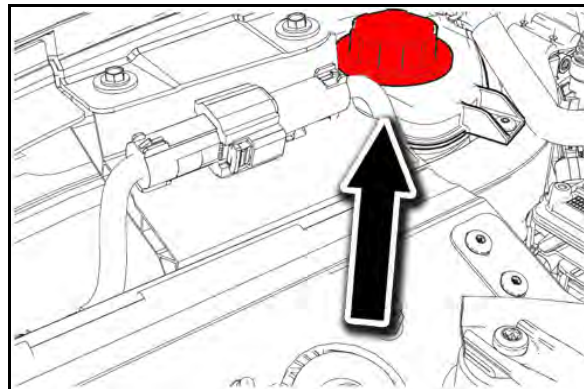
9a. Remove cap (red in image below) from low temperature electronics coolant reservoir.

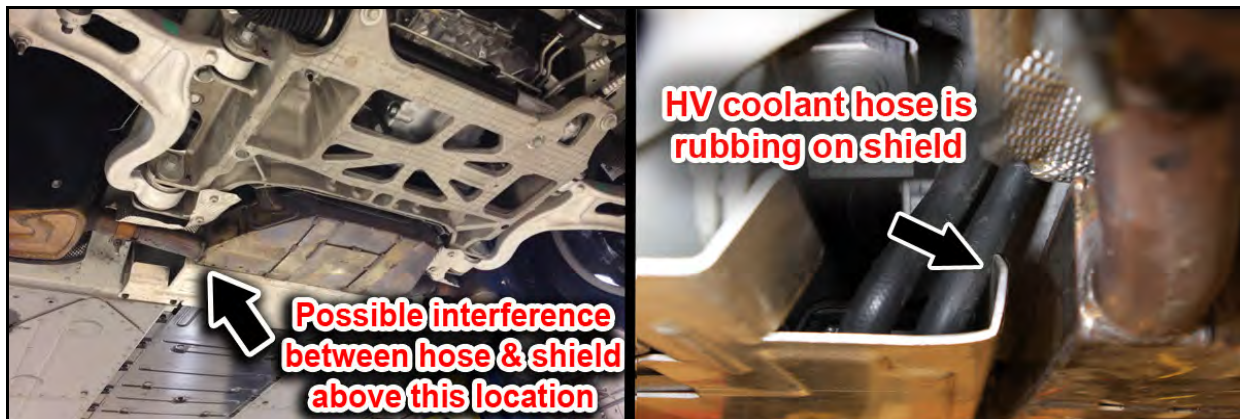
10a. Inspect low temperature HV battery coolant line for interference with generator shield (refer to images below).

- If HV battery coolant line is not touching generator shield, no additional repairs are required.
- If HV battery coolant line is touching generator shield (as seen in right image below), continue with following instructions to eliminate interference.

10b. Bend shield flap forward to give more clearance for coolant hoses as shown in image below.

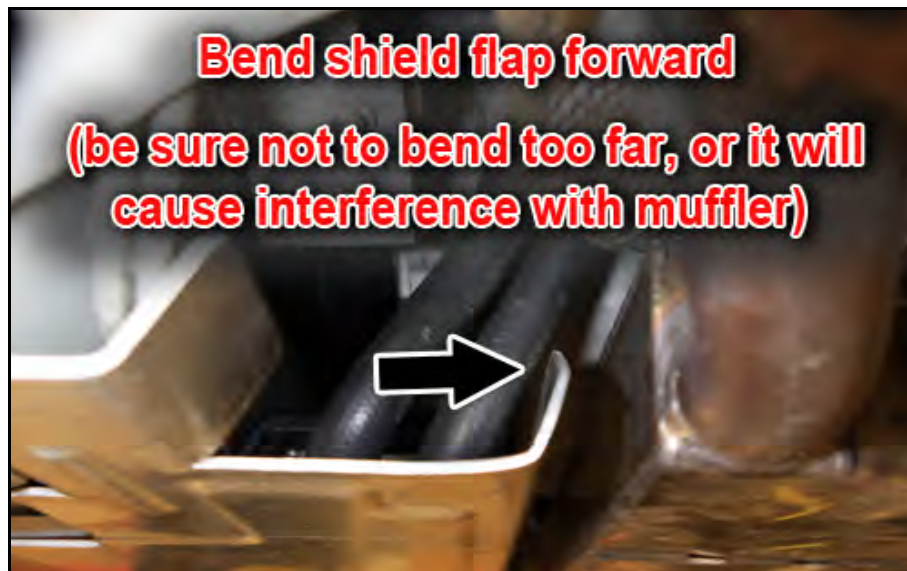
**NOTE:** Do not bend shield too far forward or else it will cause interference with muffler and cause rattle.

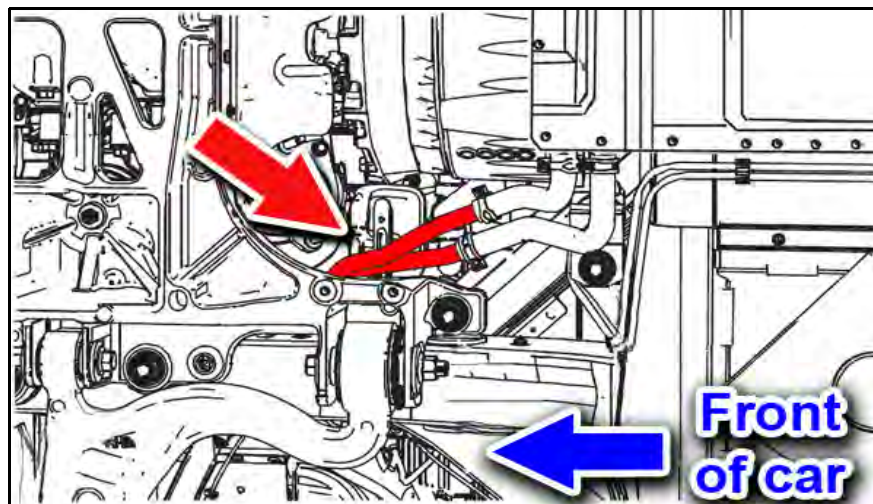
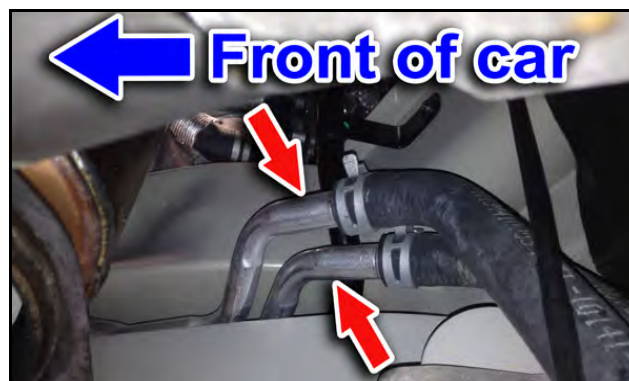
10c. To give additional clearance between coolant hoses and shield, it's possible to slightly bend coolant pipes (see red colored pipes in illustration below) located above muffler assembly.

**NOTE:** Pipes should not be bent more than a 2 degree angle, or else you can damage them.

*Actual image of coolant pipes.*

**Do not bend coolant pipes leading into HV Battery or damage to battery will occur.**
