SERVICE BULLETIN

APPLICABILITY: 2012MY Impreza
SUBJECT: ABS Wheel Speed Sensor (rear)

NUMBER: 06-42-12

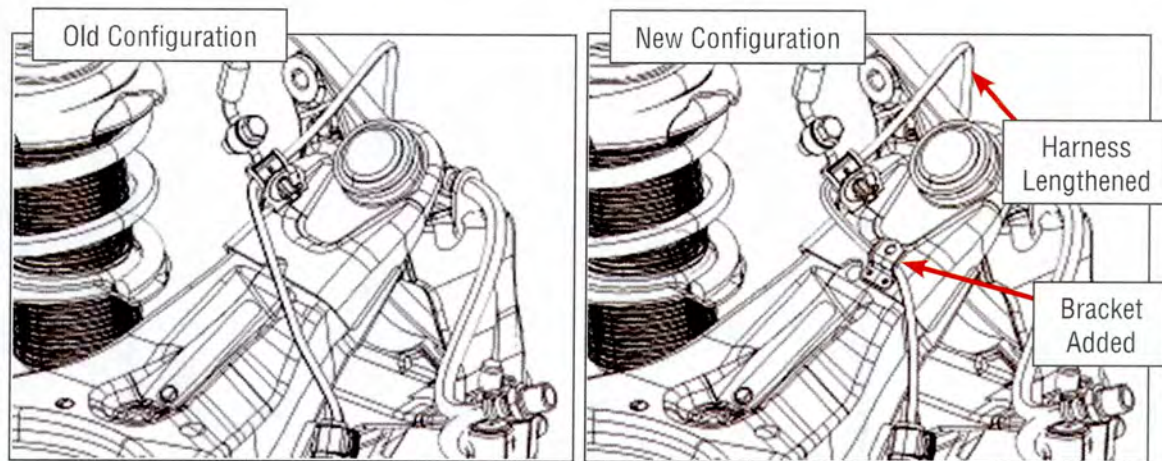
The purpose of this bulletin is to inform you of a change made to the rear ABS Wheel Speed Sensors. For manufacturing purposes, the length of the wiring harness was increased by 15mm. A bracket was also added to the rear upper arm assembly to secure the harness.

Note: The old style sensors have a white mark next to the part number stamping.

Refer to the applicable service manual for replacement procedure. **Note:** If replacing the rear upper arm assembly, a new self-locking nut must be used.
