SB-10043652-4582

SERVICE BULLETIN

NUMBER: 06-001-12

Clutch Pedal Inoperative

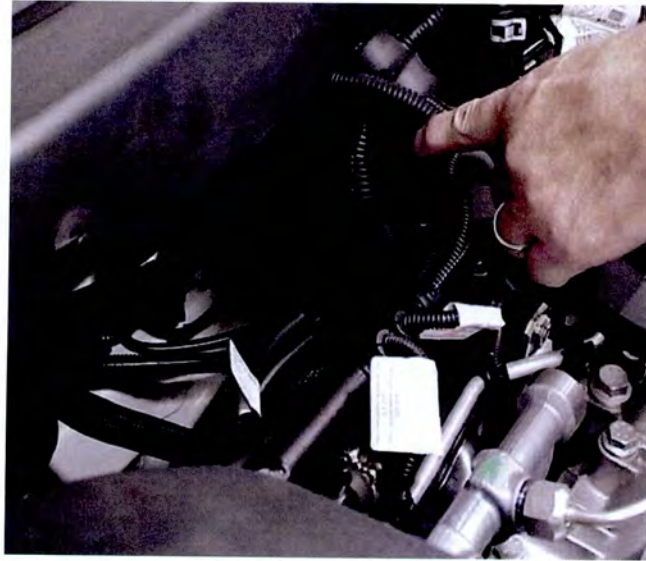
Fig. 1 Engine Compartment

2. Stick your arm behind engine controller with an oil absorbing towel and place under damper (Fig. 1) and (Fig. 2).

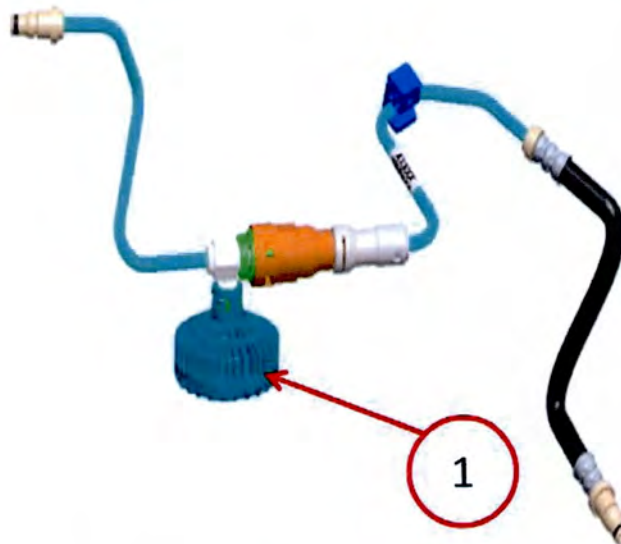
Fig. 2 Hydraulic Line With Damper

This may be caused by the hydraulic clutch damper leaking fluid.

The damper will be replaced with a cap.

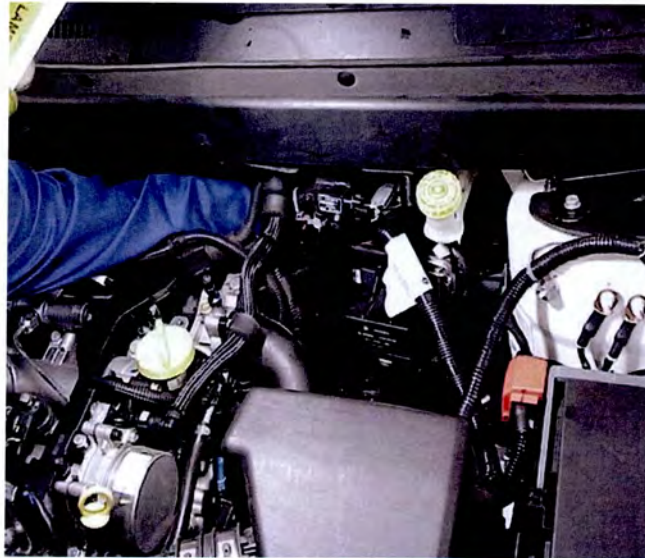
Fig. 3 Engine Compartment

3. Stick your arm with a small screwdriver behind the engine controller (Fig. 3).

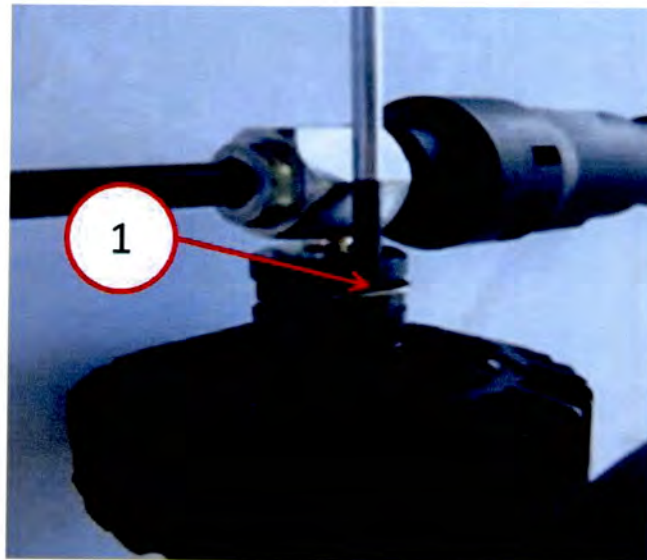
Fig. 4 Clutch Damper

-
4. Rotate damper so you can see the damper retaining clip (Fig. 4).

1 - Damper Retaining Clip

-
5. Pull the retaining clip out to the stop and remove the damper and discard (Fig. 4) and (Fig. 5).

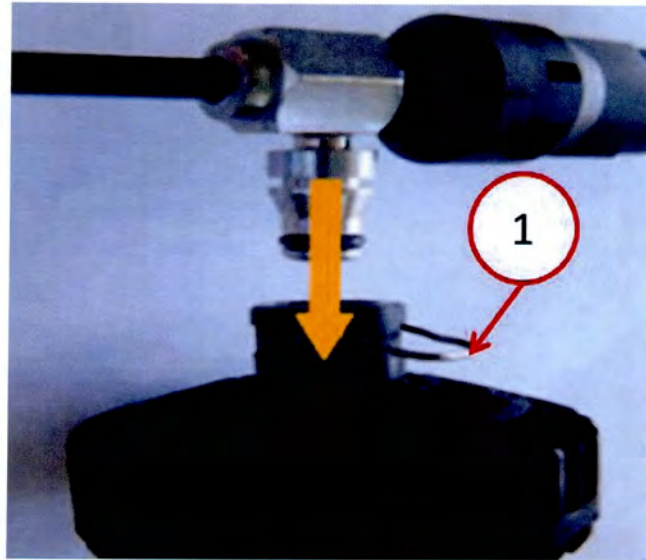
Fig. 5 Clutch Damper

1 - Clip Pulled Out

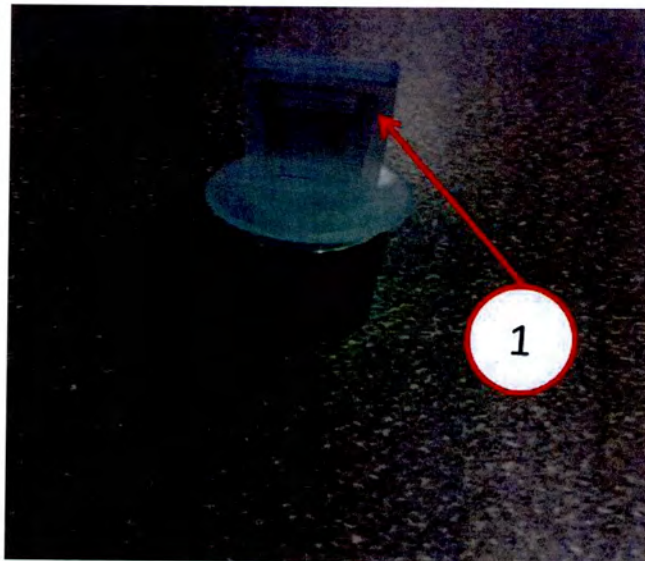
Fig. 6 Clutch Cap With Plug

1 - Dust Plug

6. Remove dust plug from cap part number 68166291AA and discard (Fig. 6).

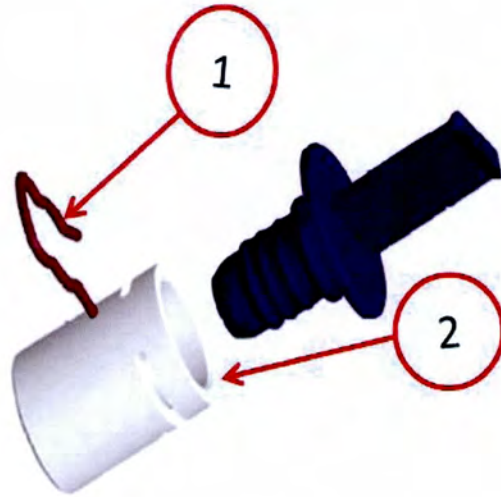
Fig. 7 Clutch Cap

- 1 - Clip
- 2 - Cap

7. Install the retaining clip onto the new cap part number 68166291AA (Fig. 7).

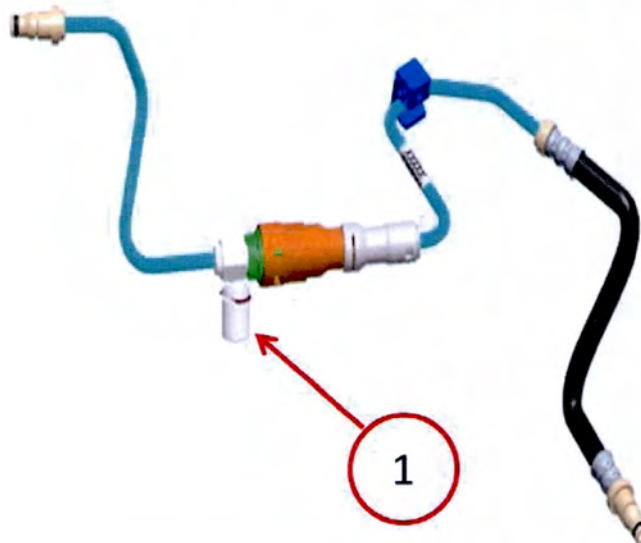
Fig. 8 Hydraulic Line With Cap

- 1 - Cap
-

8. Install cap onto the hydraulic line in place of the damper (Fig. 8).
