GROUP Transaxle	MODEL '12 Optima
	NUMBER PS205	DATE February 2012

<b>SUBJECT:</b> PITSTOP: OPTIMA (QF) DASHBOARD SHIFTER POSITION INDICATOR

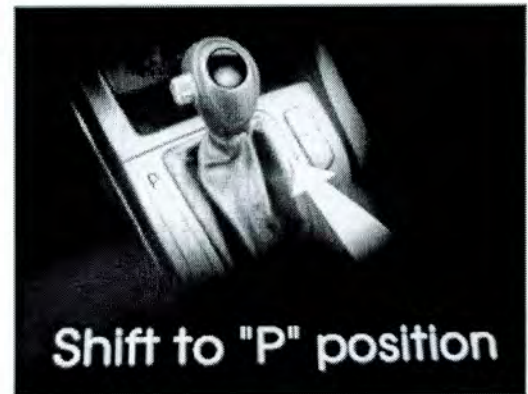
Some 2012 MY Optima (QF) vehicles may experience a situation where the shifter is placed in the 'PARK' position but the dash display may show 'Shift to "P" position' and the vehicle stays in accessory mode, however the transaxle parking pawl is engaged with no vehicle movement possible.

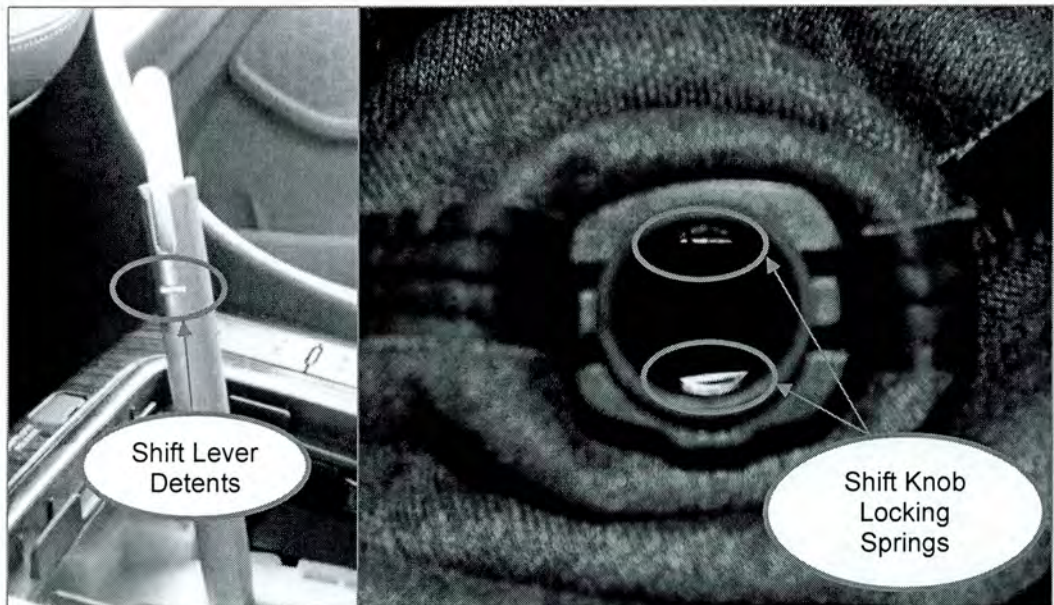
A possible cause for this may be due to the shift knob not seated correctly on the shift lever. The shift knob is designed with locking springs that set in detents on either side of the shift lever as shown.

- Check if there is any slight up and down movement with the shift knob.
- Disengage the shift boot retainers from the console using a plastic tool
- With a swift, hard pull, pull the shift knob (and shift boot) off the lever completely and check function of the shift lever as described below.

If the shift knob is determined to be the cause, replace the shift knob as required.

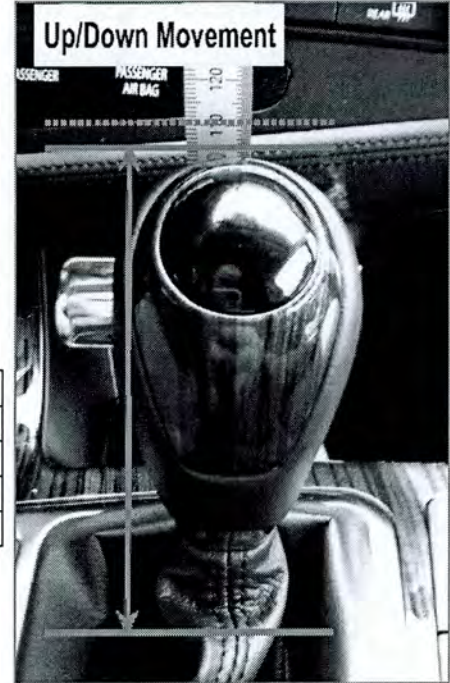
With the shift knob removed the shift lever should function normally. To disengage the shift lock, press down on the white plastic rod at the top of the shift lever.
