Authorized Field Change

AFC 11934

Subject: Heater Supply Pipe Change / Grease Application for Exhaust Gas Recirculation (EGR) Valve / HVAC Front Inside Module Drain Repair

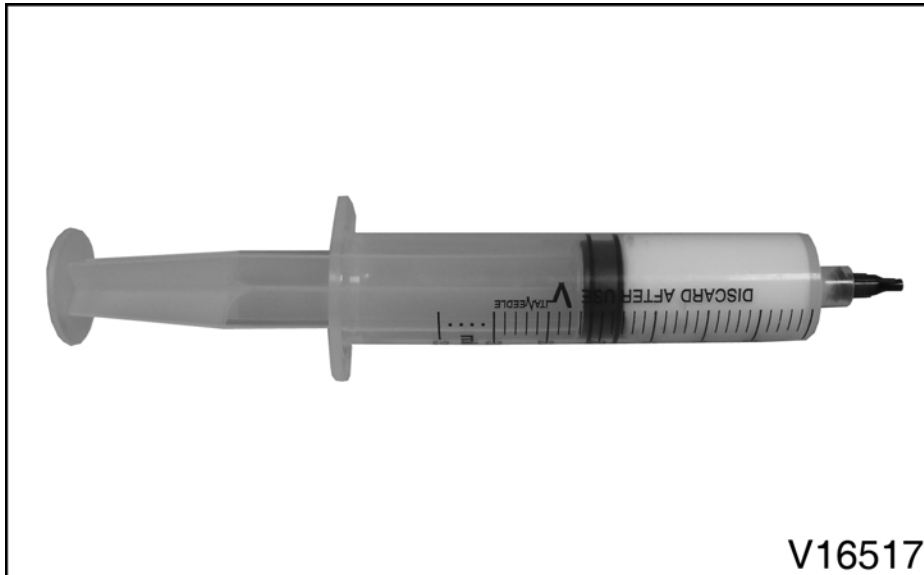
Figure 4 Syringe Assembly

14. Remove protective cover from end of syringe assembly by rotating counterclockwise.

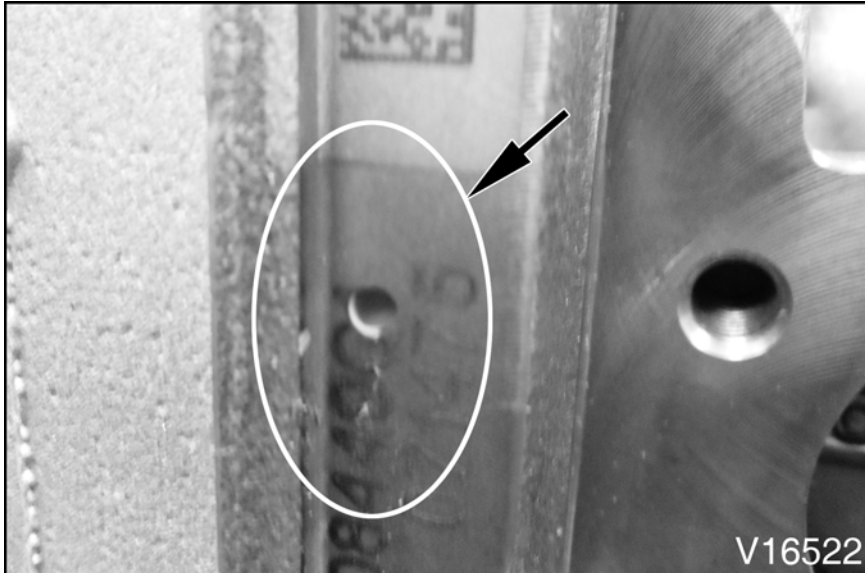
Figure 9 EGR Housing Surface

24. Apply brake cleaner or equivalent to a clean shop towel and wipe EGR housing surface clean of any grease.

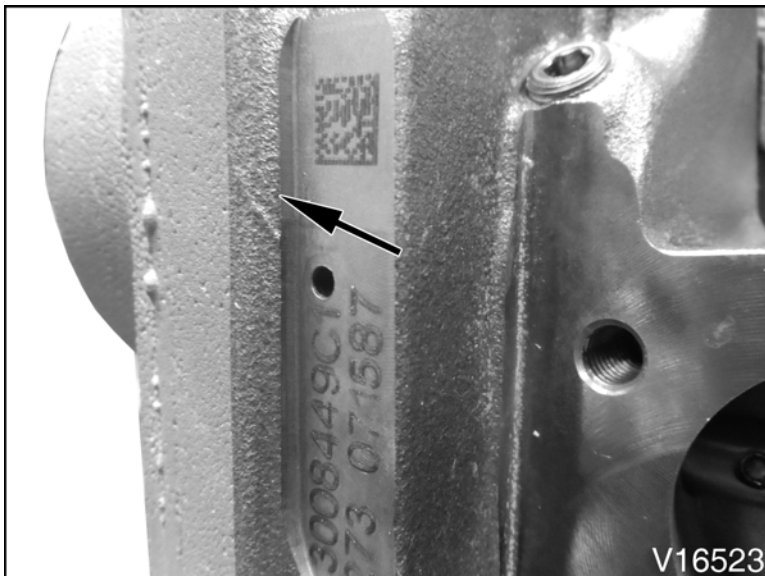
Figure 10 EGR Housing Surface Height Difference

NOTE – Due to the difference in height between the as-cast and machined surfaces of the EGR housing, it will be necessary to use a spacer to install the blind rivet.

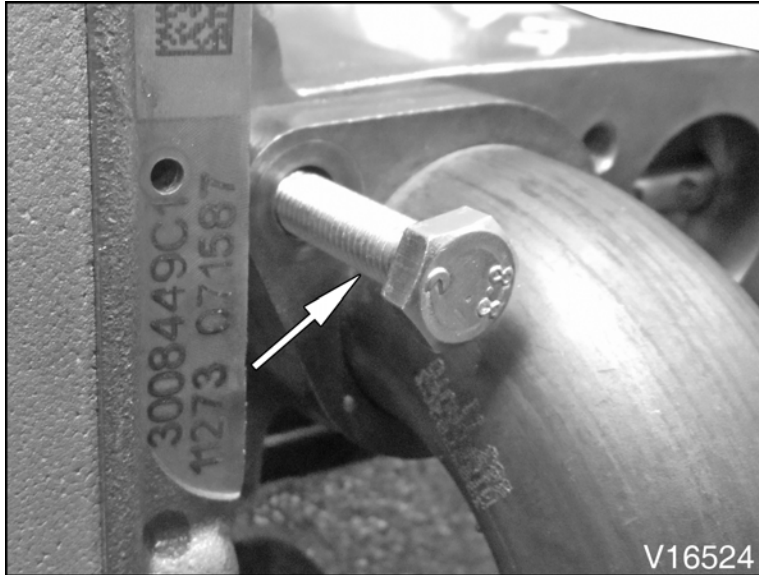
Figure 11 Jig Bolt

25. Reinstall the jig bolt in the EGR housing to where there is approximately 1.0 in. (26 mm) of thread left above the exhaust flange.

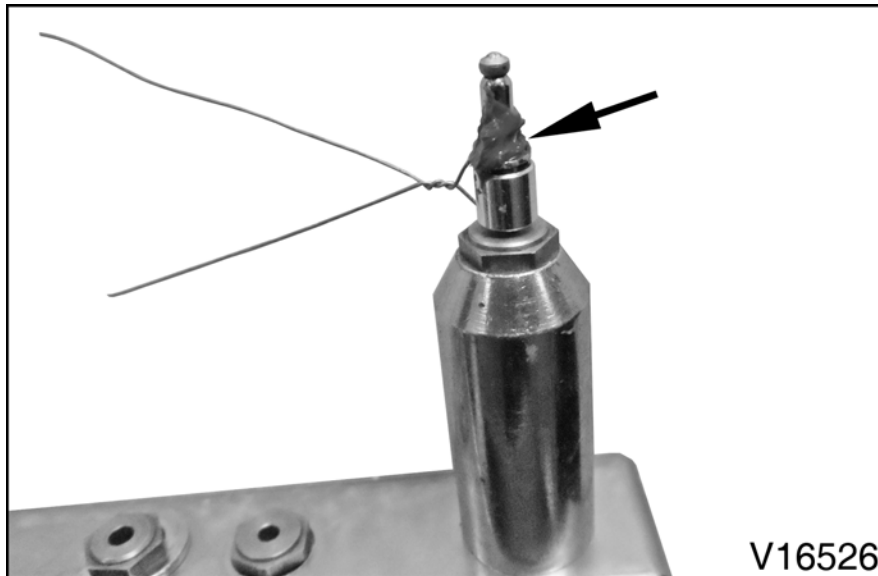
Figure 13 Rivet/Spacer Assembly Positioned in the Rivet Gun

28. Using the rivet gun to hold the rivet/spacer assembly, apply RTV sealant around the diameter of the blind rivet shank as shown.

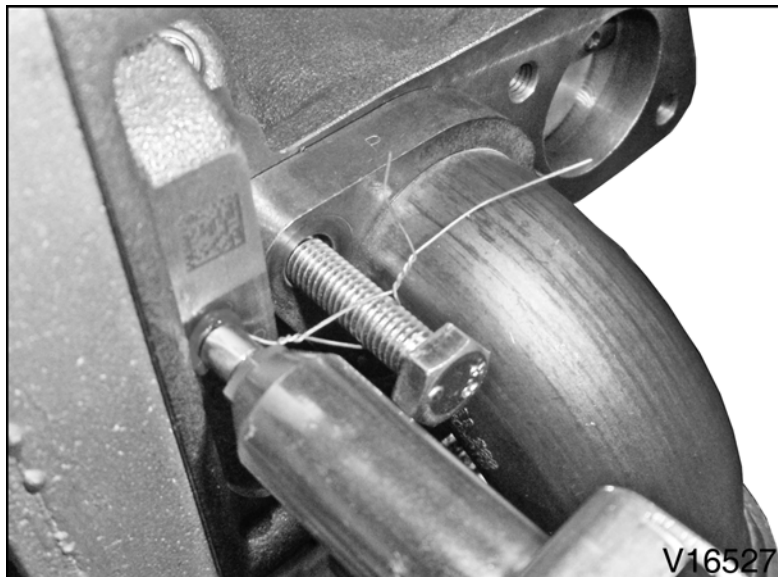
Figure 14 Tether Rivet/Spacer Assembly to Jig Bolt

29. After coating the blind rivet with RTV sealant, insert the blind rivet/spacer assembly into the drilled hole. Position tether wire on rivet/spacer assembly in such a way where the wire can be tied to the jig bolt.

30. Tie the tether wire of the blind rivet/spacer assembly around the jig bolt to retain the spacer when the mandrel on the blind rivet breaks off.
31. Squeeze riveter handles until rivet stem pulls free from the blind rivet. Tether wire should keep spacer assembly attached to jig bolt.

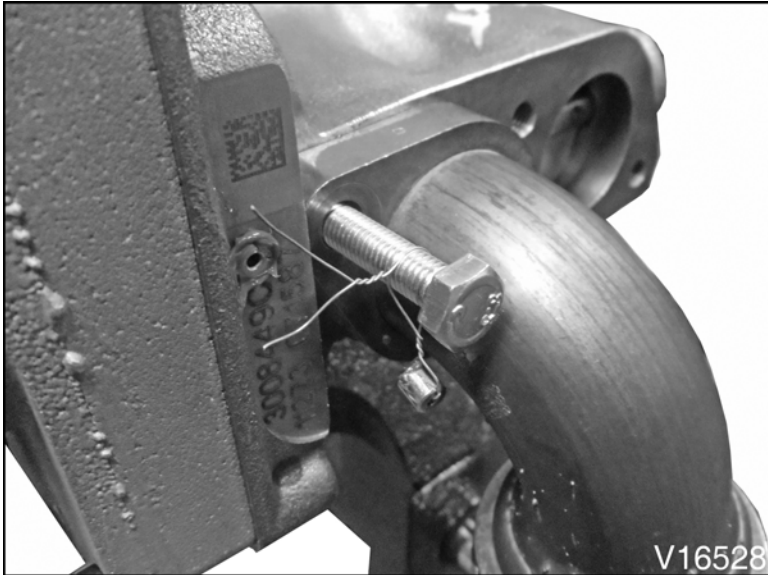
Figure 15 Blind Rivet Installed

32. Remove spacer assembly and jig bolt from EGR valve and discard.

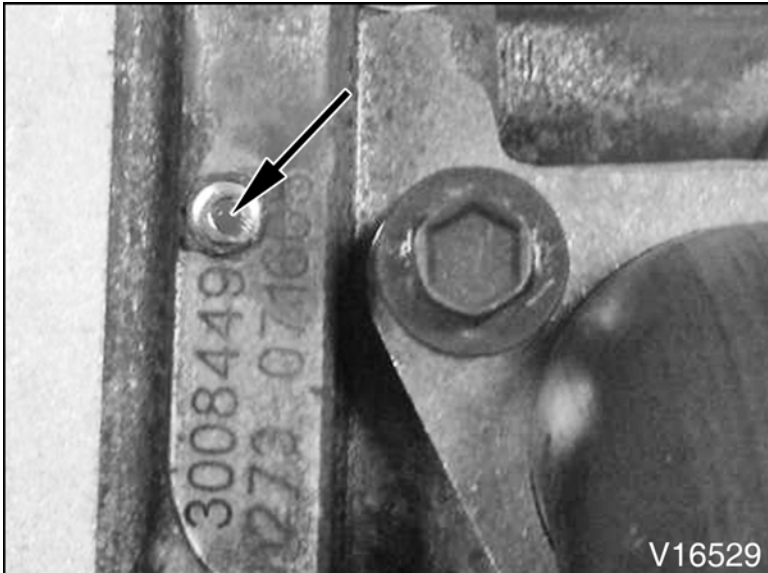
Figure 16 Rivet Filled with RTV

33. Apply a small amount of RTV sealant to remaining hole. Additional RTV sealant over the head of the blind rivet is acceptable and does not need to be removed.
34. Install new M8 x 25 heat-resistant bolt to EGR inlet tube flange and tighten to 18 lb-ft (24 N•m).
35. Install coolant manifold (rear of EGR) according to installation procedure in the “Exhaust Gas Recirculation (EGR) System” section of the *EGES-465 Engine Service Manual*.

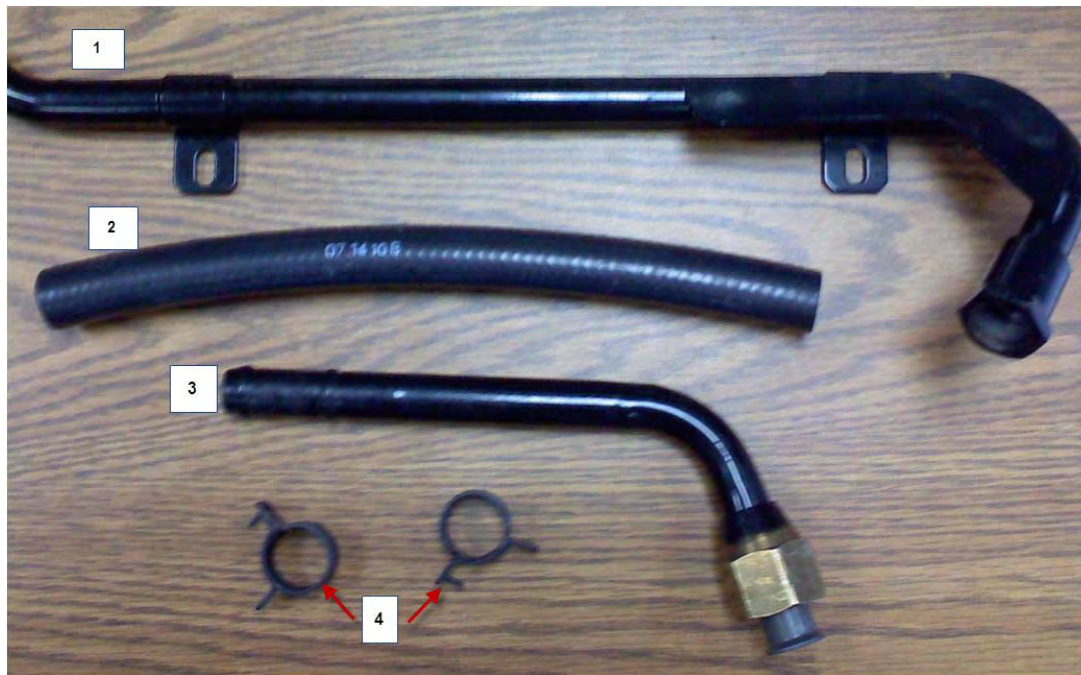
Figure 18 Three-Piece Heater Supply Hose

1. Top of engine-side of heater pipe
 2. 15 in. (380 mm) section of 0.75 in. (19 mm) heater hose (supplied hose may need to be trimmed to 15 in. (380 mm))
 3. Flare-side of heater pipe
 4. 2 x Mubea #27 clamps
4. Remove the nipple or shut-off valve from the single-piece pipe and install the nipple or shut-off valve to the new heater supply pipe BEFORE installing on the engine (See Figure 19, page 16).

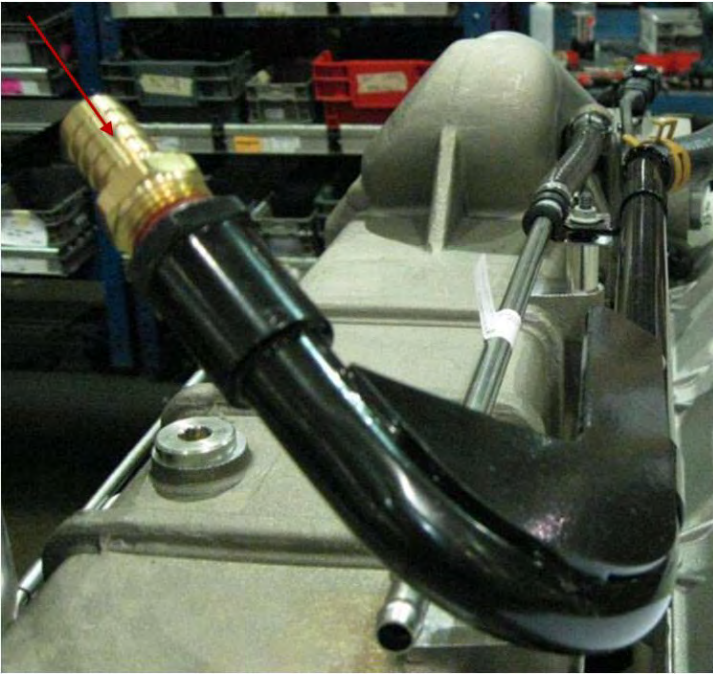
Figure 19 Adding Nipple to Assembly Heater Front Supply Pipe

5. Add the 15 in. (380 mm) hose section onto the rear end of the curved pipe that mounts to top of the engine BEFORE installing on engine. Use P80® lubricant on hose and pipe for assembly. Install hose approximately 1 in. over the raised flare on the pipe.
6. Add the Mubea #27 clamp to the step 5 assembly.
7. Install step 6 assembly onto engine and fasten down using the 2 M6 hex flange nuts (See Figure 20, page 17) that were removed in step 2.

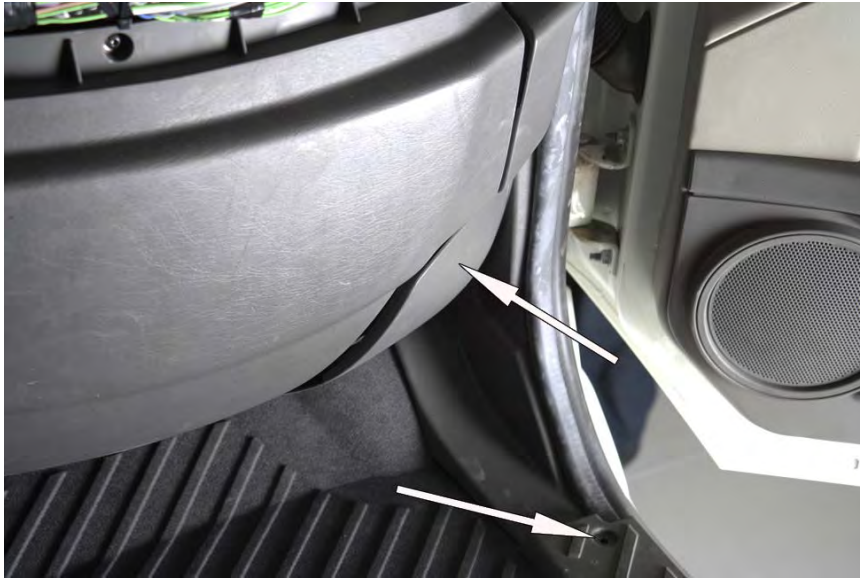
Figure 22 Removing Kick and Scuff Panels

1. Remove the kick panel and scuff panel on the passenger side of the truck (See Figure 22, page 19).

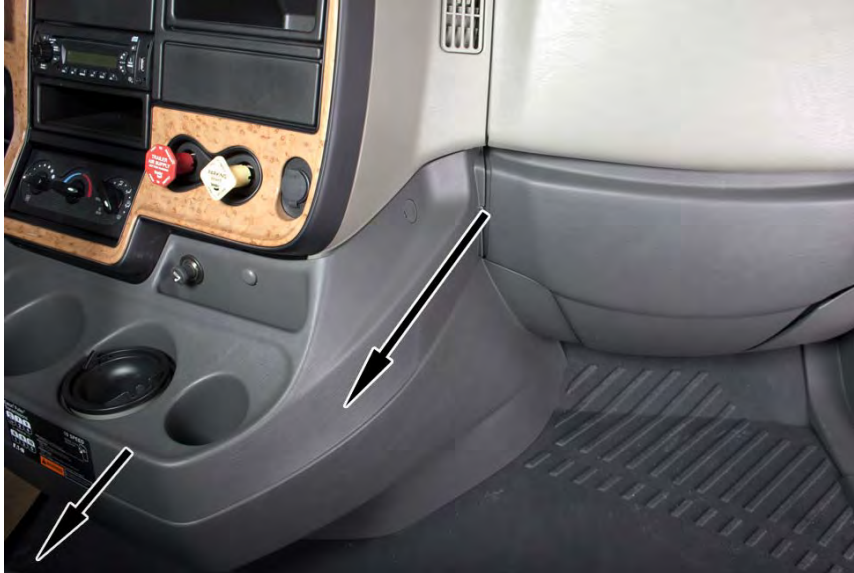
Figure 23 Removing Center Console

2. Detach and pull back the center console to expose the floor mat (See Figure 23, page 19).

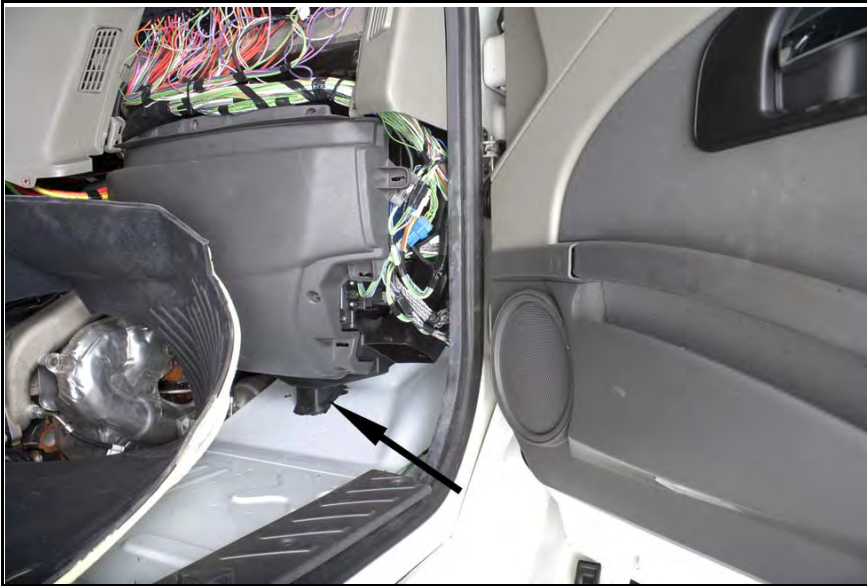
Figure 24 Pulling Floor Mat away from Drain Area

3. Pull the floor mat away from the drain area (See Figure 24, page 20).

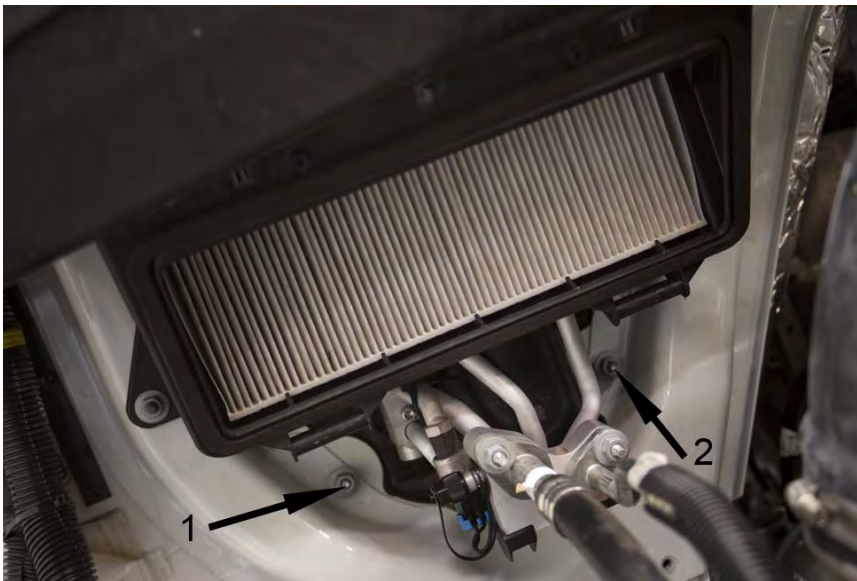
Figure 25 Loosening Mounting Nuts

- a. In the engine compartment on the firewall, loosen the lower mounting nuts from area shown (See Figure 25, page 20).

1. Outboard Nut next to HVAC TXV
 2. Inboard Nut next to HVAC TXV
- b. Back the nuts off the studs until the end of the nut is approximately flush with the end of the stud (do not remove completely).

5. Tighten the HVAC module mounting nuts (See Figure 25, page 20).
6. Using a thin piece of cardboard / credit card, place the cardboard between the floor and the HVAC module.
 - a. Push the cardboard halfway under the HVAC module.
 - b. Continue this operation for all sides of the drain. This will make sure the drain valve is not caught.
 - c. Slide the cardboard / credit card from the firewall side completely under the HVAC housing to ensure it is not folded under. You will be able to see the drain valve end as you slide the cardboard / credit card under the module between HVAC Module and Floor (See Figure 29, page 23).

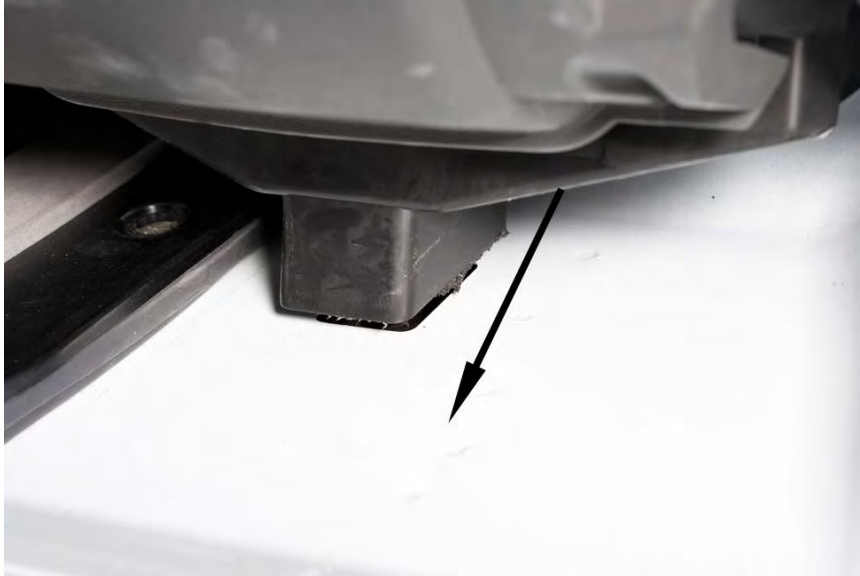
Figure 26 Pulling HVAC Unit Rearward

- c. With the mounting nuts loosened, gently pull the HVAC unit rearward to expose the drain seal for easier removal (See Figure 26, page 21) and (See Figure 27, page 21). Remove the foam seal and not the rubber drain valve (See Figure 28, page 22).

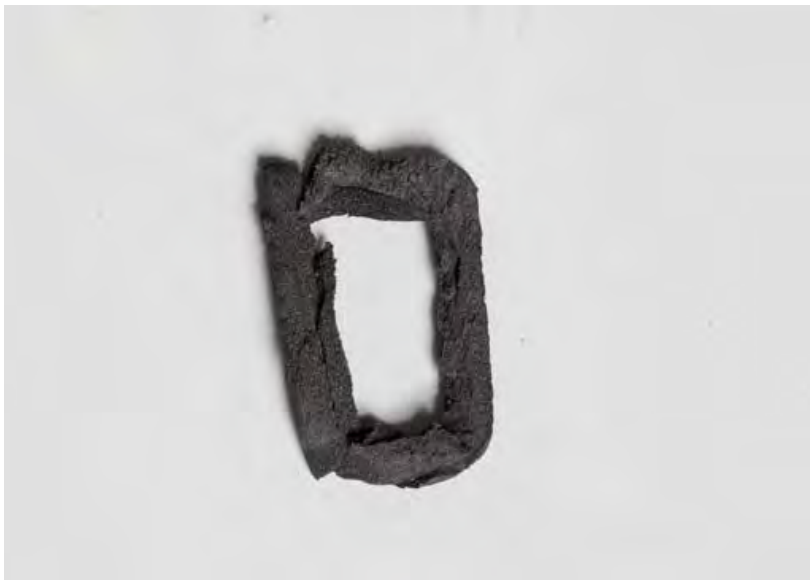
Figure 27 Typical Condition of the Foam Seal after Removal

1. The HVAC module floor seal interferes with the drain tube and forces it open or closed. Condensate inside the module does not properly drain and instead is pulled into the blower motor.
2. The floor seal is mis-positioned or damaged during HVAC module installation.

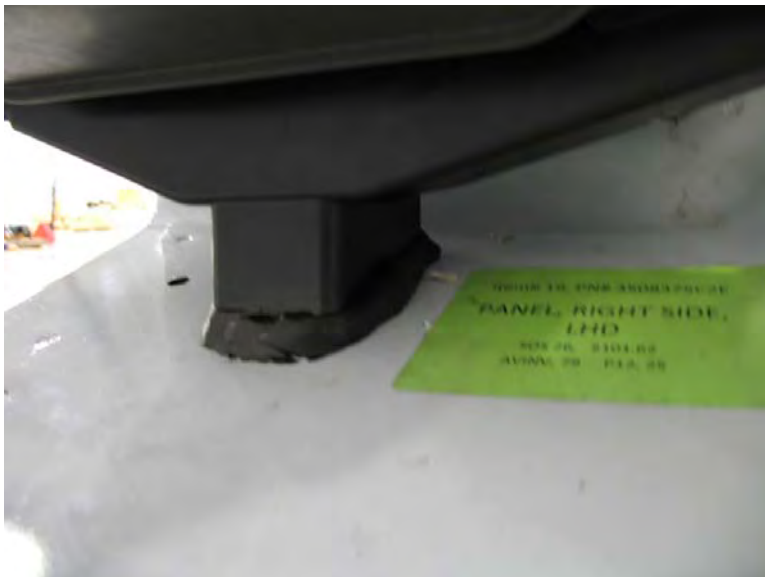
Figure 30 Sealing HVAC unit to the Floor

7. Use sealant (p/n 8000934R91) to seal the HVAC unit to the floor. Make sure not to force excessive sealant into the gap (See Figure 30, page 23).

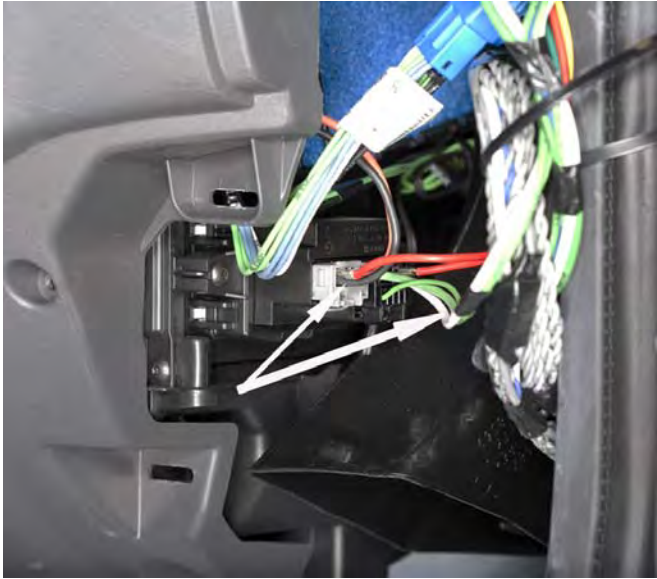
Figure 31 Locating the LPM

- c. If the blower turns on, go to each blower speed and verify that the blower is operational. If the blower is operational, go to step 10.
- d. If the blower does not turn on or has limited airflow, locate the Linear Power Module (LPM) behind the passenger-side kick panel (See Figure 31, page 24) and do the following:

- Black wire on the two-cavity connector.
 - White heavy ground wire on the 6-way connector.
- e. Use a 12-gauge jumper harness to place the jumper across these two wires (See Figure 32, page 25).
