**SB-10043721-7590**

## Technical Information Bulletin

**E046**

PACCAR MX Engines Oil Filter Cap Locks Campaign

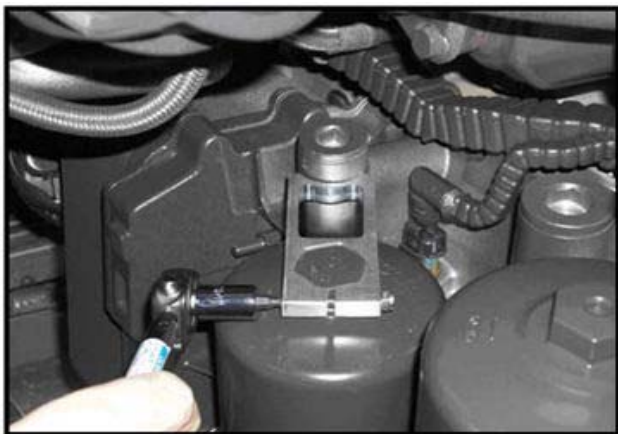
Aluminum lock: 1871869PE  
complete E046 campaign

- For chassis with the aluminum lock device, part number 1871869PE, replace part per E046 Procedure.pdf
- For chassis that already have new style lock device, kit number STD1534PE, no repair is necessary.
- For chassis that have no locking device at all, repair per Recall bulletin E026R (DealerNet, Warranty tab, item, Federal Recall Information).

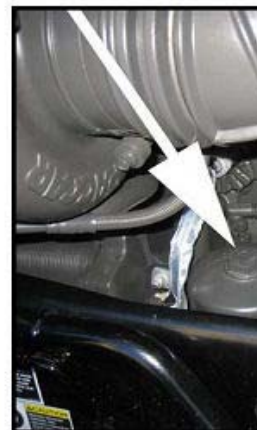
No locking  
complete E
