## Door Frame Cracking at Door Check Mounting Location

60-150

Freightliner  
Service Bulletin

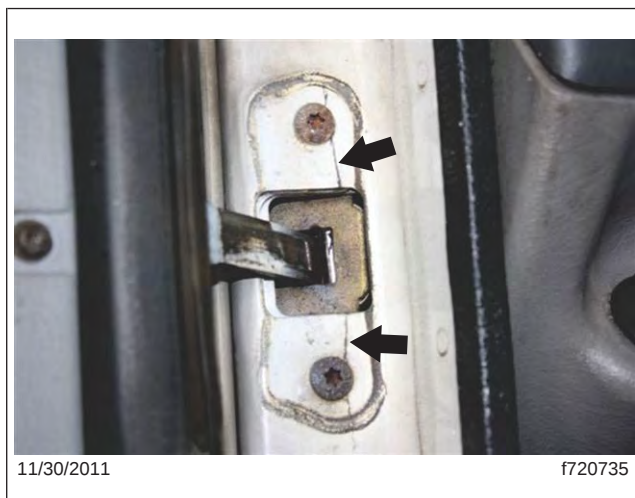
Some Century Class, Columbia, and Coronado vehicles may develop cracks on the driver-side door frame at the door check mounting area, due to vehicle age and use. See [Fig. 1](#). If cracks are present at the door check mounting location, use the procedure below to repair the door frame.

Fig. 1, Example of Door Frame Cracking

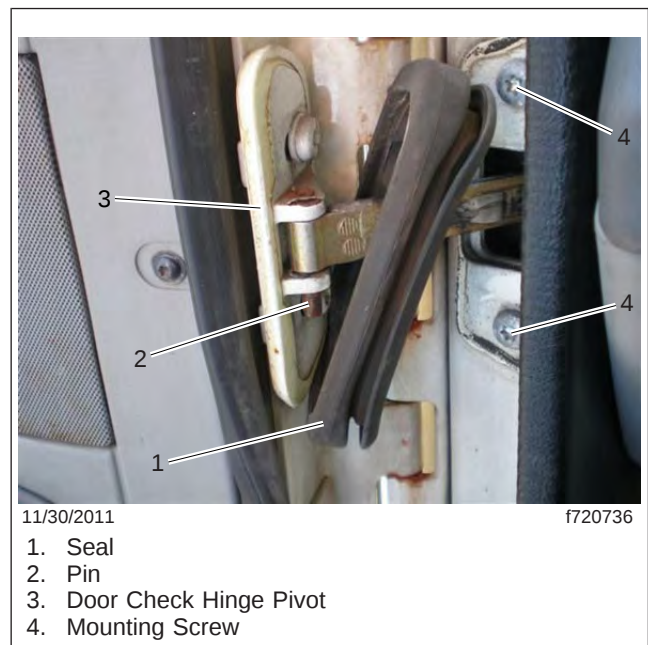
1. Park the vehicle on a level surface, shut down the engine, and set the parking brake. Chock the tires.
2. Remove the driver-side lower interior A-pillar cover.
3. Pull the door check seal off the door check hinge pivot. See [Fig. 2](#).

Fig. 2, Door Check Installation

4. Remove the pin from the door check hinge pivot. Ensure that the door does not swing out when the pin is removed.
5. While holding the door check with your free hand to keep it from falling inside the A-pillar, remove and discard the two mounting screws that attach the door check to the cab.
6. Reach through the interior A-pillar opening and remove the door check assembly.
7. Inspect the door check assembly for damage. If the retaining pin on the cab side is bent or pulled into the rubber bumper (**Fig. 3**), replace the door check assembly.

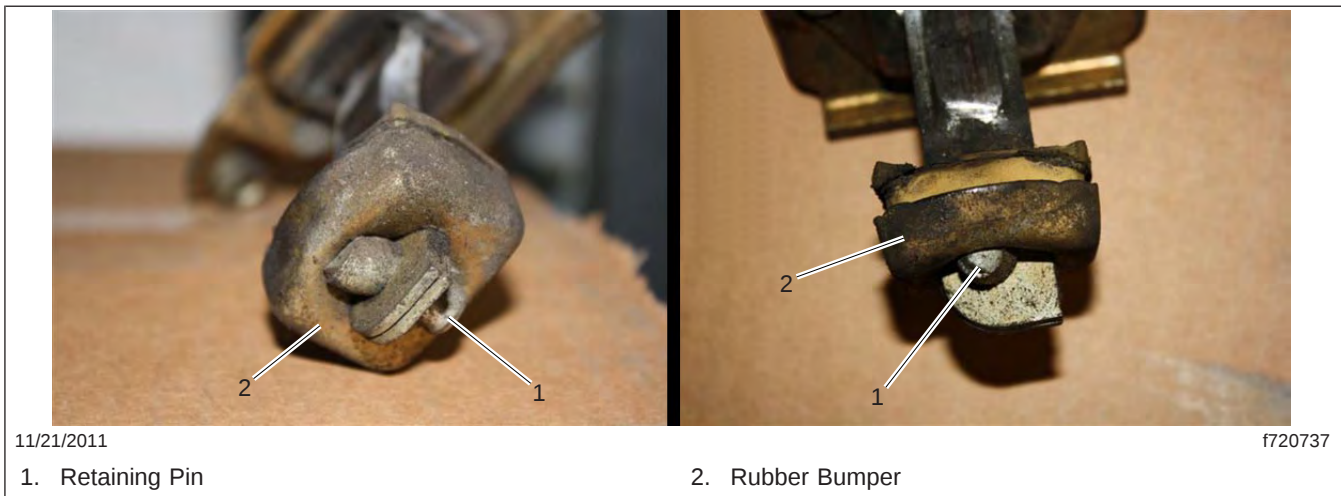
**Fig. 3, Example of Damaged Retaining Pin and Rubber Bumper**

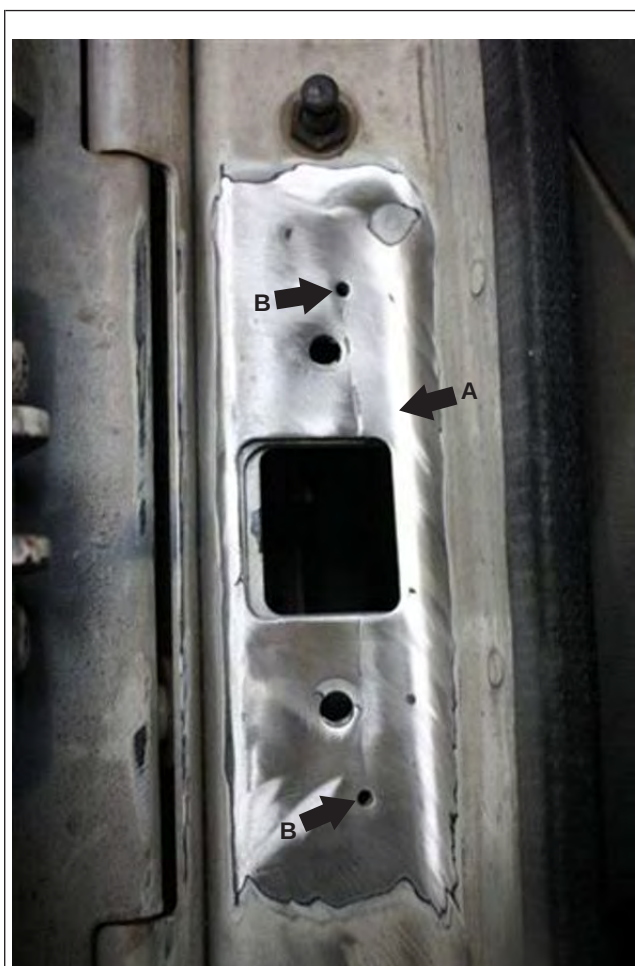
f720738

- A. Grind the door check mounting area down to bare metal.
- B. Drill 1/8-inch holes at each end of the crack.

**Fig. 4, Preparing the Door Check Mounting Area**

8. Grind the door check mounting area down to bare metal. See **Fig. 4**.
9. Using a drill and a 1/8-inch (3-mm) drill bit, drill holes at each end the crack to prevent the crack from extending.

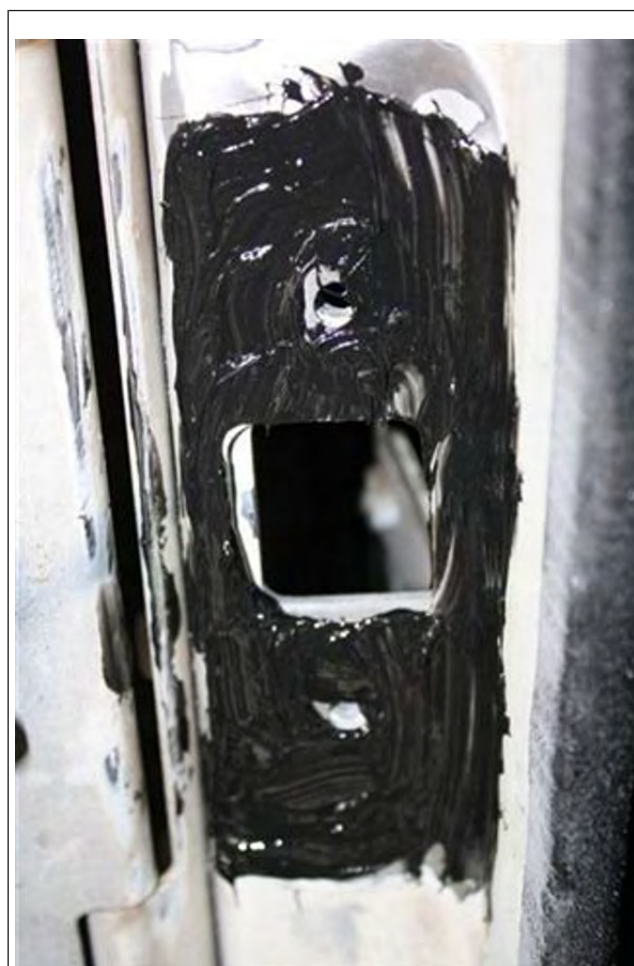
f720739

**Fig. 5, Applying Urethane Adhesive**

10. Apply urethane adhesive to the bare metal. See **Fig. 5**.
11. Insert the door check assembly through the interior A-pillar opening. Secure it so it will stay in place without falling inside the A-pillar.

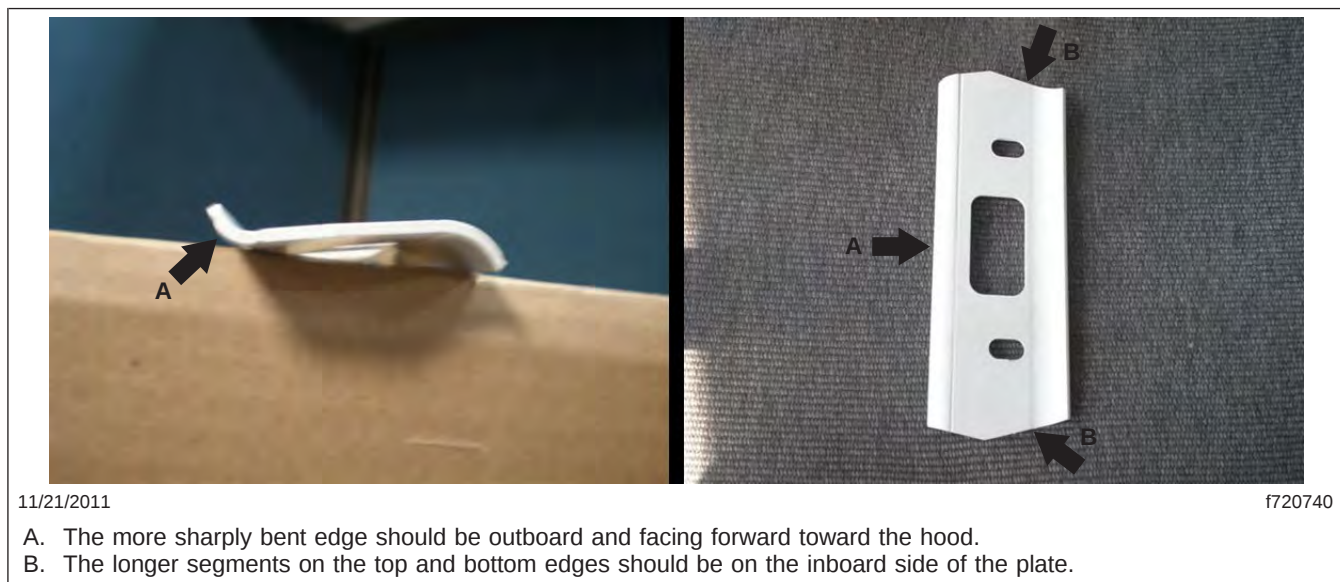
**Fig. 6, Door Jamb Patch Plate**

12. Position the door jamb patch plate on the door frame. The side with the sharper curve should be facing outboard, with the edge facing forward. On the top and bottom edges, the longer segment should be on the inboard side of the plate. See **Fig. 6**.

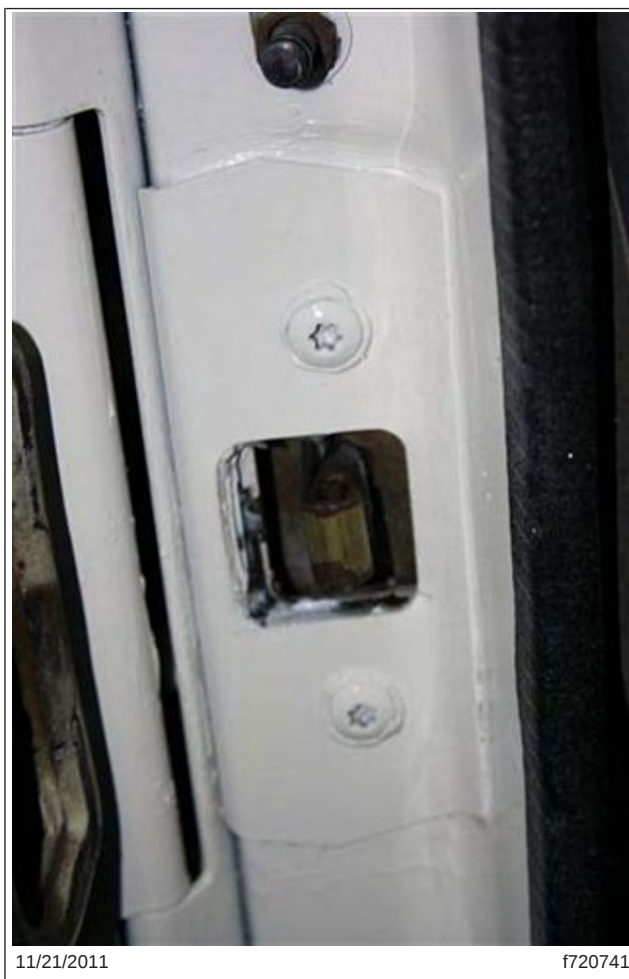
**Fig. 7, Door Jamb Patch Plate Installed**

13. Using two screws (23-12277-150), secure the plate, door frame, and door check assembly together. See **Fig. 7**.
14. Install the door check seal.
15. Install the lower interior A-pillar cover.
