## Battery Terminal Corrosion CXU

### FSB 313-001, Battery Terminal Corrosion

February 2012

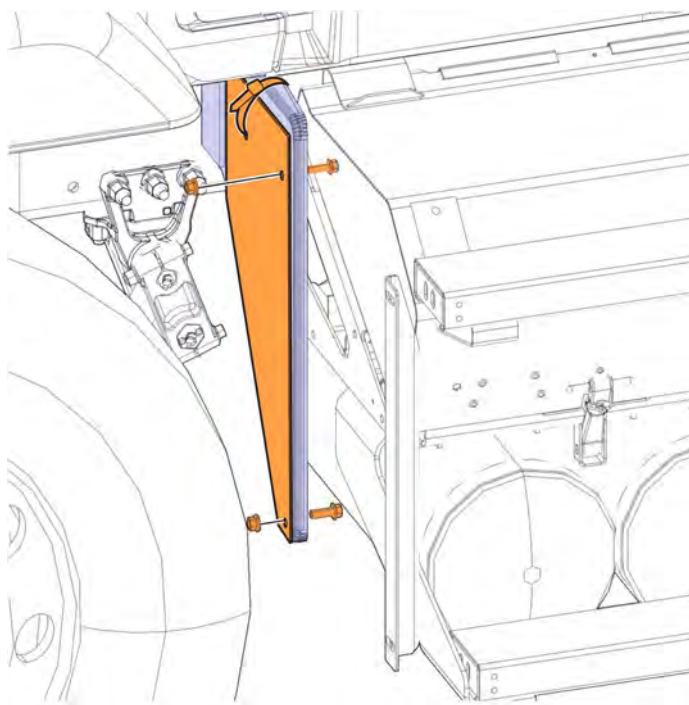
W3071682

On certain CXU models equipped with the three battery box design, the battery terminals have corroded due to contaminants splashing directly onto the batteries. The left front fender splash shield bracket has a triangular shaped hole in it that is in line with the 3 battery box. Perform the shield installation below to correct the condition.

- 2 Remove the inside (upper & lower) fasteners on the left side splash shield.
- 3 Install part number 82723124 into position as shown in the illustration. Start both fasteners and loosely tighten.

**Note:** The new part slides in between bracket and splash shield for proper installation.

- 4 Finish tightening both fasteners and torque to specifications, see Group 30
- 5 Install cable tie through the remaining hole in shield part number 82723124 and wrap around bracket to secure.
- 6 Install battery box cover.
