**Field campaign**

<b>Topic</b>	Gear selector – warning and fault code – gear knob switch resistance high (SC12/02)
<b>Market area</b>	Worldwide Bentley (1WBE)
<b>Brand</b>	Bentley
<b>Transaction No.</b>	2028014/1
<b>Campaign number</b>	E763
<b>Note</b>	
<b>Type</b>	
<b>US code</b>

**Vehicle data****Mulsanne****Sales types**

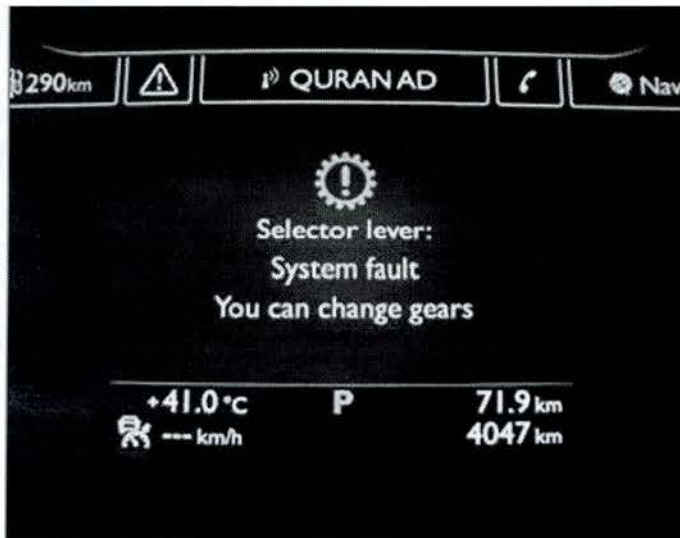
A warning may be displayed in the driver's instrument panel that reads *Selector lever: System fault* *You can change gears*, this warning will be accompanied by fault code P17EC00, recorded in module 81-Selector lever sensors control unit UDS

The cause has been attributed to the four pin electrical connection between the gear knob and the gear selector shaft that forms part of the gearshift interlock. The relative movement produced between these two parts both from the drivers hand and from vehicle resonance can, in severe cases, result in a degradation of the terminals contact area. The subsequent out of specification resistance will result in this code being logged and the warning displayed

The vehicles detailed in the applicability section above require the application of a conductive enhancer to the four electrical connector pins located inside the gear knob

The conductive enhancer to be used is named Stabilant 22 which should be mixed, 4:1, with 99% Isopropanol or pure Ethanol the Stabilant 22 can also be applied neat. Only 99% Isopropanol or pure Ethanol must be used when mixing the Stabilant 22 mixture.

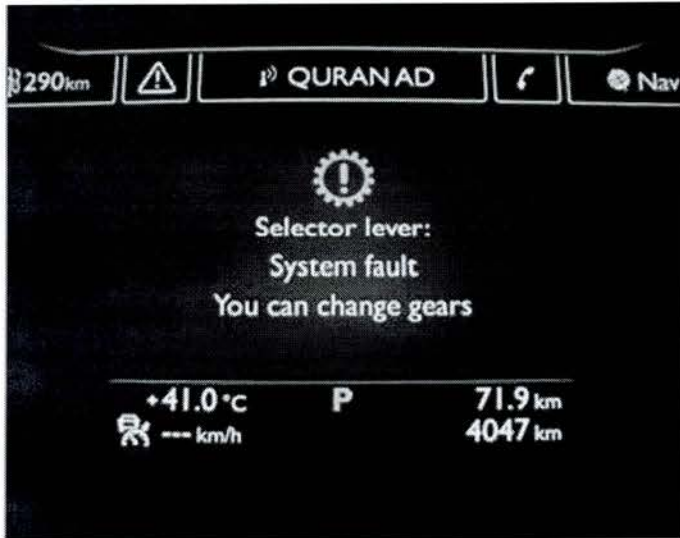
A warning may be displayed in the driver's instrument panel that reads *Selector lever: System fault* *You can change gears*, this warning will be accompanied by fault code P17EC00, recorded in module 81-Selector lever sensors control unit UDS

The cause has been attributed to the four pin electrical connection between the gear knob and the gear selector shaft that forms part of the gearshift interlock. The relative movement produced between these two parts both from the drivers hand and from vehicle resonance can, in severe cases, result in a degradation of the terminals contact area. The subsequent out of specification resistance will result in this code being logged and the warning displayed

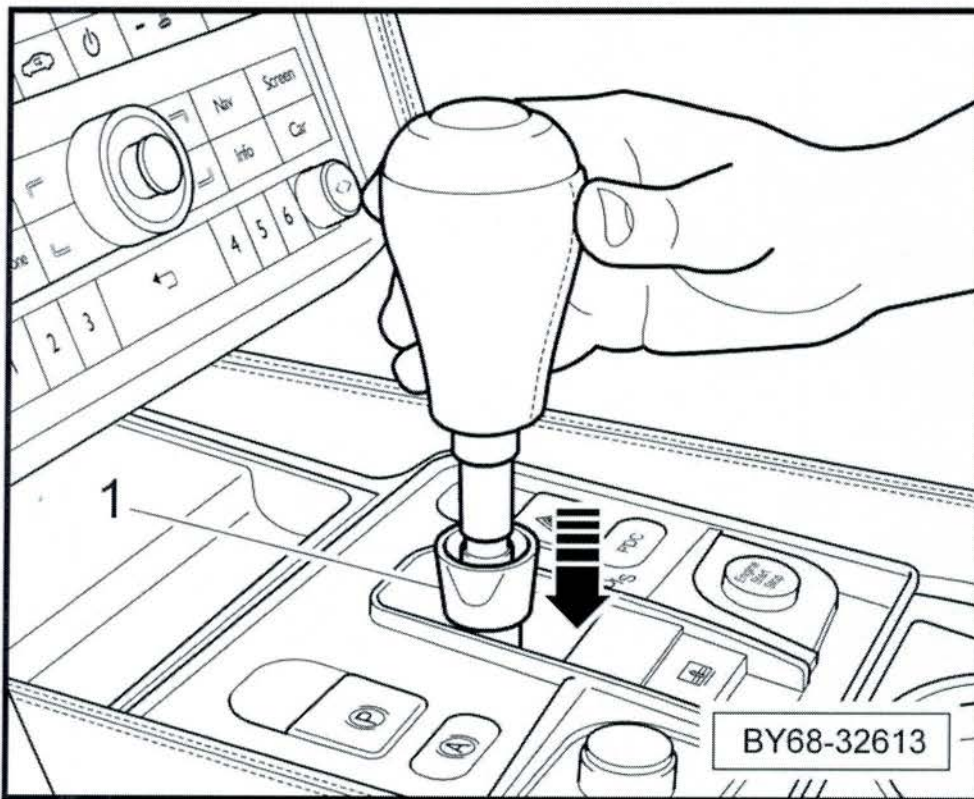
Figure 2

1. Remove the gear knob. Slide the collar (1) downwards then pull off the gear selector knob (see Figure 2)
2. Prepare the Stabilant
  - The Stabilant 22 kit (WT10224) includes 5ml of Stabilant 22 concentrate, an empty 15ml mixing bottle, application brushes, and manufacturers mixing instructions. The Stabilant 22 should be mixed by following the manufacturers mixing instructions.

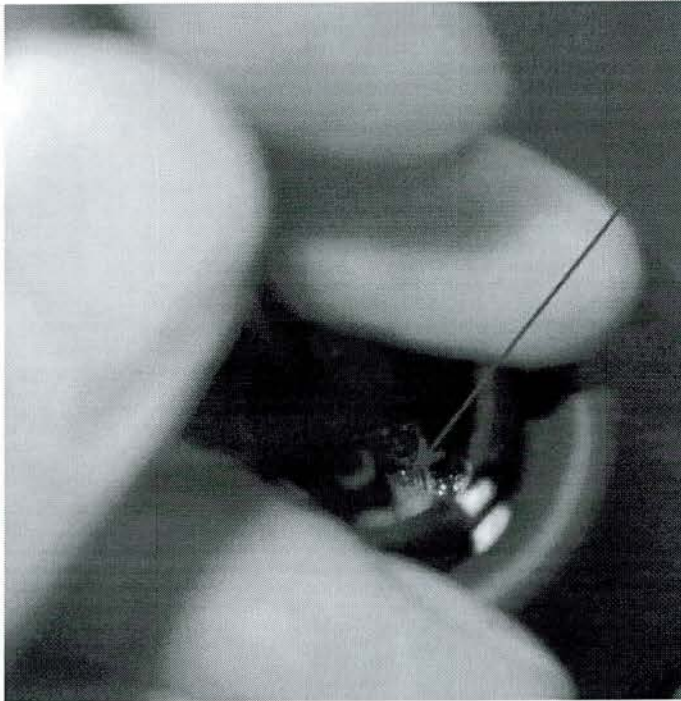
- Figure 3
3. With the gear knob removed and away from the vehicle invert the knob to apply the Stabilant (see Figure 3)
    - Apply the mixed Stabilant 22A or 22E to the electrical pins located inside the gear knob. Use the application brush supplied in the kit, or a new clean cotton bud to apply a thin coating of Stabilant 22A/22E to each of the four connections. Ensure the pins are evenly and completely coated

- Allow approximately 2-3 minutes for Isopropanol/Ethanol to evaporate, which will leave a thin layer of Stabilant 22 on the connections
  4. Apply yellow campaign completion mark to the base of the gear knob (see Figure 4)

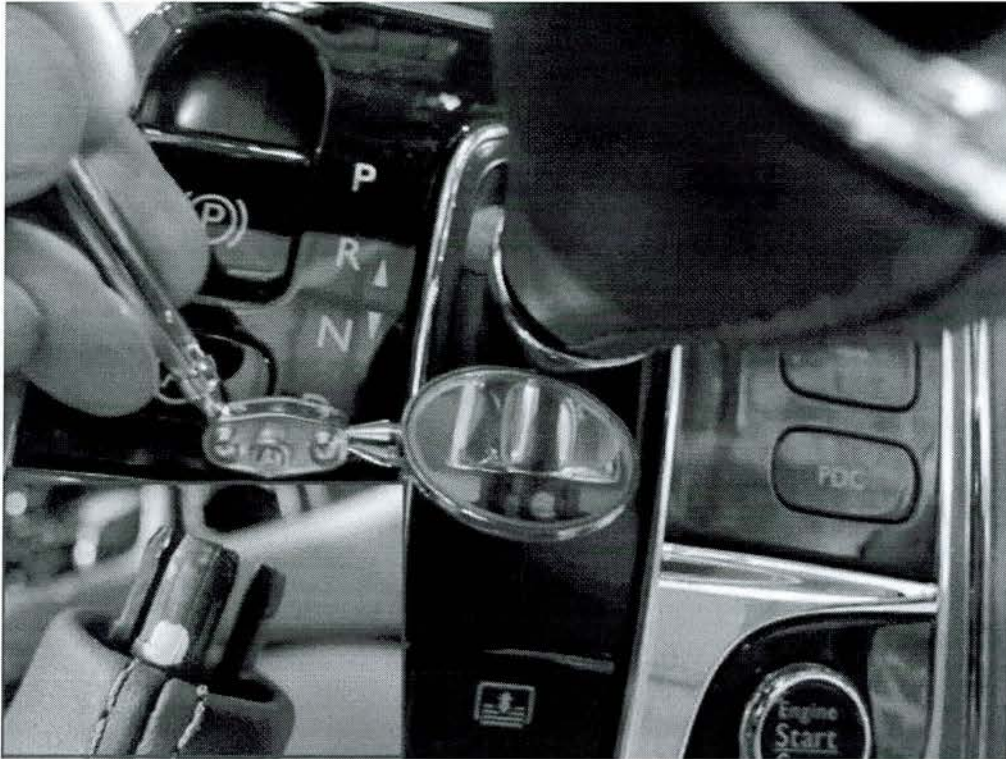
Figure 4

On completion apply a yellow campaign completion mark to the underside of the gear knob

If the vehicle is not already listed as repaired in the "Repair history" (in ElsaPro), check the vehicle for the campaign identification mark, (see Figure 4), if this is not visible carry out the required work in accordance with these instructions
