IB12-L-001

DEF LEVEL GAUGE AND DEF TANK SIGHT TUBE DO NOT MATCH

- All Isuzu N-Series
- 2012 NPR Stripped Chassis (Reach Van)
Equipped with Selective Catalyst Reduction (SCR)

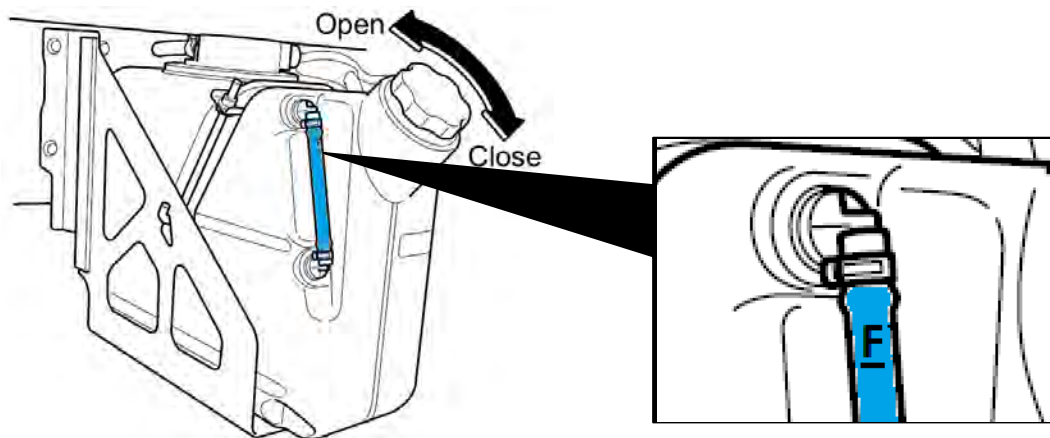
Some customers may complain that the DEF Tank Sight Tube and DEF Level Gauge in the MID (Multi Information Display) do not match. The DEF Tank Sight Tube is used for filling purposes only in order to prevent overfilling. Actual DEF level should only be determined by viewing the DEF Level Gauge in the MID.

Note: Do not add DEF above the “E” position. DEF may leak from the breather hose while driving.
