Front Windshield Glass Delaminating

XF (X250) with Heated Front Windshield *only*

VIN: R00001 - S05128
Model Year: 2009 - 2011

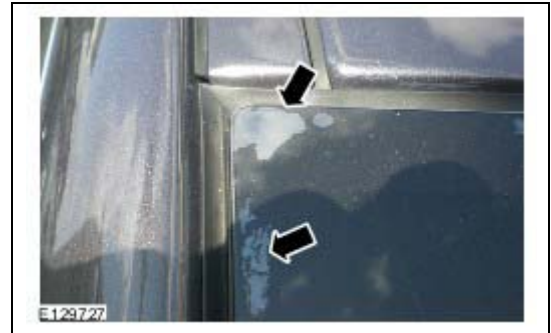
1. Inspect front windshield glass for delaminating / bubbling and is a Jaguar windshield ('JAGUAR' in the lower left-hand corner).
 - If the glass shows signs of delaminating / bubbling, continue to step 2.
2. Refer to Workshop Manual, section 501-11: *Glass, Frames and Mechanisms*, and replace the front windshield.

INSTALL NEW HEATED FRONT WINDSHIELD GLASS
