## SB-10043878-9462

**Title** Loose connectors in front seat cable harness  
**Ref No** US25330.1.0 en-US  
**Issuer** -  
**Partner** 3 US 7510 Volvo Cars North America  
**Func Group** 8521  
**Func Desc** front seat, complete

<b>Volvo Car Customer Service</b>		
	<b>TJ Instruction</b>	
	<b>No 25330</b>	
		Date February 2012 Issue 01
Title	Loose connectors in front seat cable harness

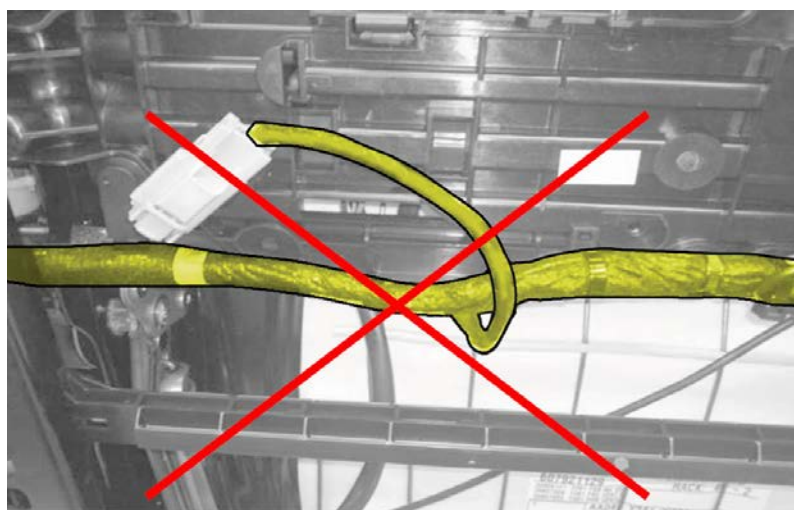
**Note! Vehicles with Seat Ventilation**
