# Technical Service Information

TSI-12-08-01

**Subject:** RE Bus Battery Cable, Transmission Cooler Hose, and Air Management Panel Area Maintenance

Model: RE School and Commercial Bus built prior to July 2007, with rear-mounted radiator cooling package and air-management panels

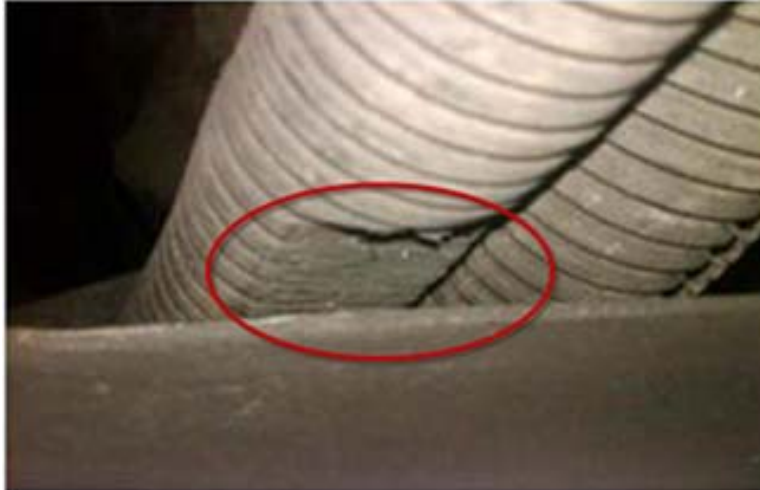
**Figure 1 Battery Cable or Harness Conduit Abrasion**

The figures below represent some typical rub points that can occur over time (see Figure 1, Figure 2, and Figure 3).

Battery cable, harness, and fluid hose routing and clipping is designed to provide and maintain appropriate clearance to avoid damage due to abrasion. Time in service, route conditions, and repairs performed can result in movement of hoses, battery cables, and other circuits over time.

Battery cable, harness, and fluid hose inspections are to be performed during regularly scheduled maintenance to make sure no rubbing or chafing has occurred. At a minimum, inspection should be performed as part of the annual maintenance interval.

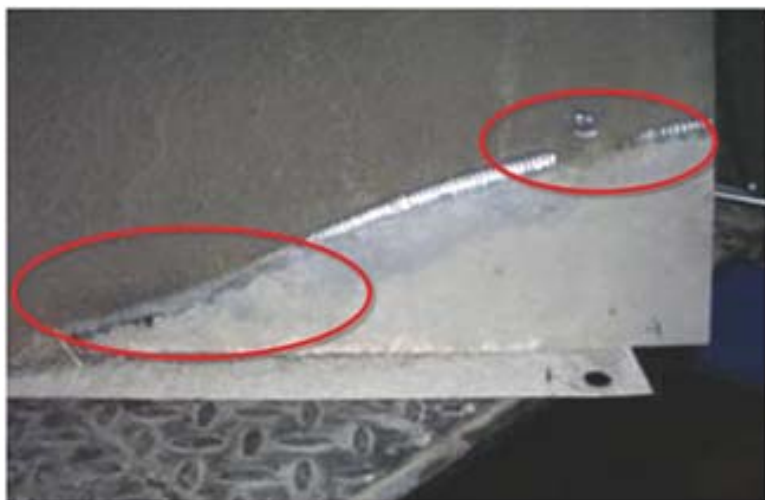
Figure 2 Evidence of Contact (Cable/Harness/Hose) with Air Management Panel

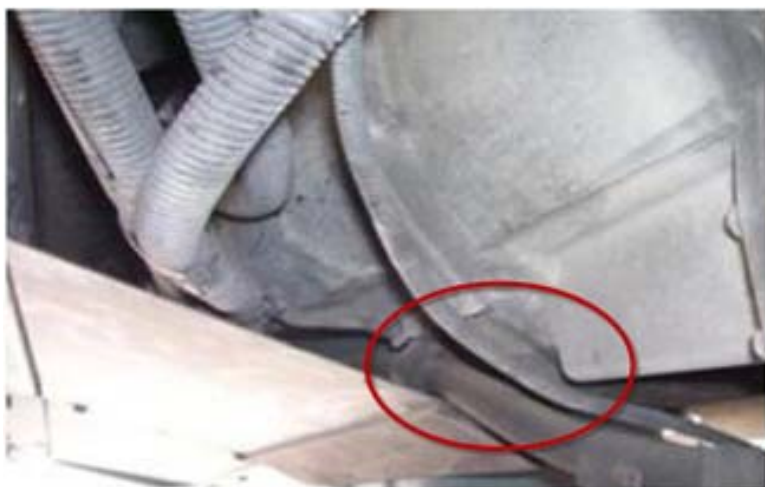
Figure 3 Evidence of Transmission Cooler Hose Abrasion

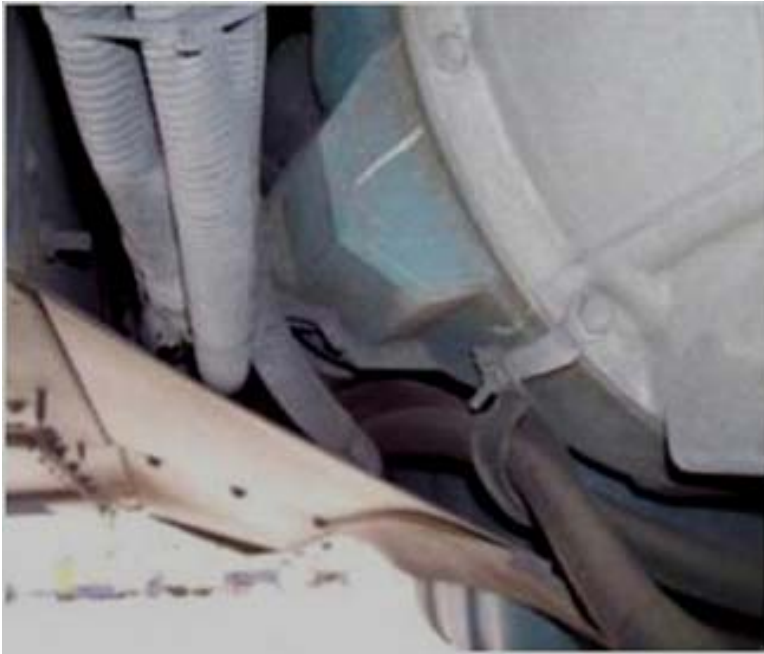
Many areas of the engine and air management panel area allow inspection of the battery cables, harness, and fluid hoses without further disassembly. Below are example areas which should be included in your overall inspection process. See Figure 4.

**Figure 4 Areas Accessible from under the Unit Looking into the Air Management Panel Area**

Battery cable, harness, and fluid hose inspection and maintenance should not be limited to the areas outlined above. Routine maintenance practices should include a total vehicle inspection. If a suspect cable, circuit, or hose condition is observed during inspection, further actions may be required to access the suspect area for complete inspection or replacement. If chafing or damage are found during the inspection, replace the suspect cable, conduit, circuit, or hose. Take time to ensure that any item replaced has been properly routed and clipped to avoid future abrasion points.

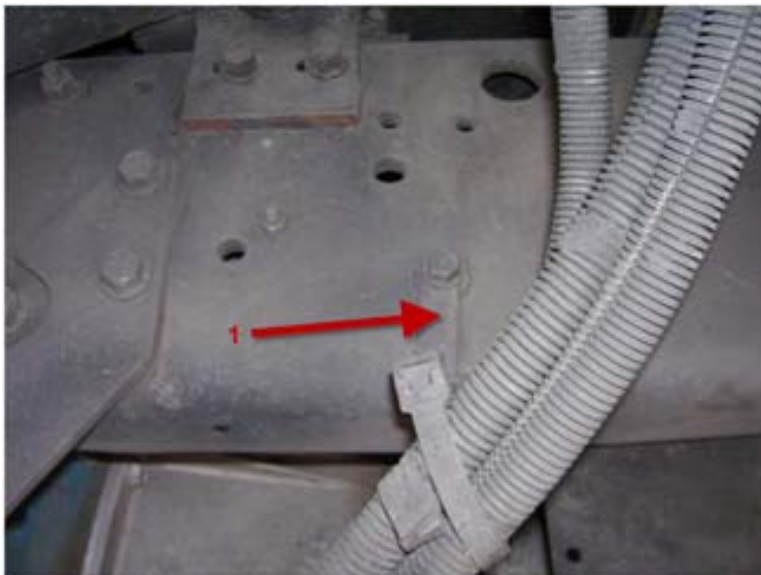
**Figure 6 Routing and Clipping Points to be Aware of on an I6-Equipped Unit**

1. Battery Cable and Harness Frame Rail-Mounted Standoff Bracket, Saddle and Tie-Strap, Located Between Exit of Battery Box and Starter Mounting Point

Below are routing and clipping points to be aware of on an I6-equipped unit to ensure proper securing of the battery cables, harness, and transmission cooler hoses (see Figure 5 and Figure 6).
