87 Moisture in driver or front passenger footwell

87 12 25 2024644/3 March 26, 2012. Supersedes Technical Service Bulletin Group 87 number 11 – 18 dated March 31, 2011 for reasons listed below.

Moisture in the driver or front passenger foot well.

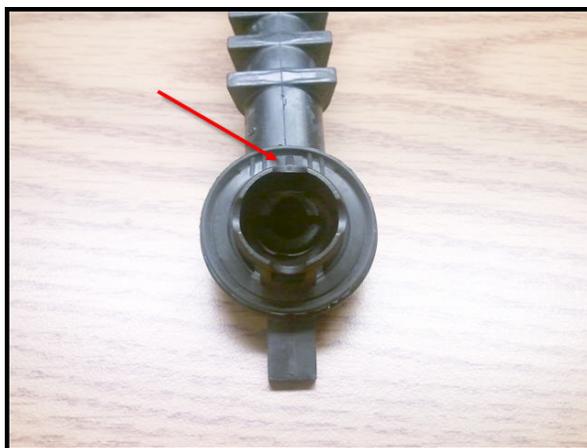
2. Inspect both drain hoses to identify if they are incorrectly assembled with the locating tab pointing up as seen in Figure 1. The correct orientation for this locating tab should be pointing down.

Figure 1. Incorrectly assembled drain hose, with locating tab pointing up.

3. Install new service parts; do not repair original drain hoses. Improper installation at the factory may have damaged the snap feature (opposite the locating tab), thus creating a poor seal to the body.

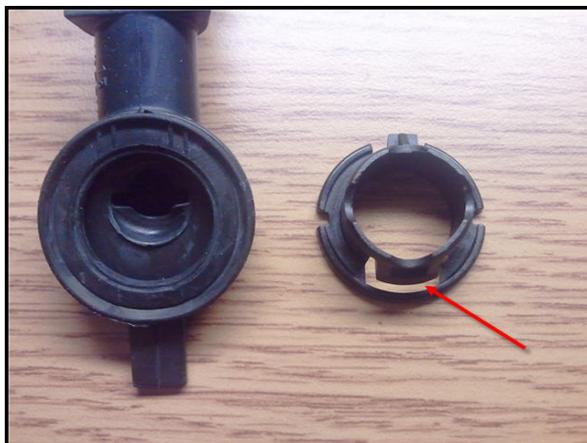
When the snap ring is installed upside down, it allows water to leak out through a hole at the bottom of the snap ring (Figure 2). The water can then soak into either of the front footwell carpeted areas.

Figure 2. Hole in snap ring.

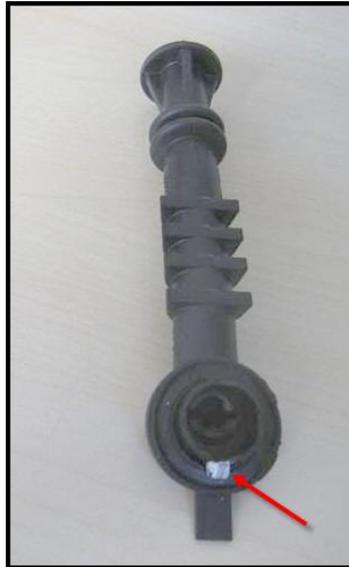
Service parts have been checked, but it is still possible to receive unchecked parts. Corrected parts will be marked in white on the locating tab. This tab must be pointing down (Figure 3).

Figure 3. White mark on locating tab.

4. If the locating tab on the new part is in the wrong position (pointing up), then use a small set of needle-nose pliers to gently pull the snap ring out of the rubber hose and align it in the correct position (pointing down). Dipping the end of the hose in soapy water may make the process easier.
5. Reinstall the snap ring in the correct position indicated by Figure 4.

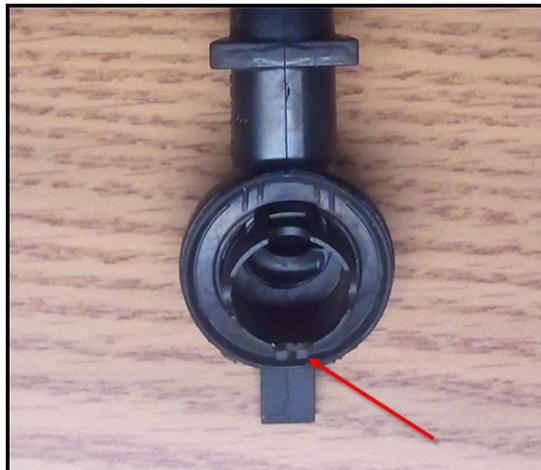
Figure 4. Snap ring installed in the correct position.

6. Connect the hose to the body before connecting it to the HVAC unit. Insert the locating tab (bottom of the hose) into the body hole and press the top portion of the snap ring into place.
There should be an audible click to indicate the hose has made a firm connection.
7. Inspect the seal by gently tugging on the hose to ensure it is completely seated.
8. Connect the top of the hose to the HVAC unit.
