Subject: VARIABLE VALVE TIMING (VVT) NOISE AND/OR TIMING CHAIN NOISE	Bulletin No: 01-012/12
	Last Issued: 04/03/2012

2006-2007 Mazdaspeed6

2007-2009 Mazdaspeed3

2007-2010 CX-7 2.3L Turbo vehicles with VINs lower than JM3ER*****327444 (prod. before Feb. 26, 2010)

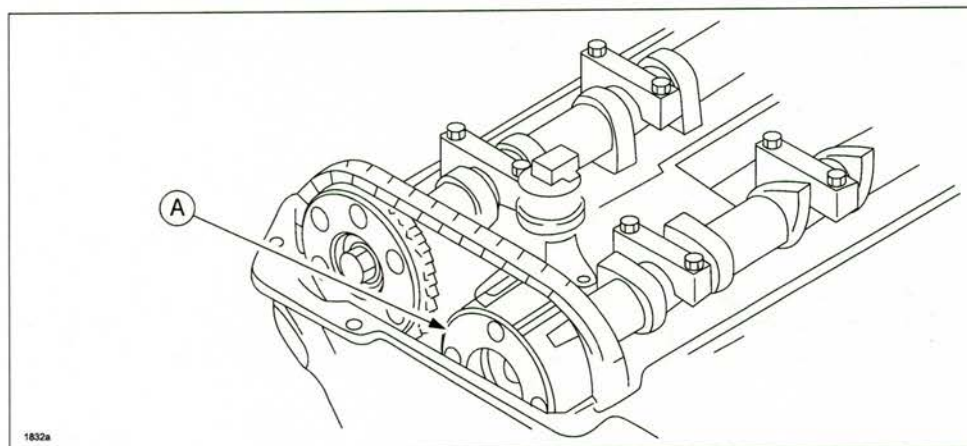
When the engine is first started, some vehicles may exhibit a loud ticking noise from the variable valve timing (VVT) actuator (A). This is caused by the lock pin of the variable valve timing actuator not fully engaging or from a worn lock pin hole.

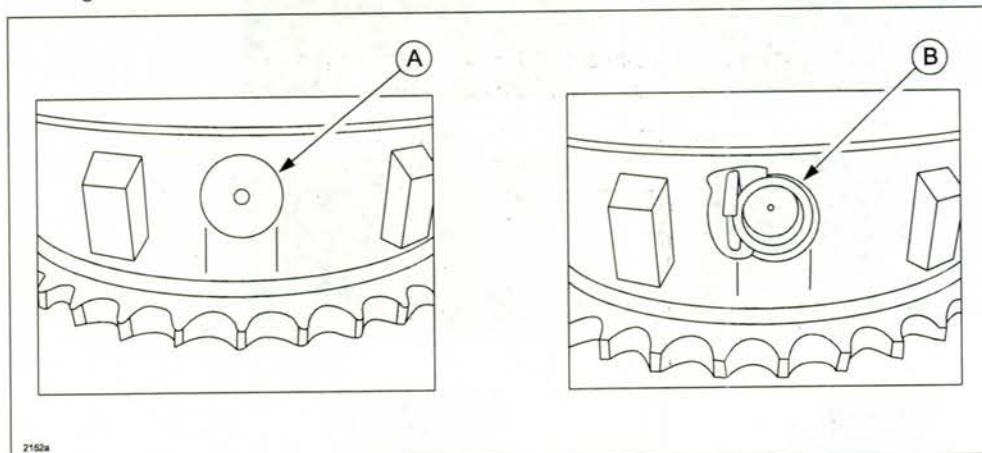
4. Inspect the VVT actuator for damage around the stopper pin cap (A) or a missing stopper pin cap spring and stopper (B).
 - If no parts are missing or damaged, go to next step.

- If parts are missing or damaged:
 - **Without modified Timing Chain (see page 2):** Replace the Timing Chain and VVT actuator. See REPLACEMENT OF TIMING CHAIN AND VVT ACTUATOR in this TSB (page 25).

- **With modified Timing Chain (see page 2):** Replace the VVT actuator. See REPLACEMENT OF VVT ACTUATOR ONLY in this TSB using new SST (page 6).

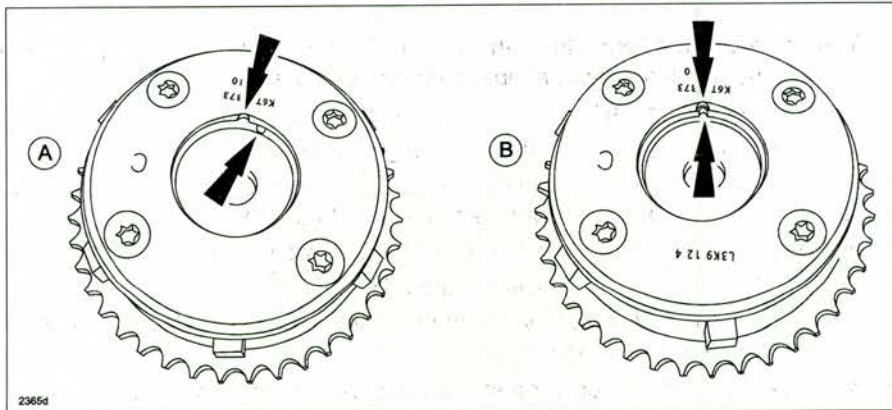
5. Turn the crankshaft clockwise so that the notches on the VVT actuator can be checked.
 - A. If the notches are NOT aligned, go to the next step.
 - B. If the notches are aligned, there is no problem with the VVT actuator and this information is not applicable. Refer to MS3 for troubleshooting.

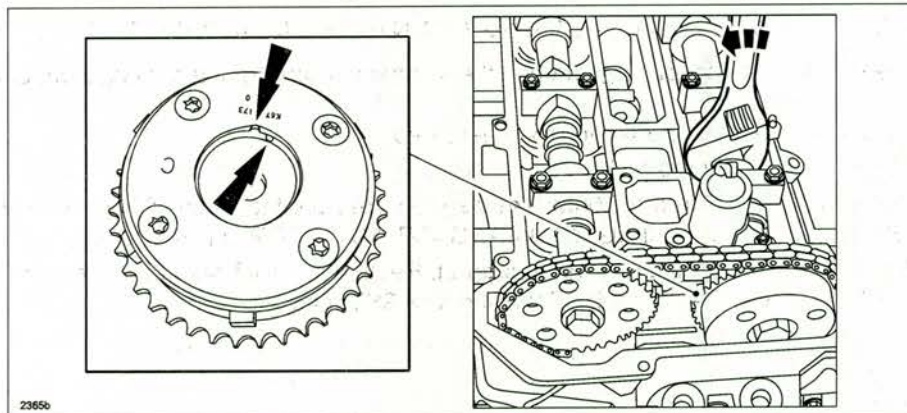
6. Turn the camshaft counterclockwise to align the notches on the variable valve timing actuator.

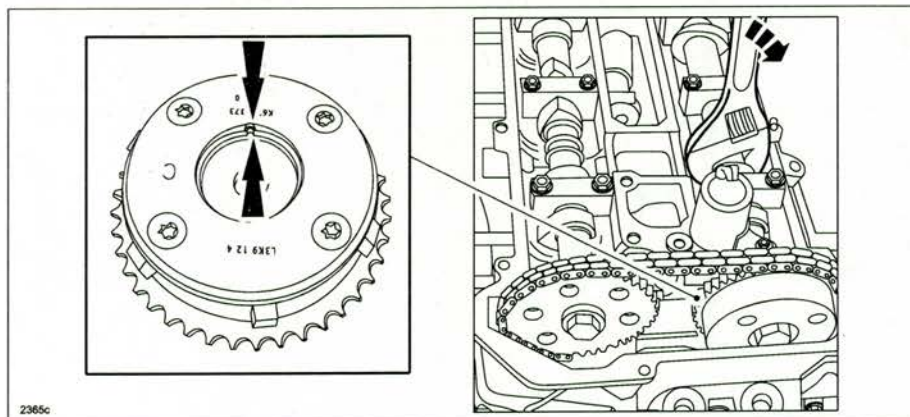
7. With the notches aligned, turn the camshaft clockwise 90 degrees using an adjustable wrench (or 24 mm box end wrench) on the intake camshaft cast hexagon as shown.

CAUTION: Do not use the bolt on the VVT actuator to rotate the camshaft.

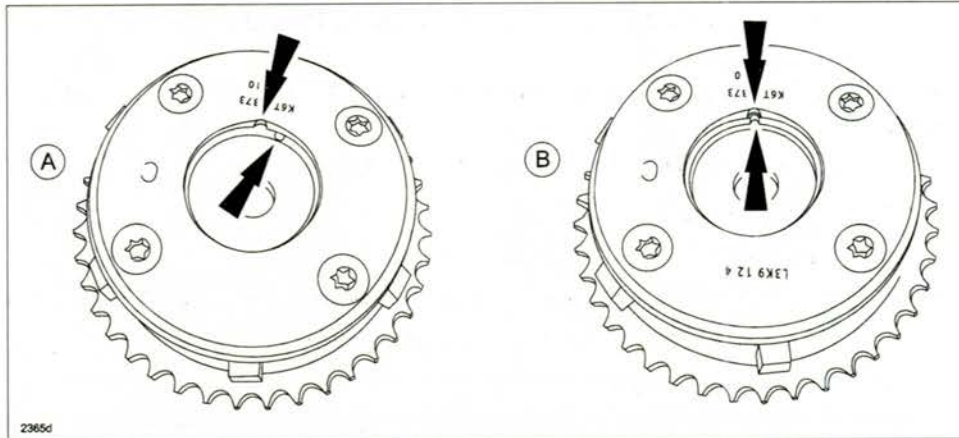
8. Check the notches again.
- A. If the notches are NOT aligned, replace the VVT actuator. See REPLACEMENT OF VVT ACTUATOR ONLY in this TSB using new SST (page 6).
 - B. If the notches are aligned, there is no problem with the VVT actuator and this information is not applicable. Refer to MS3 for troubleshooting.

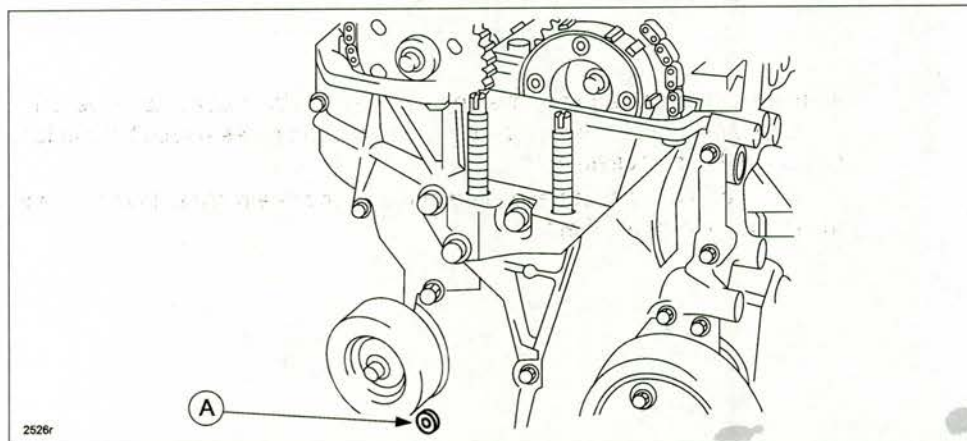
1. Record the customer's radio station presets.
2. Disconnect the negative battery cable.
3. Remove the splash shield (RH).
4. Remove the charge air cooler. See INTAKE-AIR SYSTEM REMOVAL/INSTALLATION [L3 WITH TC] on MS3.
5. Remove the high pressure fuel pump. See HIGH PRESSURE FUEL PUMP REMOVAL/INSTALLATION [L3 WITH TC] on MS3.
6. Remove the ignition coils. See IGNITION COIL REMOVAL/INSTALLATION[L3 WITH TC] on MS3.
7. Disconnect the wiring harness.
8. Remove the ventilation hose.
9. Remove the cylinder head cover. See TIMING CHAIN REMOVAL/INSTALLATION [L3 WITH TC] on MS3.
10. Remove the drive belt. See DRIVE BELT REMOVAL/INSTALLATION[L3 WITH TC] on MS3.
11. Remove the engine front cover lower blind plug (A).

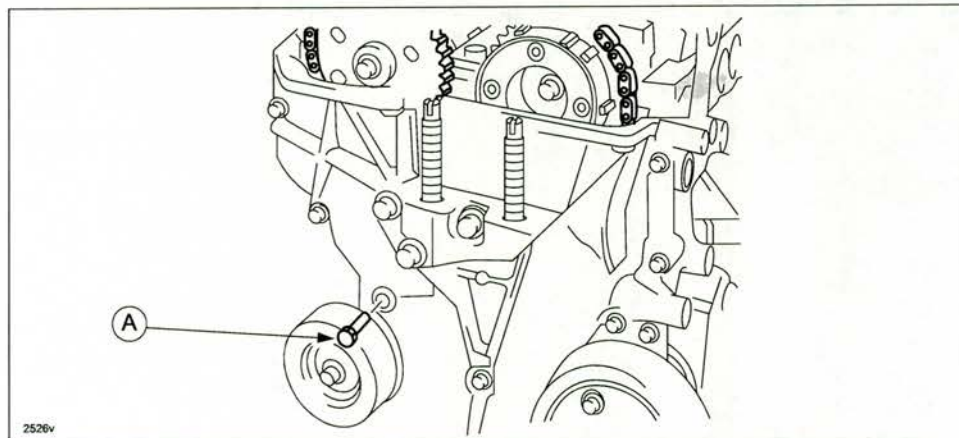
12. Remove the engine front cover upper blind plug (A).

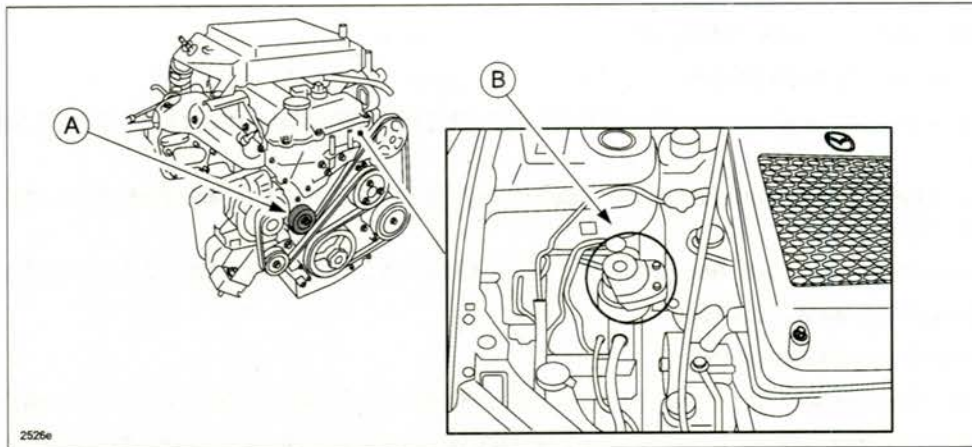
13. Remove the drive belt idler pulley (A). For the Mazdaspeed6, remove the No.3 engine joint bracket and the No. 3 mount (B).

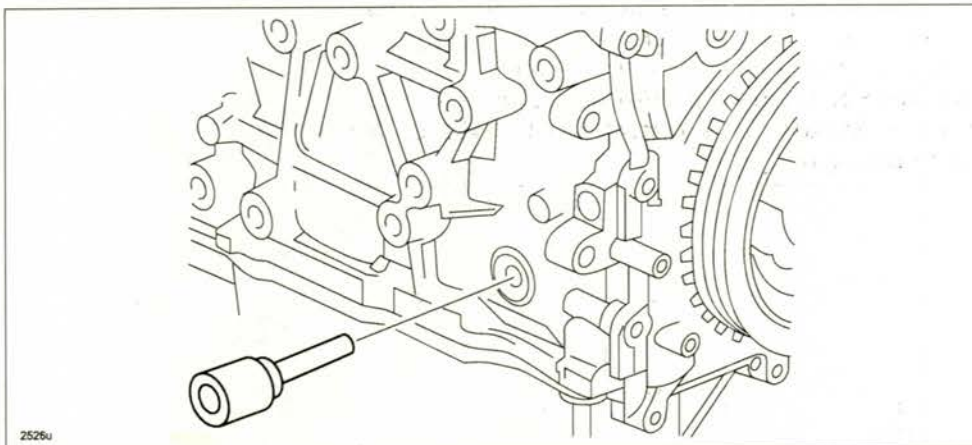
14. Remove the cylinder block lower blind plug, and install the SST.

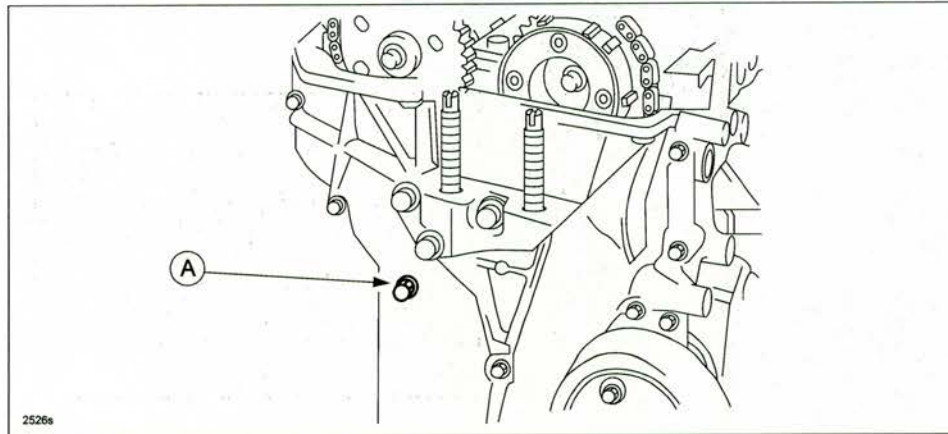
16. Insert a suitable bolt (A) - M6 X 1.0, length 25—35 mm (0.99—1.3 in) - into the engine front cover upper blind plug and tighten it until it contacts the chain tensioner arm, and then rotate it back one turn. (Set the bolt slightly away from the chain tensioner arm so that it does not contact it.)

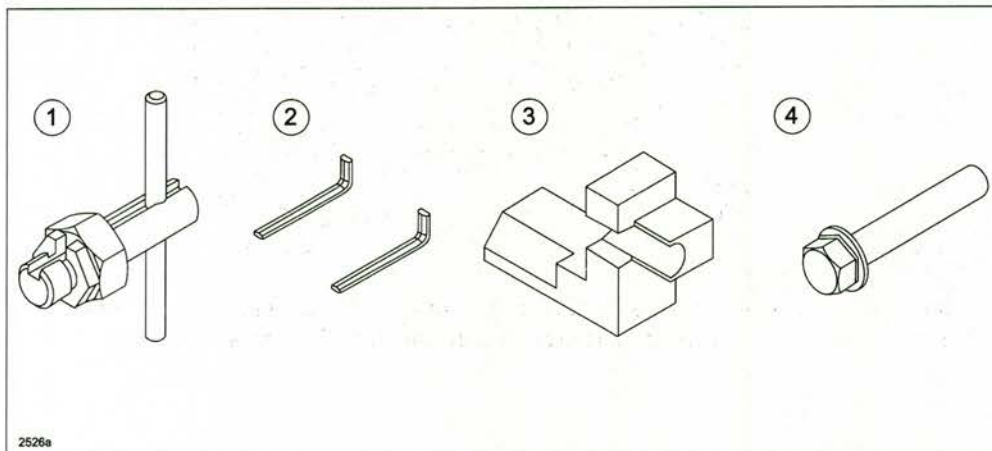
17. Unlock the timing chain tensioner ratchet with the Tensioner Release Tool Set (Part Number 49-G010-4A0)

Tensioner Release Tool Set includes:

- (1) Tensioner Release Tool: 49-G010-401, quantity 1
- (2) Tensioner Release Arm: 49-G010-402, quantity 2
- (3) Tensioner Release Guide (plastic): 49-G010-403, quantity 1
- (4) Flange Bolt: quantity 1

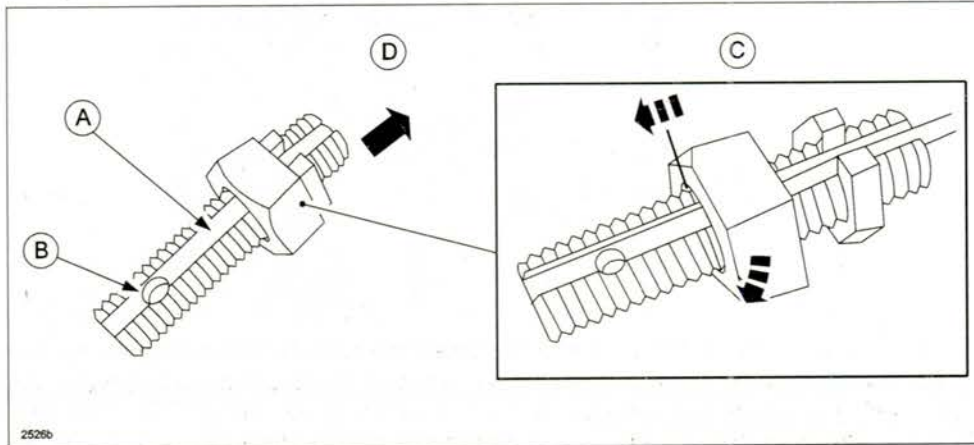
Tensioner Release Tool

- (A) Tensioner Release Arm Groove
- (B) Handle Lever Hole
- (C) Nut - to remove tensioner release arm (reverse threaded); use in case the tip of the arm is deformed and unable to remove by hand
- (D) End to engine front cover blind plug hole

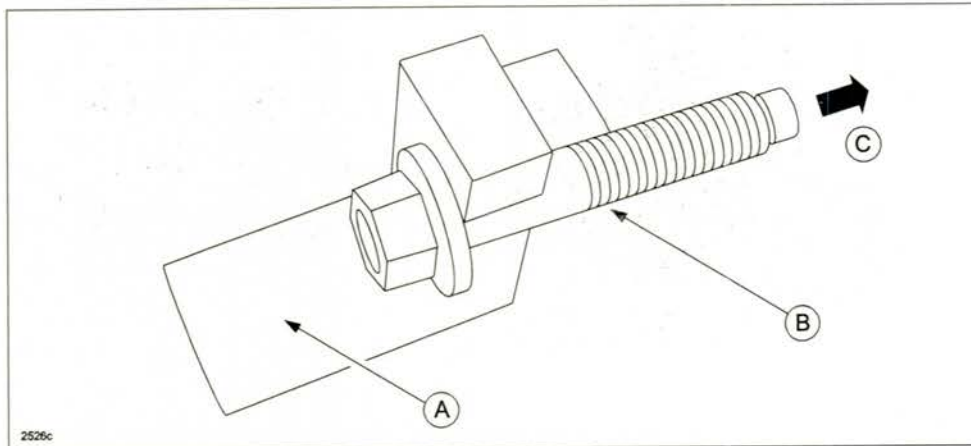
Tensioner Release Guide and Flange Bolt

- (A) Tensioner Release Guide
- (B) Flange Bolt
- (C) End to idler pulley threaded hole

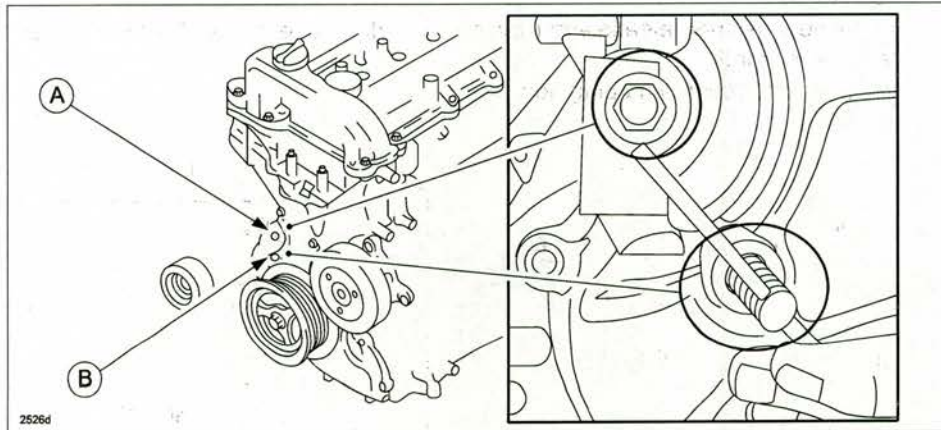
The tensioner release guide and flange bolt (A) will attach to the front drive belt idler pulley hole and the tensioner release tool (B) will attach to the engine front cover lower blind plug hole.

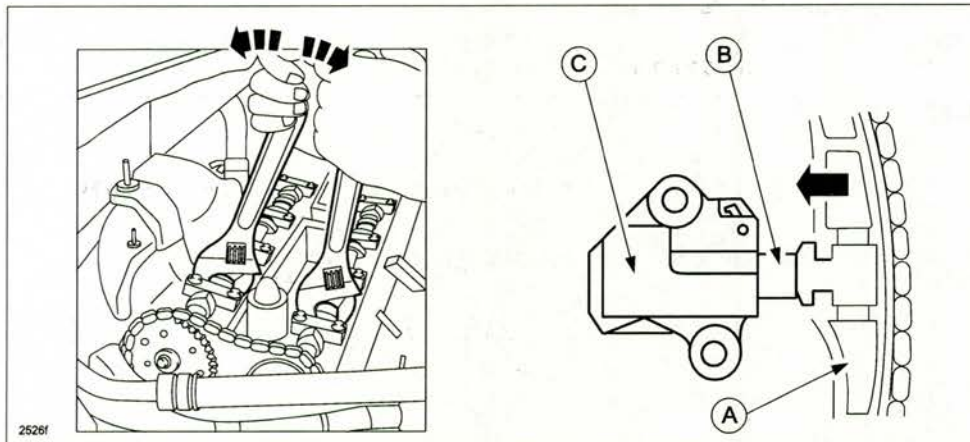
- a. Using the cast hexagon on the exhaust and intake camshafts, hold the intake cam with an adjustable wrench (or 24 mm box end wrench) then using another wrench rock the exhaust camshaft back and forth (approximately 10 times) to move the tensioner arm (A) and tensioner plunger (B) to drop the oil pressure inside the chain tensioner (C). Apply force counterclockwise to facilitate unlocking the chain tensioner ratchet.

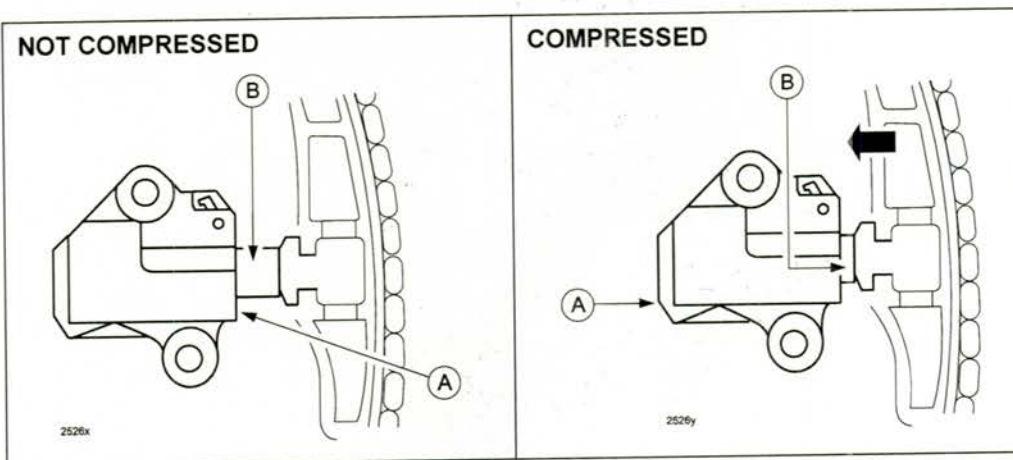
NOTE: The chain tensioner rack is compressed using the chain tension generated by applying force to the exhaust camshaft in the direction of the engine rotation.

A: Chain Tensioner
B: Plunger

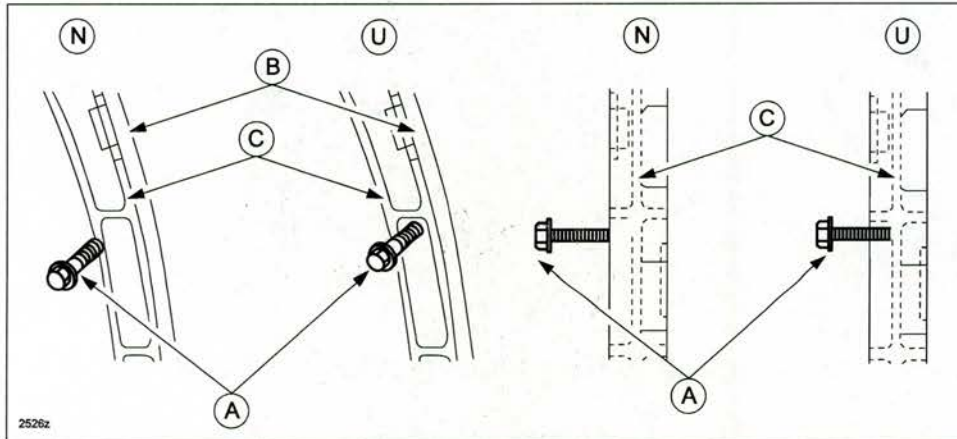
- The ratchet has not been unlocked if the bolt cannot be screwed in approx. 5 mm {0.2 in}.
- Screw in the bolt set in step 16 approximately 5 mm {0.2 in} and secure the tensioner arm with the rack compressed.

- A: Bolt (M6x1.0, Length 25-35 mm {0.99-1.3 in})
- B: Tensioner Arm
- C: Rib
- N: Not Unlocked
- U: Unlocked

- If the tensioner arm cannot be secured, return the bolt to its original position and repeat the procedure from Steps (i- j).

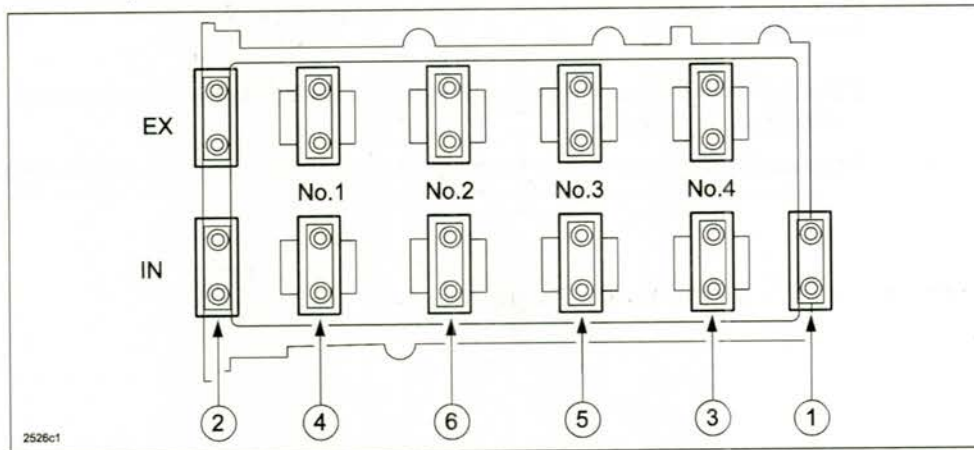
20. Remove the oil control valve (OCV). (See OIL CONTROL VALVE (OCV) REMOVAL/INSTALLATION[L3 WITH TC].)
21. Loosen the camshaft cap bolts in two or three passes in the order shown in the figure and remove the camshaft cap.

NOTE: The camshaft caps are to be kept in order for correct reassembly in their original positions. Do not mix the caps.

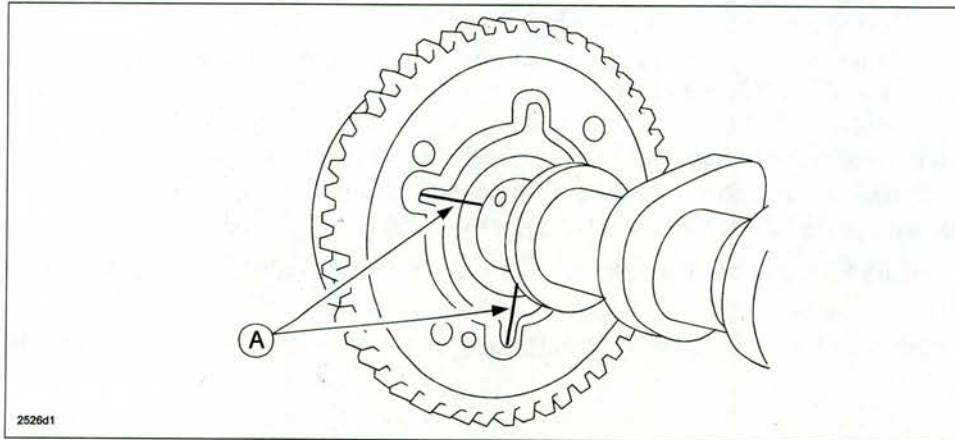
- a. Place alignment marks (A) on the camshaft and variable valve timing actuator as shown in the figure so that the variable valve timing actuator is re-assembled in its original position.

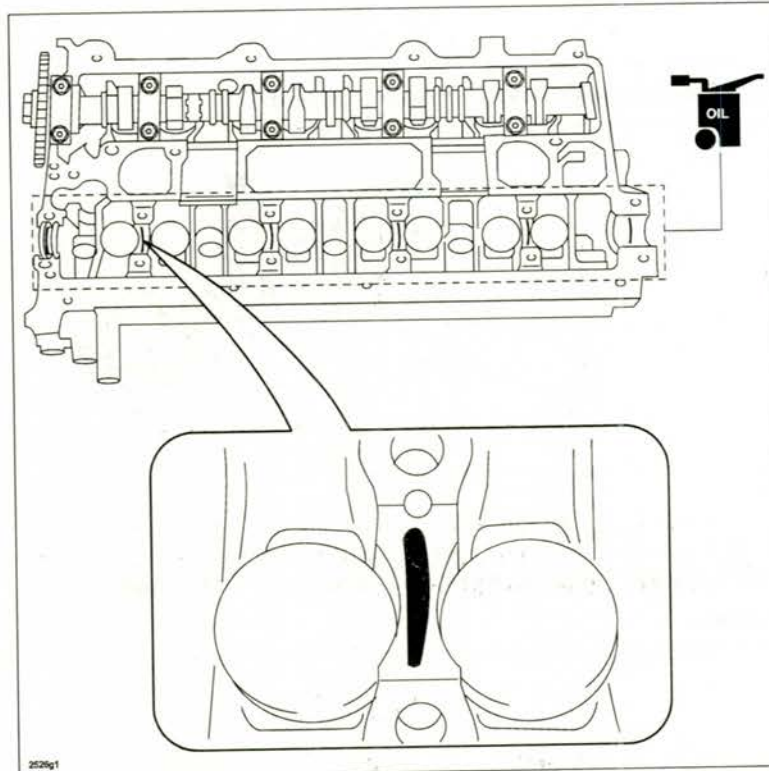
27. Apply gear oil (SAE No. 90 or equivalent) to each journal of the cylinder head as shown in the figure.

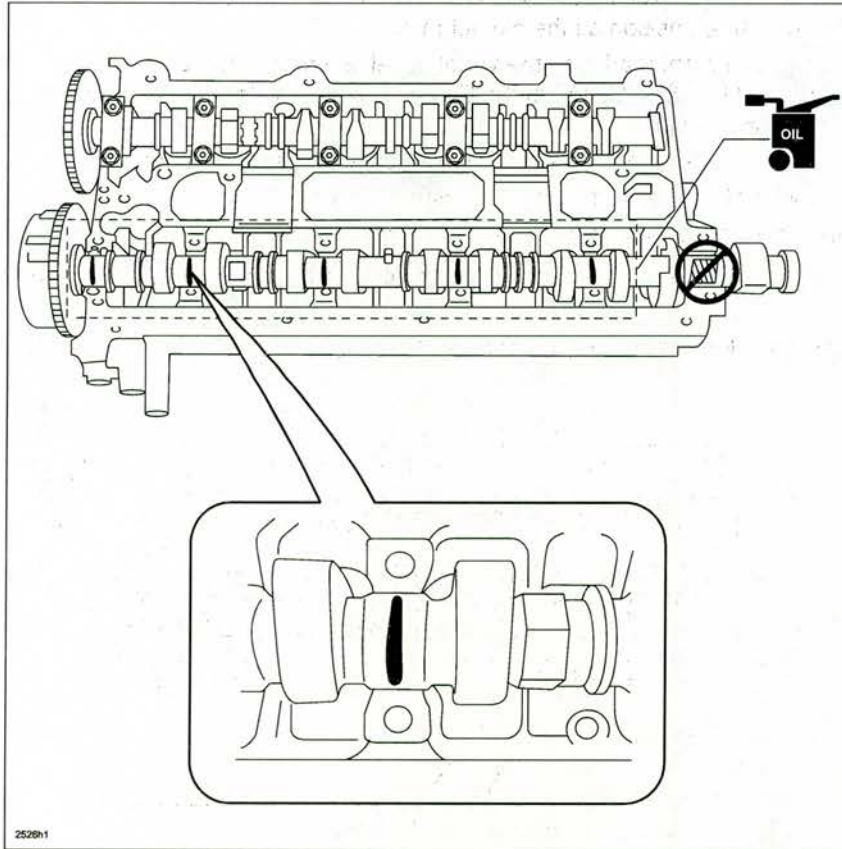
29. Apply the gear oil (SAE No. 90 or equivalent) to each journal of the camshaft as shown in the figure. However, do not apply it to the end journal of the intake camshaft.

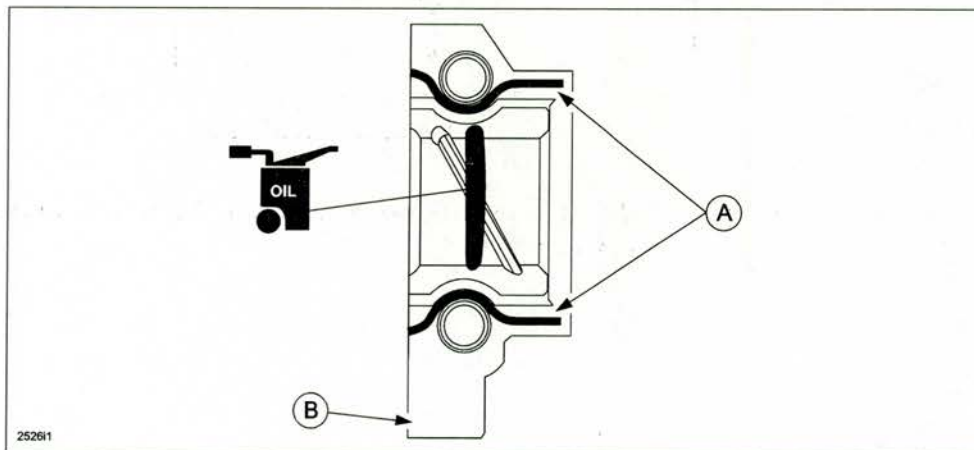
30. Carefully apply adhesive agent (Loctite 518 or 962) to the area indicated in the figure (A) so that it does not leak into the sliding part then, apply the gear oil (SAE No. 90 or equivalent) to the journal.
Adhesive agent thickness: 1.0mm (0.039 in)

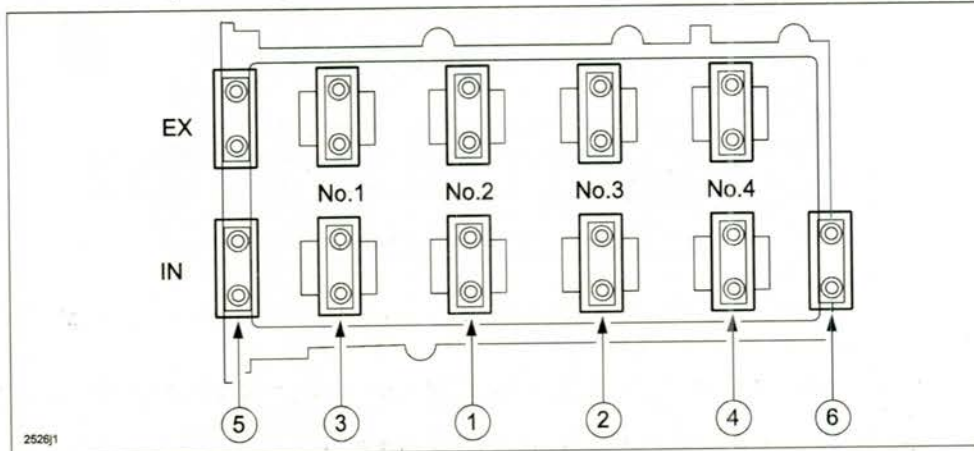
31. Install the camshaft caps and temporarily tighten the camshaft cap bolts evenly in two or three passes, and then tighten the camshaft cap bolts in two passes, using the following two steps and in the order shown in the figure.

Step 1: 5.0-9.0 Nm {51-91 kgfcm, 45-79 in-lbf}

Step 2: 14.0-17.0 Nm {1.5-1.7 kgfm, 10.4-12.5 ft-lbf}

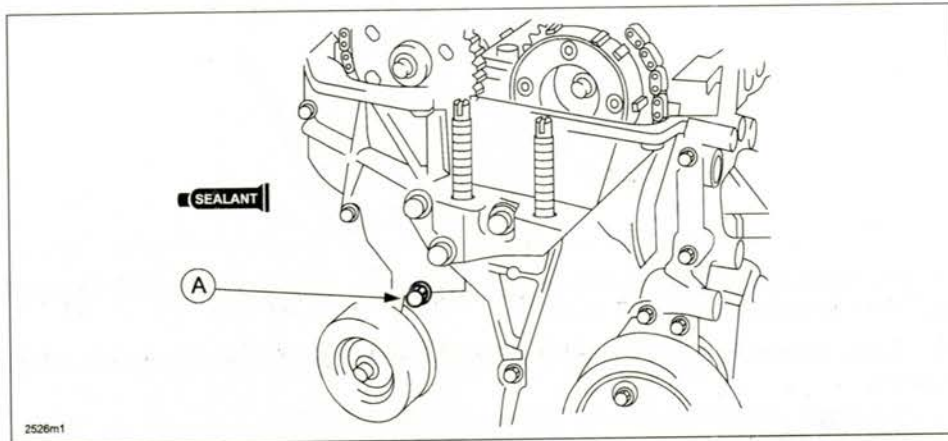
40. Rotate the crankshaft clockwise two turns and inspect the valve timing.
 - If not aligned, loosen the camshaft sprocket bolt and repeat the procedure from Step 33.
41. Install the drive belt idler pulley. For the Mazdaspeed6, install the No.3 engine joint bracket and the No. 3 mount.
42. Apply the silicone sealant and install the engine front cover upper blind plug (A).
Tightening torque: 8.0-11.5 N·m {82-117 kgf·cm, 71-101 in·lbf}

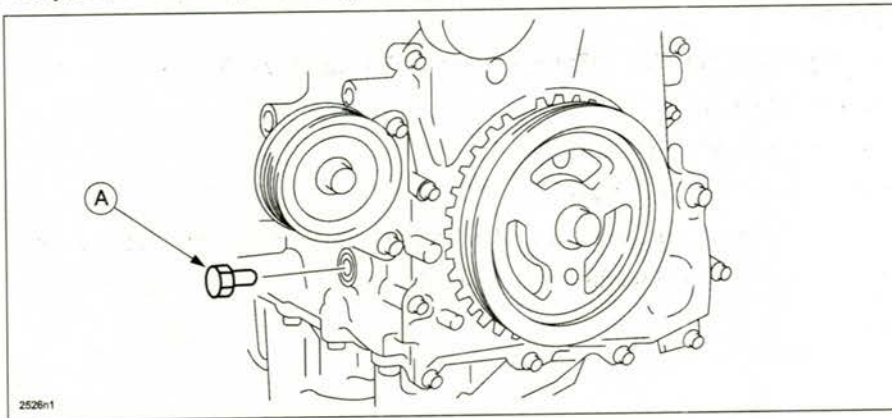
43. Install the cylinder block lower blind plug (A).
Tightening torque: 18-22 N·m {1.9-2.2 kgf·m, 14-16 ft·lbf}

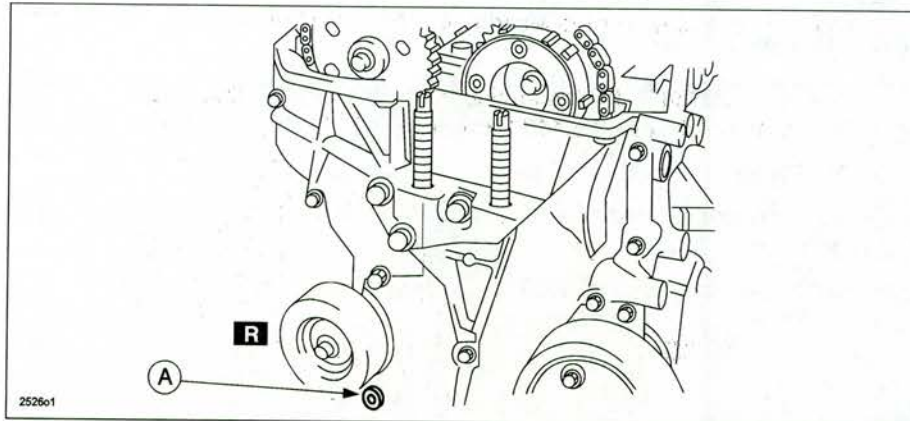
44. Install a new engine front cover lower blind plug (A).
Tightening torque: 10.0-14.0 N·m {102-142 kgf·cm, 89-123 in·lb}
