Right front seat belt or left front seat belt does not roll up completely

Topic number	LI91.40-P-053536
Version	1
Design group	91.40 Seat belts, emergency tensioning retractors
Date	04-20-2012
Validity	Model series 207, 218 in production period from 09.2011 up to and including 01.2012
Reason for change	
Reason for block

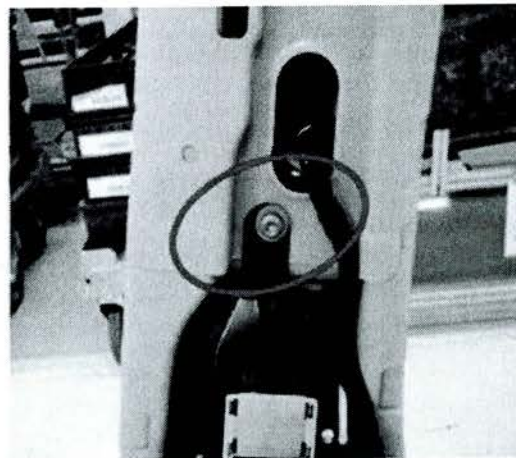
Picture 1.jpg:

Belt strap scrapes on retractor housing.

Attachments	
File	Designation
Picture 1.jpg	Not OK alignment of reversible emergency tensioning retractor

Not OK connection: Shown on model series 218 right front seat - Figure 1

Realign the reversible emergency tensioning retractor within the installation tolerance.

- Slacken the mounting bolts on the reversible emergency tensioning retractor.
- Push the reversible emergency tensioning retractor at the upper mounting bolt towards the rear of the vehicle and tighten the mounting bolt.
- Correct the torque at the mounting bolts.

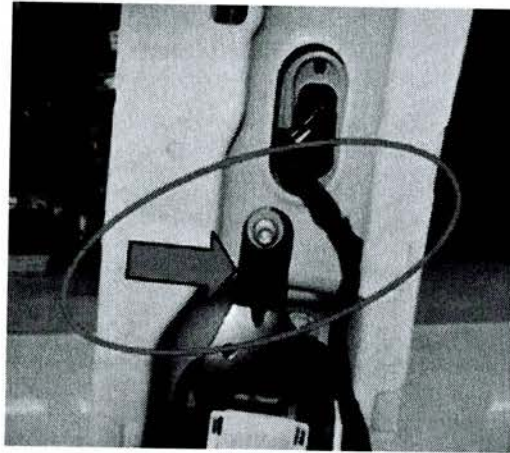
Picture 2.jpg:

OK connection: Shown on model series 218 right front seat - Figure 2

Attachments	
File	Designation
Picture 2.jpg	OK alignment of reversible emergency tensioning retractor. Shown on right front seat in model series 218.
Picture 3.jpg	OK alignment of reversible emergency tensioning retractor. Shown on left front seat in model series 207.

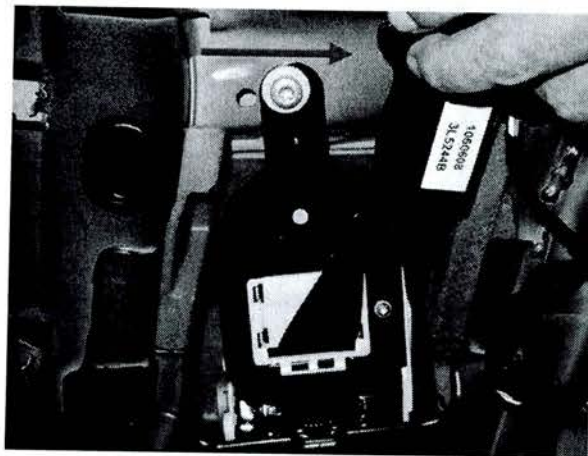
Picture 3.jpg:

OK connection: Shown on model series 207 left front seat - Figure 3
