# Service Bulletin

Bulletin No.: PI0522B

**Subject:** Tick or Rattle Noise from Front of Dash, Transmission Filler Tube Cracked or Broken (Inspect Filler Tube, Replace Tube as Necessary)

**Models:** 2007-2011 Cadillac Escalade Models  
 2007-2011 Chevrolet Silverado  
 2008-2011 Chevrolet Avalanche, Suburban, Tahoe  
 2007-2011 GMC Sierra, Yukon, Yukon XL  
 Equipped with 6L80 (RPO MYC) Automatic Transmission

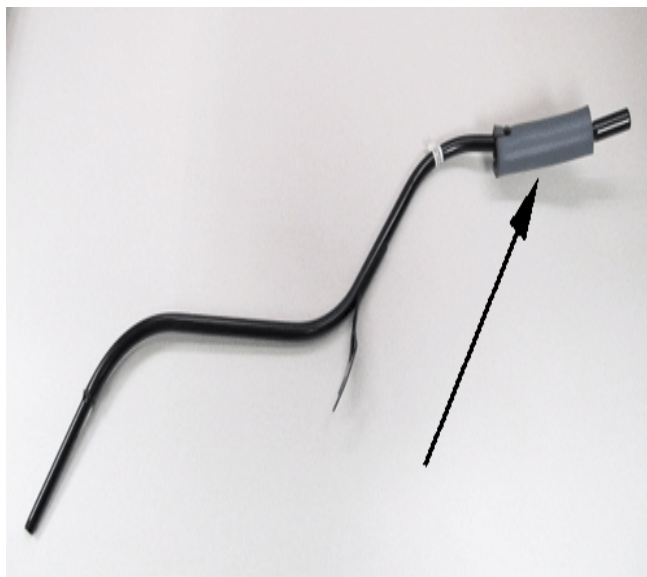
2688999

If the transmission filler tube is found to be cracked or broken, it should be replaced with a revised filler tube. This filler tube incorporates a damper near the top that prevents resonance related damage.

**Important:** The foam attached to the upper end of the tube is the damper. Do not mistake this foam for packaging material. Do not remove this foam from the tube.

If the filler tube is not cracked or broken, inspect for adequate clearance between the filler tube and the front of dash area or any heater lines that might be in the area. Create a gap between the filler tube and front of dash or heater lines as needed.
