Service Bulletin

Bulletin No.: PI0522D

Subject: Tick, Buzz or Rattle Noise from Front of Dash, Transmission Filler Tube Cracked or Broken

Models: 2007-2013 Cadillac Escalade Models (excluding Hybrids)
2007-2013 Chevrolet Avalanche, Silverado, Suburban, Tahoe (excluding Hybrids)
2007-2013 GMC Sierra, Yukon Models (excluding Hybrids)

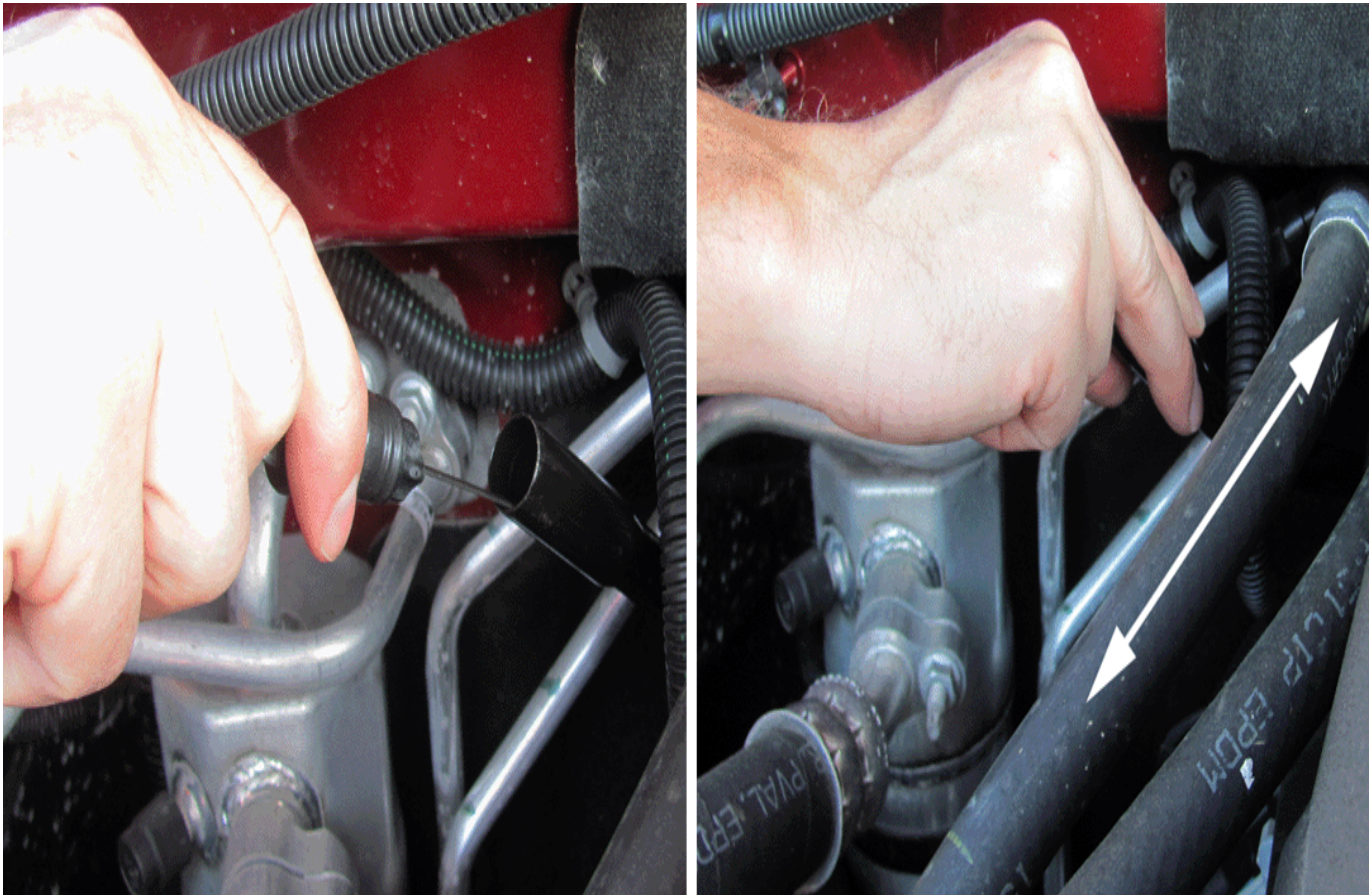
2906255

2. Remove the dipstick from the transmission filler tube.

3. Grasp the transmission filler tube with your thumb and first two fingers of your right hand. Your thumb should be on the passenger side of the transmission filler tube and parallel to the filler tube.

4. Using only your thumb and the first two fingers of your right hand, force the transmission filler tube toward the driver's seating position and then back to the passenger's front wheel two times.

5. Determine if the transmission filler tube is damaged. An undamaged transmission filler tube will move less than two inches and spring back to its original position, while a damaged transmission filler tube will move greater than two inches and will not spring back to its original position. A damaged transmission filler tube will likely crack during this inspection.

- If the transmission filler tube is not damaged, proceed to Step 6.
 - If the transmission filler tube is damaged, replace the transmission filler tube. Refer to Transmission Fluid Filler Tube and Seal Replacement in SI.

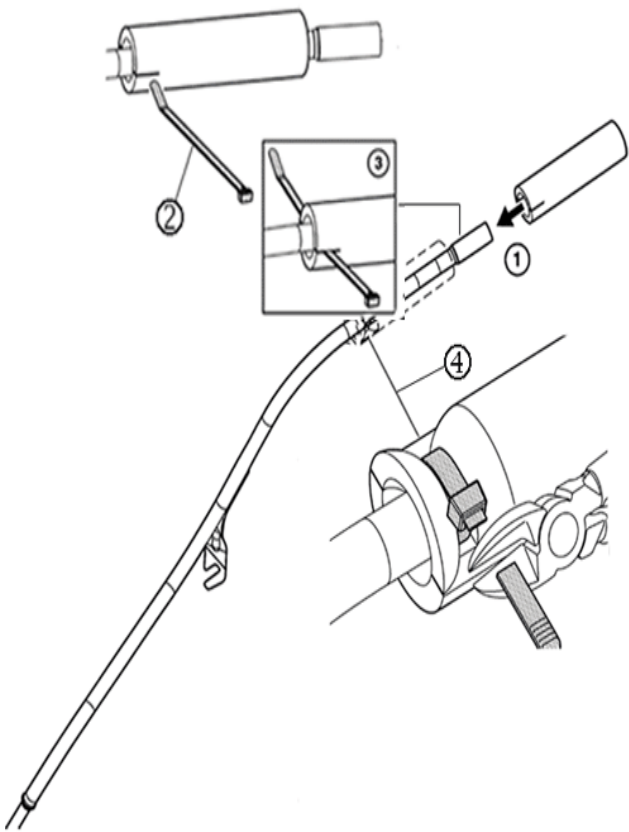
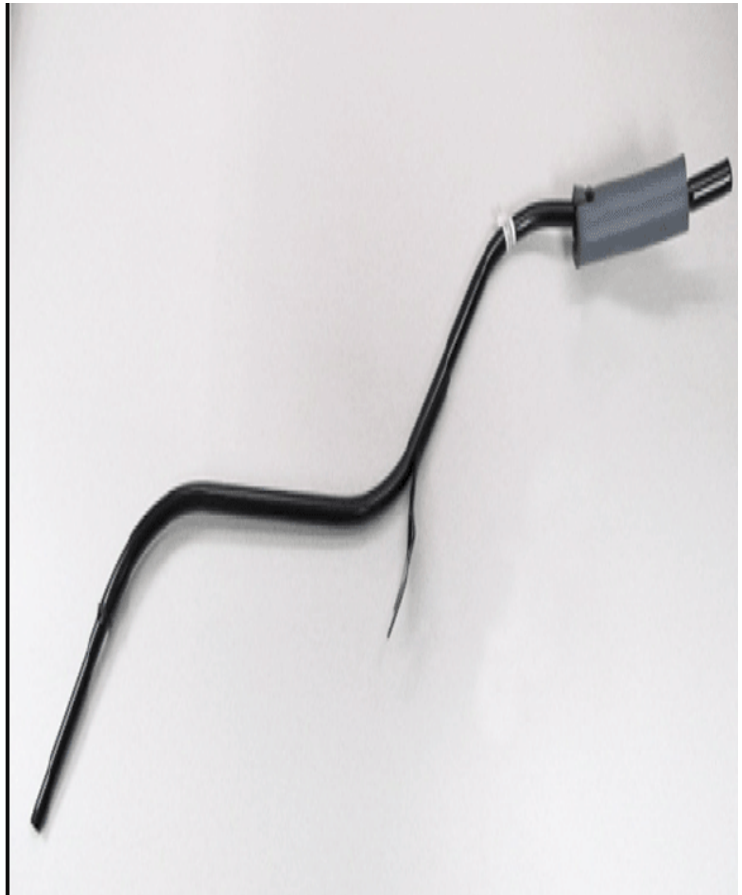
2906258

Note: The tie strap threads between the fill tube and half the foam damper using the slot in the sleeve. This is secured to the top half of the tube, leaving the lower half of the damper free.

6. Install a foam damper (sleeve) on the upper end of the transmission filler tube using a tie strap. Refer to the illustration.
7. Install the transmission dipstick.
8. Close the hood.

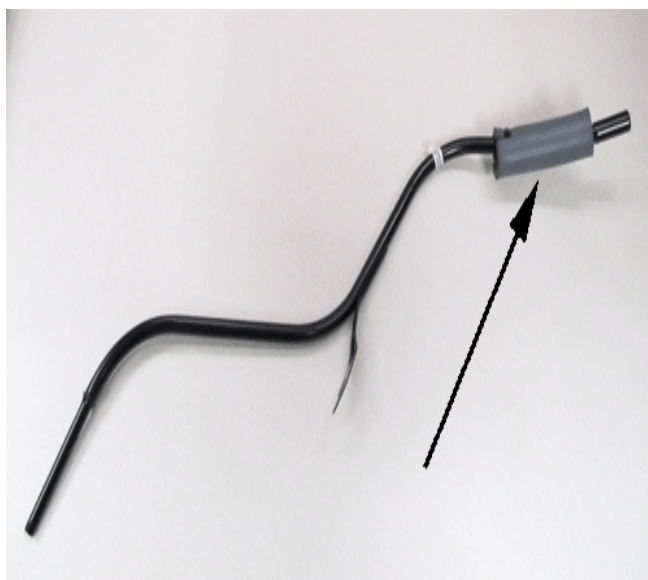
2688999

Important: The foam attached to the upper end of the tube is the damper. Do not mistake this foam for packaging material. Do not remove this foam from the tube.
