## Hydraulic Brake Interlock Circuit Protection

BULLETIN

Models Affected: Certain 2011-2013 Model Year Vision, With Hydraulic Brake Interlock

S I 2 T Z

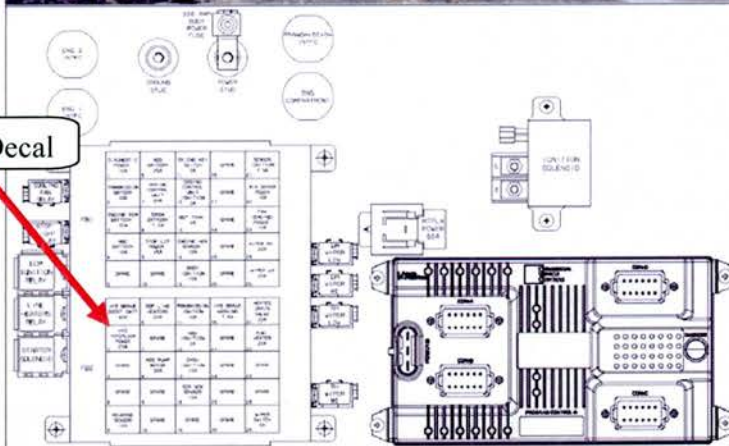
See Decal

1. Park the bus on a level surface, apply parking brakes, turn off engine and remove keys. Chock wheels.
2. Remove chassis Power Distribution Unit (PDU) cover by removing two thumb screws. The thumb screws are located at the top of each side of the cover.
3. Verify fuse or breaker installed in fuse block (FB2) position (2). See decal on reverse side of PDU cover for location. It will be listed as "HYD INTERLOCK POWER". If a 25 amp fuse is installed no action is required, replace cover. If not a 25 amp fuse, replace with Blue Bird 25 amp fuse part number 01983832 and correct existing decal with the new overlay decal (provided).
