# Service Bulletin

**SUBJECT:** Service Update for Inventory Vehicles Only  
Rear Differential Module Seal Leak  
Expires May 31, 2013

**MODELS:** 2012 Buick LaCrosse  
2012 Cadillac SRX

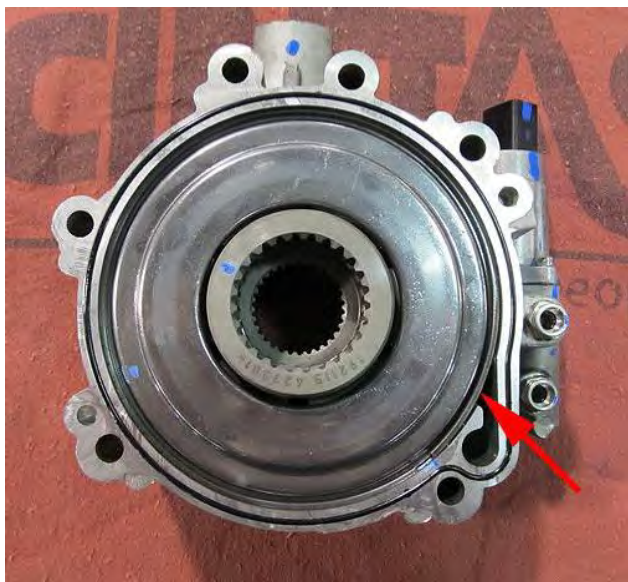
2789536

5. Remove the limited slip differential clutch low and high pressure pipes from the differential clutch.
6. Remove the electrical connector from the limited slip differential valve and remove the harness from the clip.
7. Remove the limited slip differential clutch bolts (Qty: 6).
8. Remove the limited slip differential clutch from the differential carrier assembly.

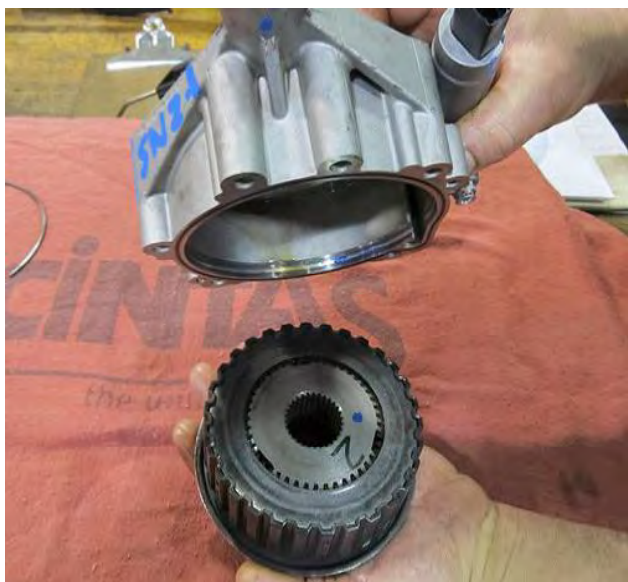
2789542

- 9. Remove the retaining ring that secures the differential clutch pack to the clutch housing.

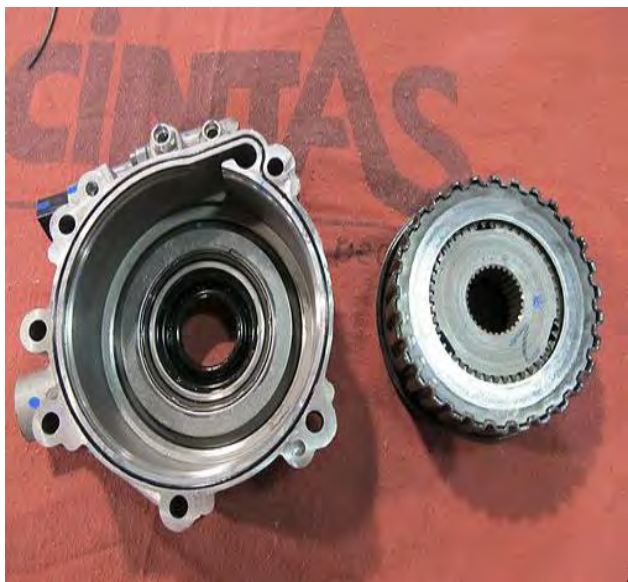
2789543

10. Remove the differential clutch pack from the clutch housing. Hold the housing in one hand and flip over to allow the clutch pack to fall into the other hand.

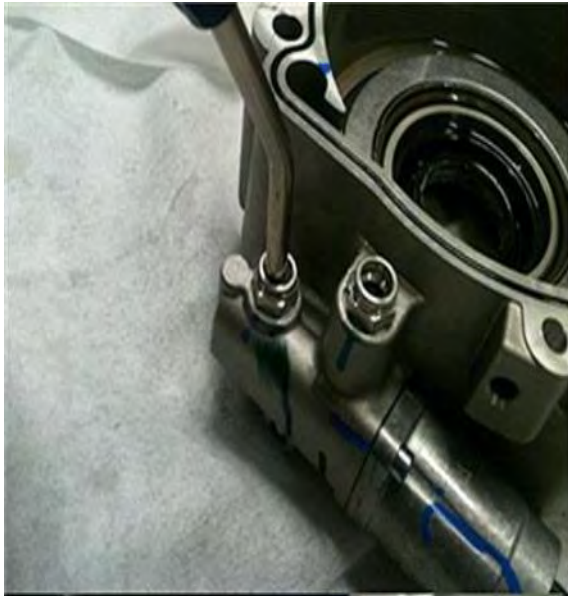
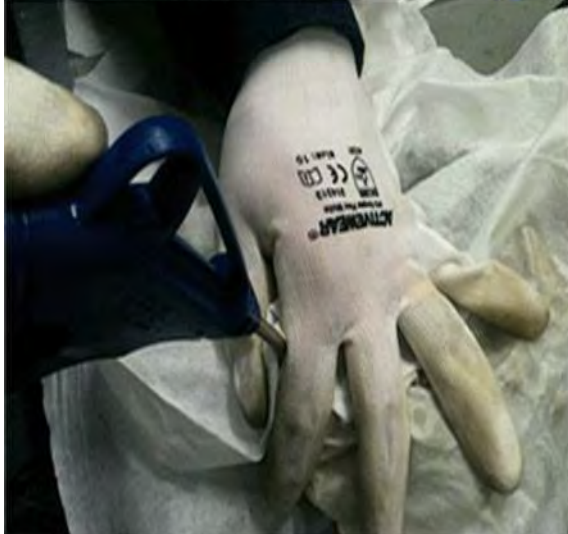
2806109

11. Apply compressed air to the low pressure pipe connector port to release the piston from the differential clutch housing.

12. Remove the eLSD clutch piston from the housing.

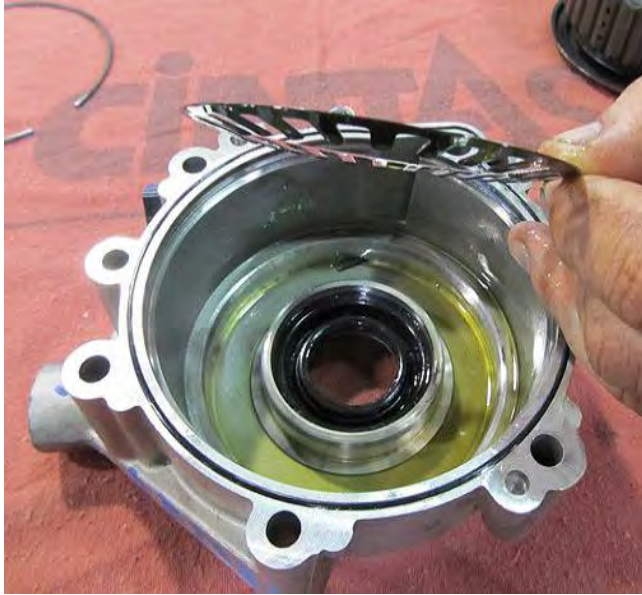
2789546

**Note:** If the piston spring is removed, ensure proper orientation when reinstalling. Spring fingers must be positioned as shown above.

13. Install the new eLSD clutch piston into the housing. Push down to seat.
14. Reinstall the differential clutch pack into the housing.
15. Reinstall the retaining ring that secures the differential clutch pack to the clutch housing.
16. Remove the low and high pressure pipe connectors from the limited slip differential clutch. Discard the connectors and pipe spring clips.
17. Install the NEW low and high pressure pipe connectors and spring clips to the limited slip differential clutch.

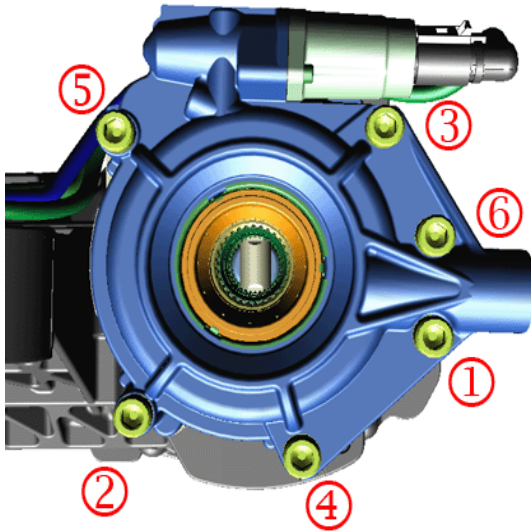
2806114

18. Reinstall the limited slip differential clutch to the differential carrier assembly.

19. Reinstall the limited slip differential clutch bolts (Qty: 6).

Tighten the bolts in proper sequence to **30 N·m (22 lb ft)**.

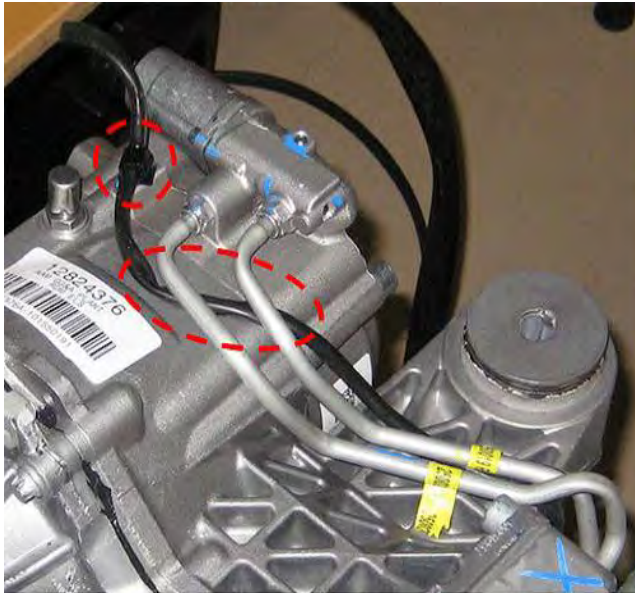
2806112

20. Reinstall the limited slip differential clutch low and high pressure pipes to the differential clutch.

21. Reinstall the electrical connector to the limited slip differential valve and harness to the clip. Route the electrical harness under the pressure lines as shown.

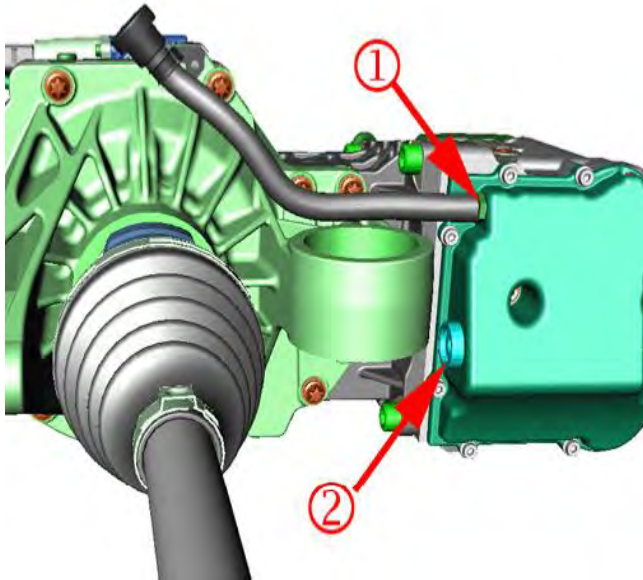
2806115

22. Remove the TTD clutch cover fill plug (2) and add 140 ml (0.15 qts) of eLSD clutch lubricant. Install the fill plug.

Tighten to **14 N·m (10 lb ft)**.

32. The eLSD clutch fluid should be level with the bottom of the eLSD clutch cover plug hole (2). If the eLSD clutch is overfilled, drain out fluid until it is at the proper level. Add fluid through the vent opening (1) if the eLSD clutch is low on fluid.
