# Service Bulletin

Bulletin No.: PI0733

**Subject:** Power Seat Functions Inoperative and Air Bag Light Illuminated

**Models:** 2011-2012 Chevrolet Cruze  
Equipped with Adjustable Multi-Directional Driver Power Seat (RPO ADS)  
and Built Prior to August 24, 2011

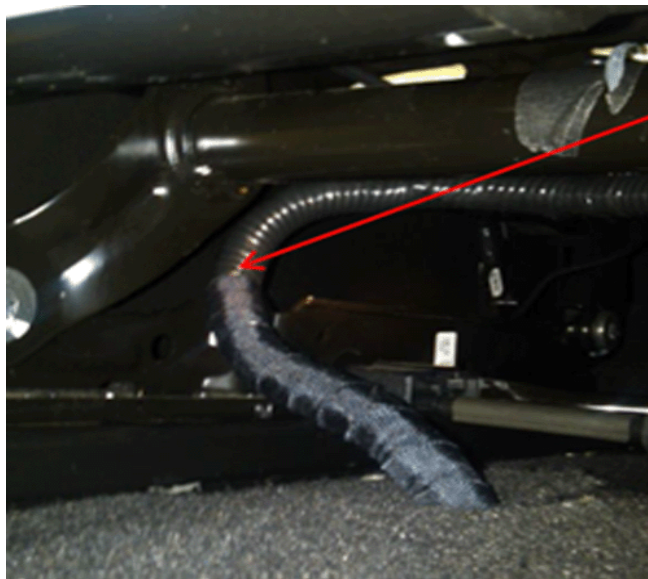
**Note:** Harness shown pinched in the height scissor.

The driver power wire harness also has other potential pinch points in areas under the driver power seat such as the height scissor, under the motor bracket and during seat installation as shown in the illustrations above.

1. Remove the seat and support the front portion up.
2. Inspect for signs of damage to the wire harness and repair the wires if necessary.

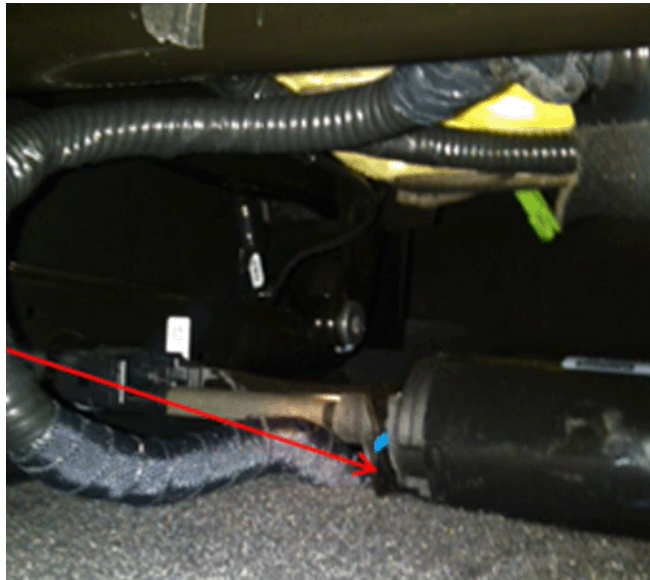
2851645

**Note:** Harness shown pinched under the motor bracket.

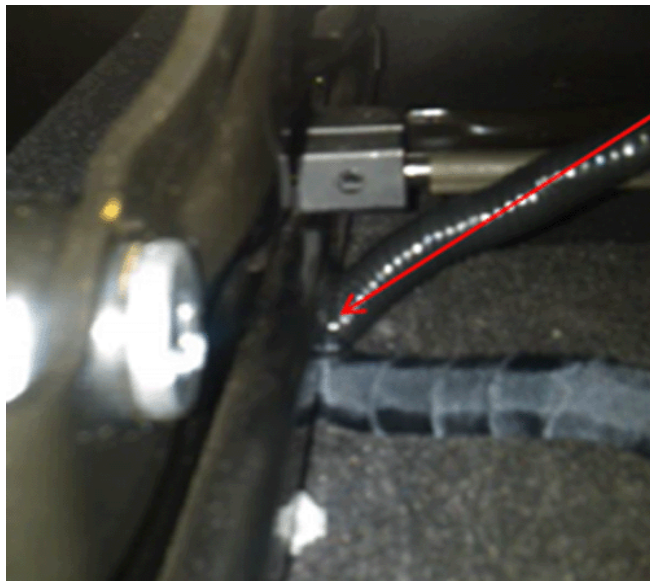
2851656

**Note:** Harness shown pinched during seat installation.

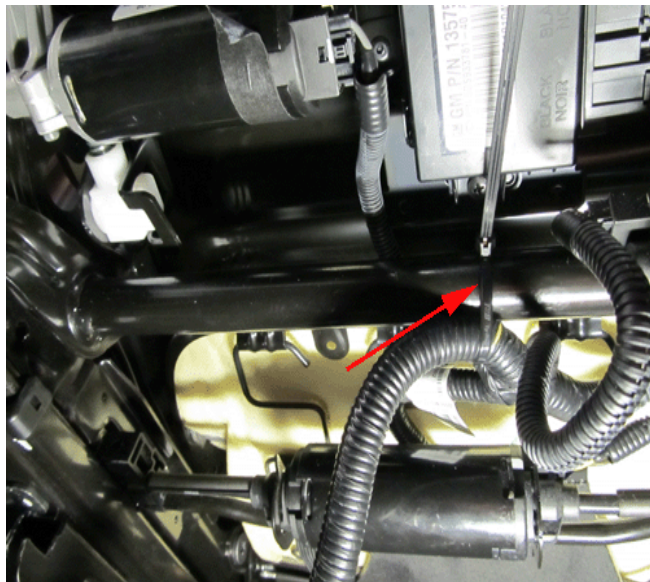
2851940

3. Using a zip tie, take the wire harness and secure tightly on the center of the cross tube, and make sure the harness is away from the three possible pinch points as shown in the illustrations above.
4. Clip the excessive strap tail.
5. Reinstall the seat.
6. Cycle the seat, forward and backward, up and down to ensure that there is a proper wire length to enable the seat to fully travel to the various possible seating positions.
