SERVICE CAMPAIGN BULLETIN

NTB12-052

VOLUNTARY SERVICE CAMPAIGN 2011 VERSA SEDAN CURTAIN AIR BAG

CAMPAIGN ID #: P1283

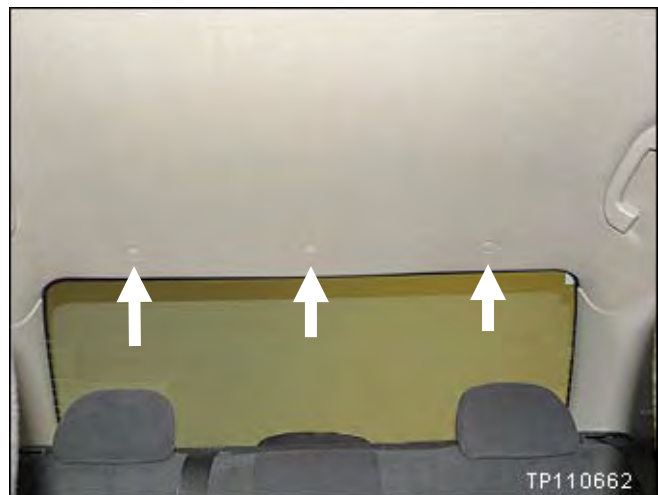
Figure 1

4. Remove the 3 headlining clips shown in Figure 1.

- Clips are located at the rear of the headlining.
- Use a plastic trim tool to pop out the clips.

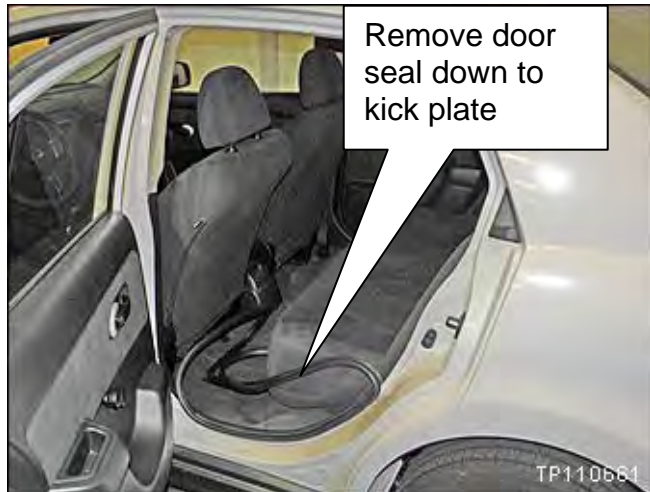
Figure 2

5. Partially remove the door seal from the rear door:
- Remove seal from top, front, and rear of door opening, down to the kick plate.

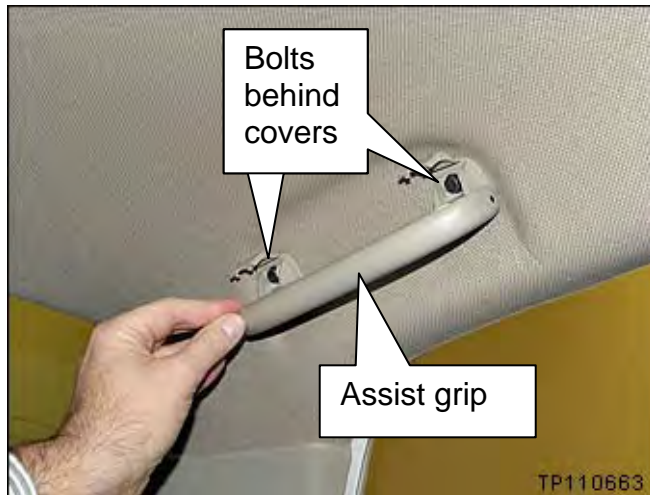
Figure 3

6. Remove the rear assist grip.
- Open the covers and remove the 2 bolts.

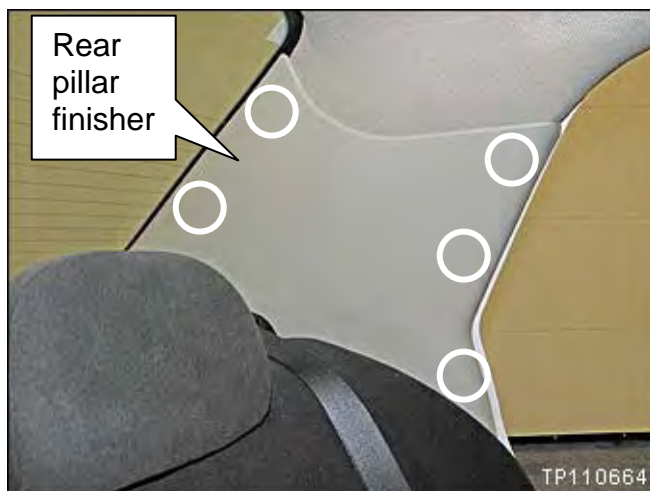
Figure 4

7. Snap loose and remove the rear pillar finisher.
- Finisher is held on with 5 clips.
 - Approximate location of the clips is shown in Figure 4.

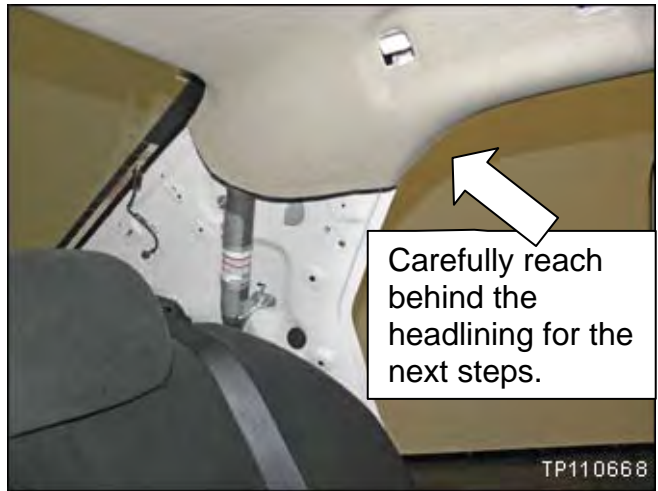
- Figure 5 shows what you will see when the rear pillar finisher is removed.
- To perform steps 8, 9, and 10 you will need to carefully reach behind / above the headlining.

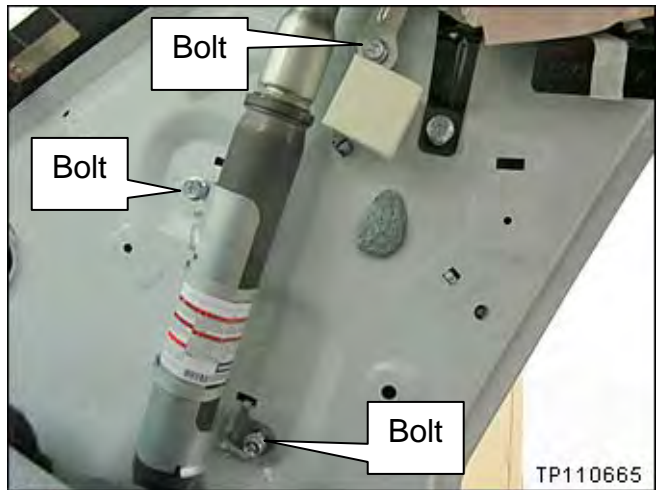
Figure 6

8. Remove the 3 air bag inflator mounting bolts shown in Figure 6.

NOTE: These bolts are one-time-use. Use new bolts for reassembly.

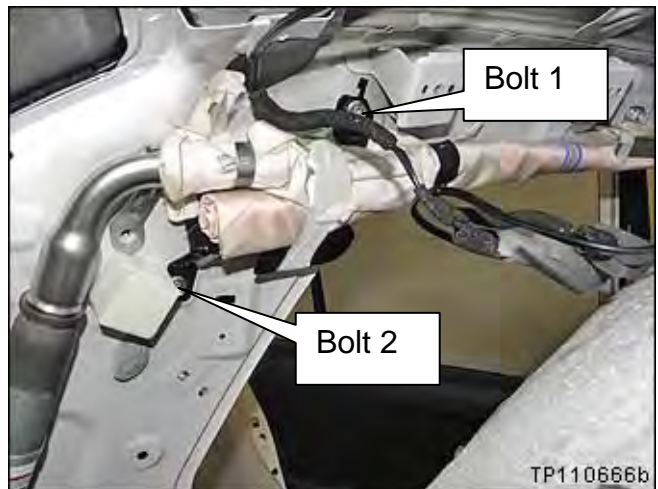
Figure 7

9. Remove the 2 air bag bracket bolts shown in Figure 7.

- These bolts are one-time-use. Use a new bolt for reassembly.
- The new bracket has only one mounting bolt. Bolt 2 location will not be used for reassembly.
- To obtain this photo the headlining was removed. You do not need to remove the headlining to access these bolts.

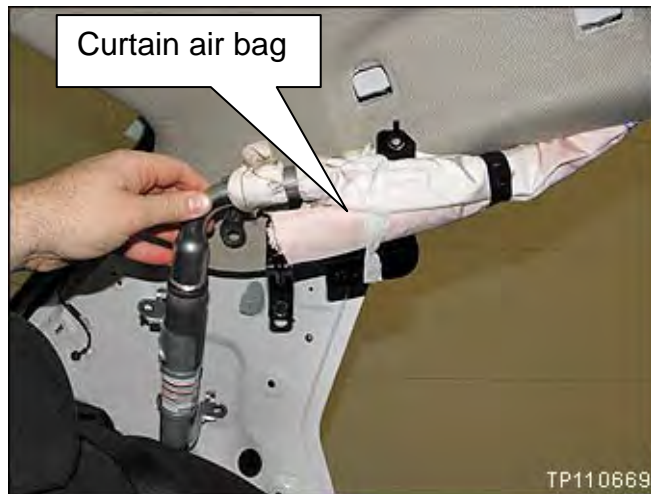
Figure 8

10. Maneuver the curtain air bag from behind the headlining as shown.

NOTE: With the air bag in this position, perform steps 11 through 16.

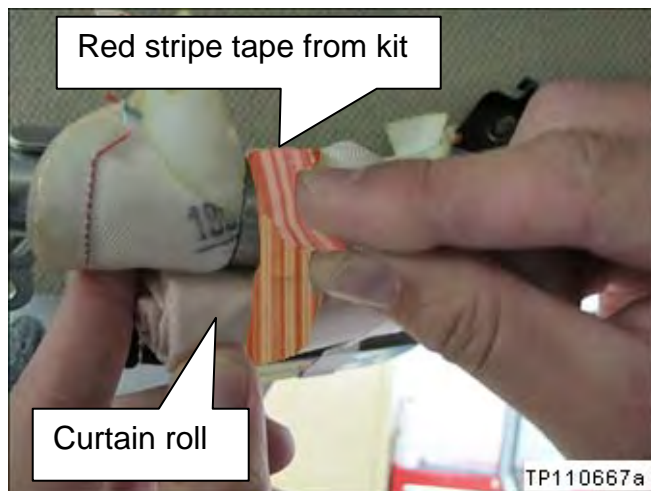
Figure 9

11. Apply tape around the end of the curtain roll as shown in Figure 9.

- Use 1 strip of red striped tape supplied with the bracket kit.
- This tape will keep the curtain from unrolling while performing the next steps.

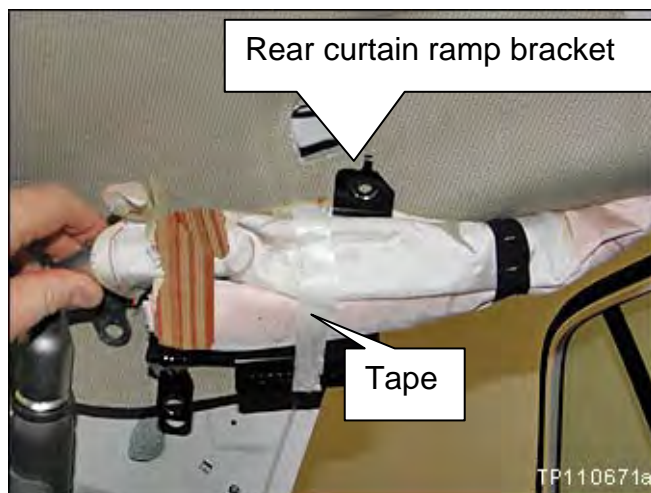
Figure 10

12. Remove tape from the rear curtain ramp bracket.

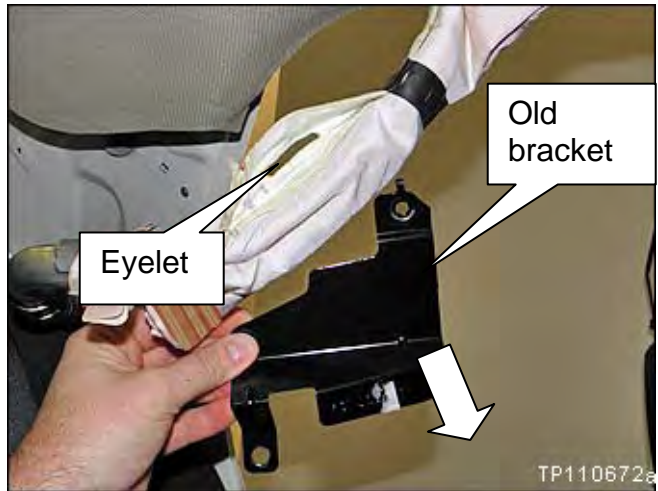
Figure 11

13. Remove the old rear curtain ramp bracket from the curtain roll eyelet.

- Do not reuse the old bracket.

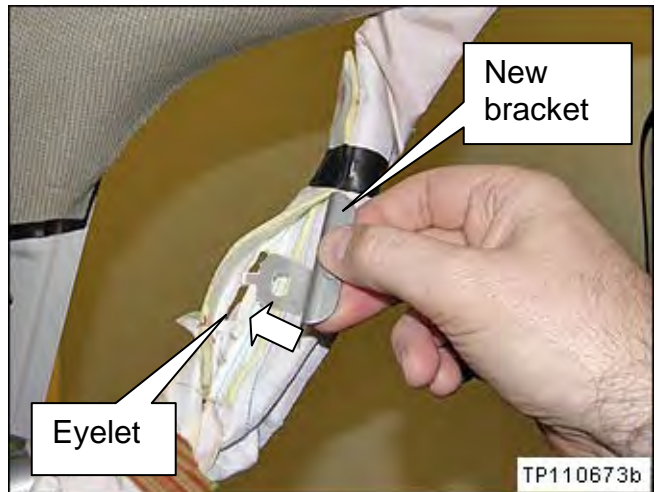
Figure 12

14. Install the new rear curtain ramp bracket into the curtain roll eyelet as shown.

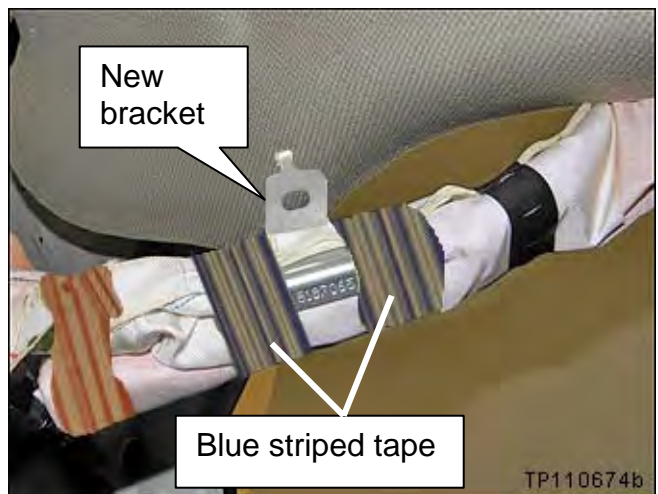
Figure 13

15. Tape the new rear curtain ramp bracket in place as shown.

- Use 2 strips of blue striped tape supplied with the bracket kit.

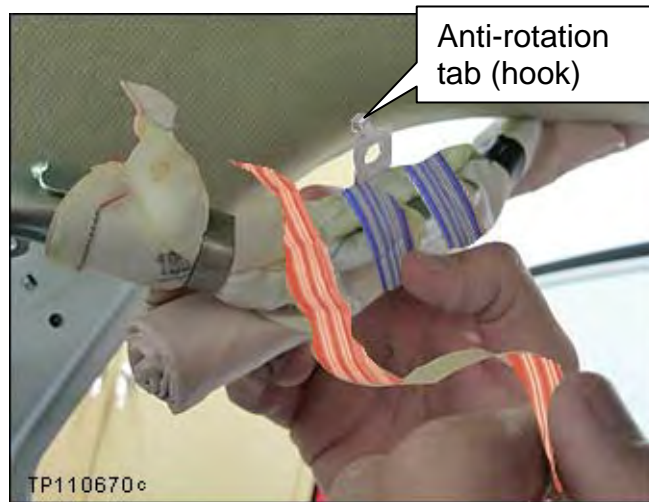
Figure 14

16. Remove the red striped tape from the end of the curtain roll.

NOTE: This is the tape you applied back in step 11.
