**MODEL:** C2

**SUBJECT:** CHASSIS PDM POWER CABLE CHAFING

**DATE:** JUNE 29, 2012

**BULLETIN:** 13

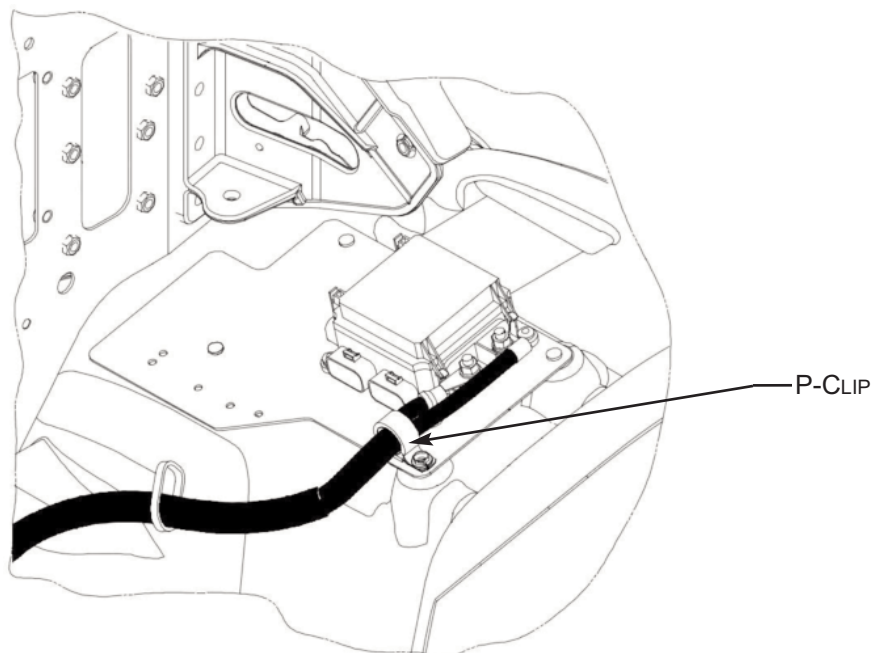
FIGURE 1

**Inspection:** Check the unit for the presence of a P-Clip as shown in Figure 1. If P-Clip is present, no further action is required.

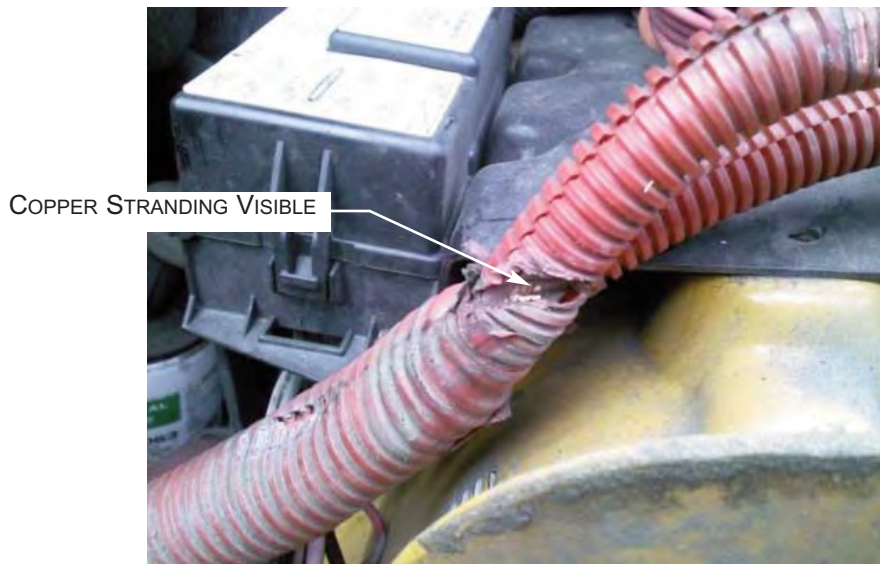
**FIGURE 2**

1. Make sure the ignition is in the "Off" position. Chock the tires and disconnect the batteries.
2. Inspect the Chassis PDM power cable for chafed insulation. The harness loom may need to be pulled back for proper inspection. Check the top and bottom of the cable insulation for visible signs of copper stranding.

- 3.1 If no copper is visible and the insulation is adequately protecting the power cable, proceed to step 7.
- 3.2 If the insulation has been damaged with copper stranding visible, continue to step 4.
- 3.3 If the insulation and copper stranding have been damaged, replace the cable and proceed to step 7.
4. Protect the open copper strands by applying heat-shrink over the damaged insulation. Disconnect the cable with damaged insulation from the Chassis PDM. Pull back the cable loom to access damaged cable insulation.

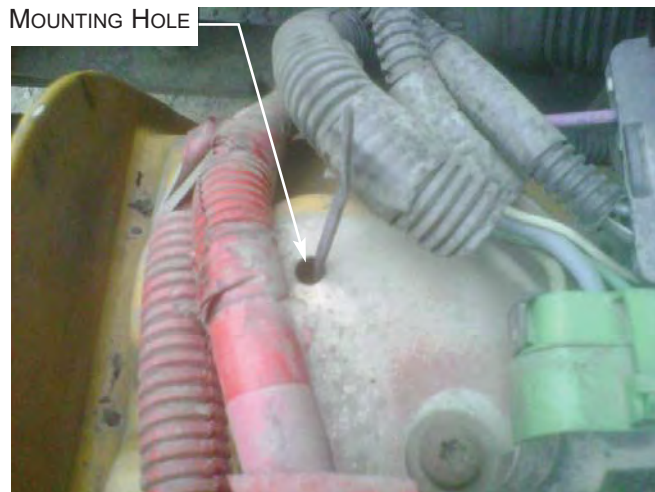
FIGURE 3

7. Locate the unused hole in the PDM mounting plate close to the power cable. **Figure 3**
8. Open the P-Clip (TBB 61480924) and install around the chassis PDM power cable that is closest to the unused hole. **Figure 4**

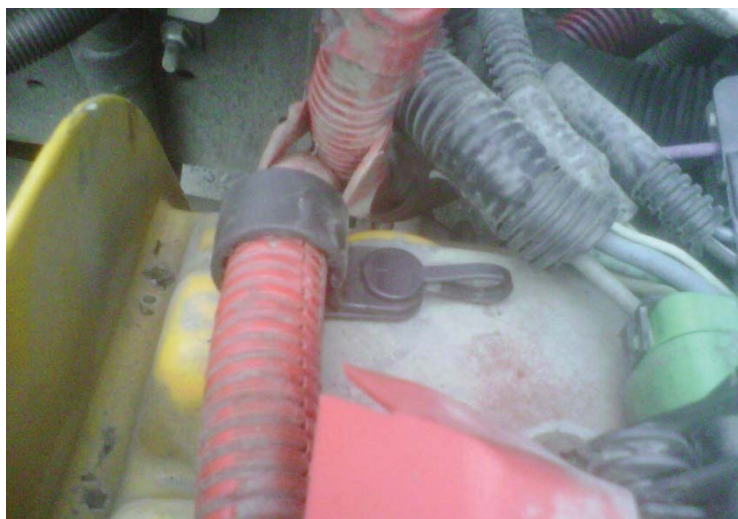
FIGURE 5

9. With the locking pin still hanging loose on its tether, push the mounting barb completely into the hole in the chassis PDM mounting plate.
10. Once the P-Clip and power cable are positioned correctly, fully install the locking pin through both tabs of the P-Clip. The locking pin will close the P-Clip and expand the mounting barb locking it to the plate. **Figure 5**

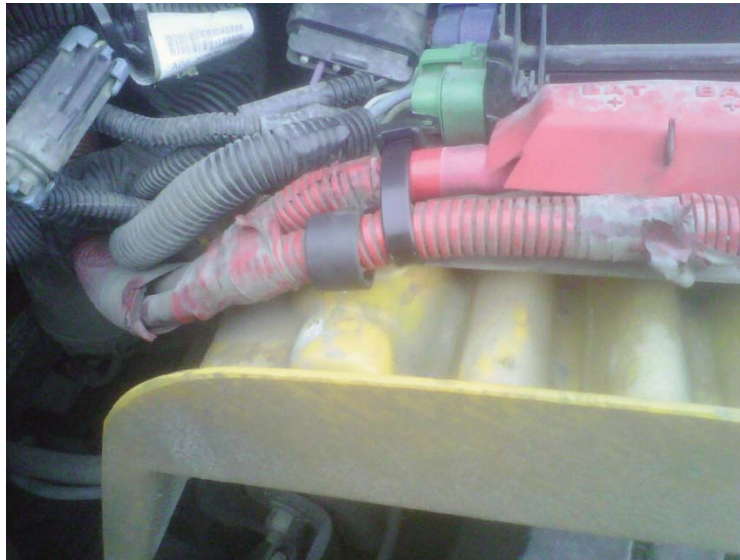
**FIGURE 6**

11. Use the Tie Wrap (TBB 61370022) to secure the second chassis PDM power cable to the first now retained by the P-Clip. When the second power cable is positioned correctly, tighten the tie wrap and trim off the excess tail. **Figure 6**
