MODEL: C2

SUBJECT: CHASSIS PDM POWER CABLE CHAFING

INDEX: C2 12

BULLETIN: 13

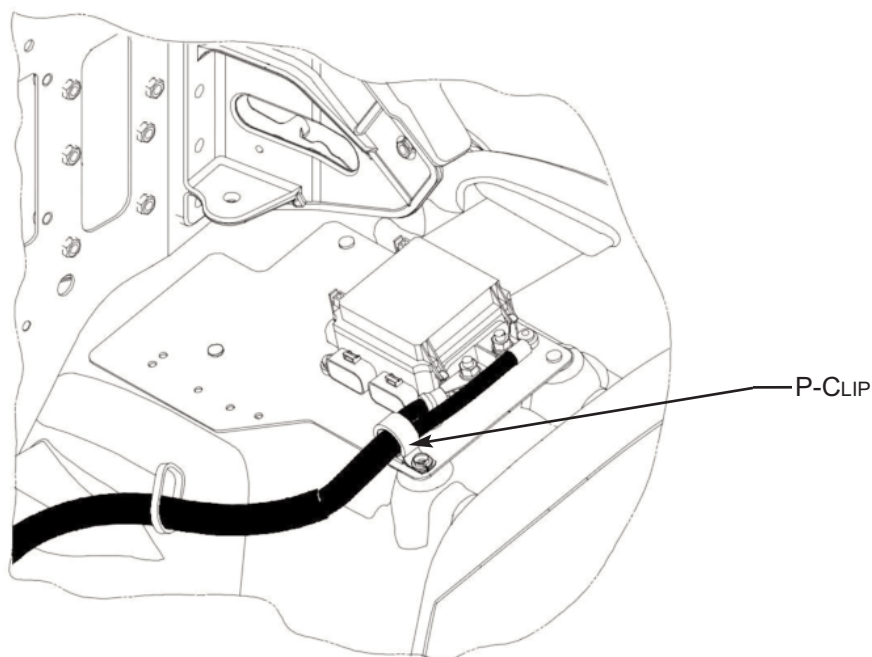
FIGURE 1

Inspection: Check the unit for the presence of a P-Clip as shown in Figure 1. If P-Clip is present, no further action is required.

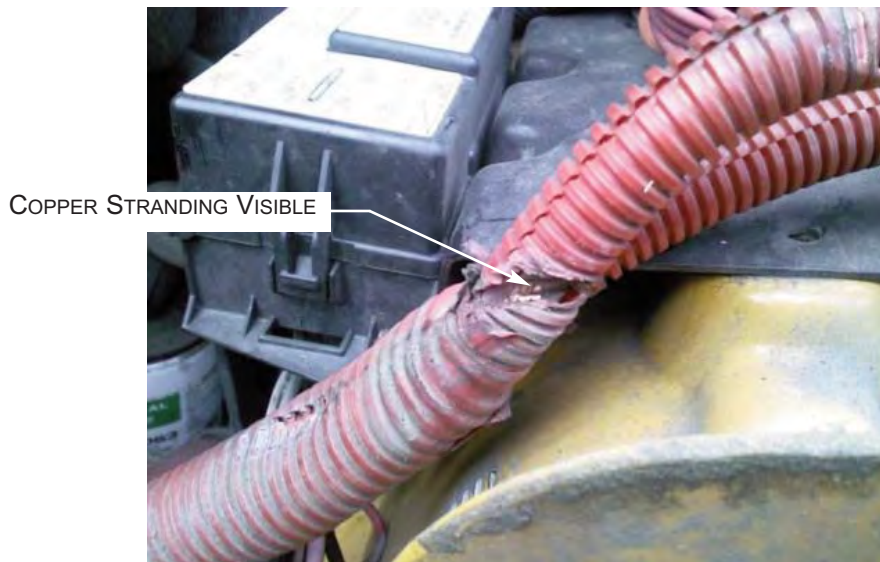
**FIGURE 2**

1. Make sure the ignition is in the "Off" position. Check the tires and disconnect the batteries.
2. Inspect the Chassis PDM power cable for chafed insulation. The harness loom may need to be pulled back for proper inspection. Check the top and bottom of the cable insulation for visible signs of copper stranding.

- 3.1 If no copper is visible and the insulation is adequately protecting the power cable, proceed to step 7.
 - 3.2 If the insulation has been damaged with copper stranding visible, continue to step 4.
 - 3.3 If the insulation and copper stranding have been damaged, replace the cable and proceed to step 7.
4. Protect the open copper strands by applying heat-shrink over the damaged insulation. Disconnect the cable with damaged insulation from the Chassis PDM. Pull back the cable loom to access damaged cable insulation.

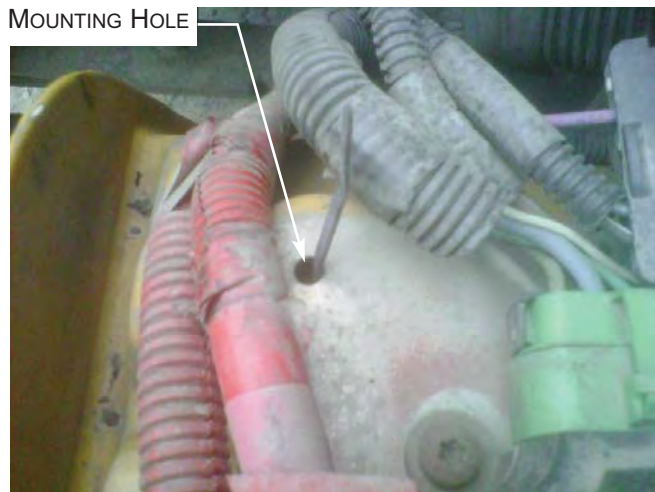
FIGURE 3

7. Locate the unused hole in the PDM mounting plate close to the power cable. **Figure 3**
8. Open the P-Clip (TBB 61480924) and install around the chassis PDM power cable that is closest to the unused hole. **Figure 4**

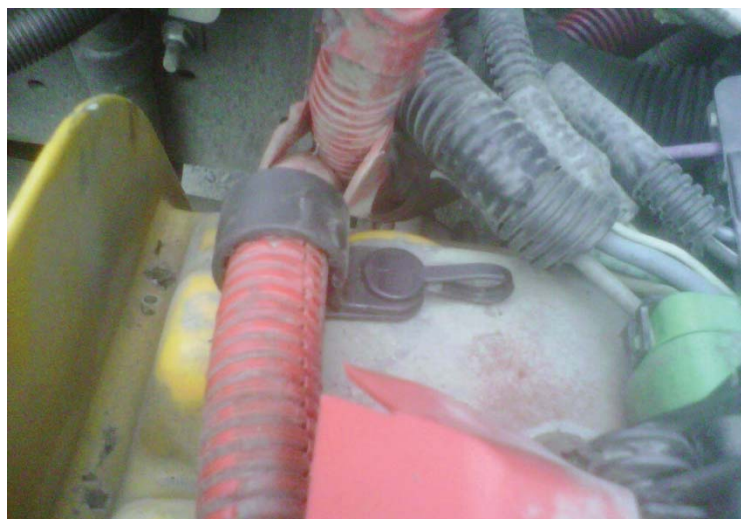
FIGURE 5

9. With the locking pin still hanging loose on its tether, push the mounting barb completely into the hole in the chassis PDM mounting plate.
10. Once the P-Clip and power cable are positioned correctly, fully install the locking pin through both tabs of the P-Clip. The locking pin will close the P-Clip and expand the mounting barb locking it to the plate. **Figure 5**
