Service Bulletin

Bulletin No.: PI0750

Subject: Power Steering Hose Design Change

Models: 2012 Chevrolet Impala

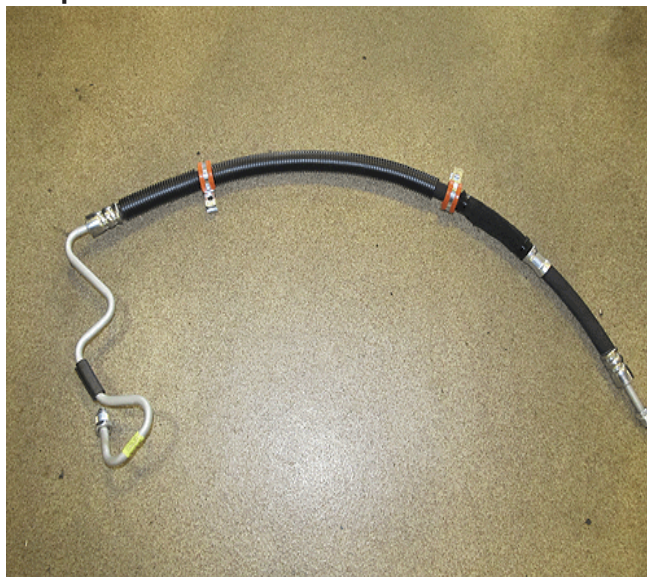
2832539

The purpose of this document is only to provide technicians instructions for installing a new power steering gear inlet hose, when necessary, due to a mid-year design change. This procedure should not be performed unless the vehicle has a first design, dual line hose that has failed and requires replacement.

Vehicles built from 2012 model year start of production until February 13, 2012 with VIN C1244911 were built with a dual line hose and a cradle that had no specific attaching points or provisions for the hose. Vehicles built after this breakpoint have an updated cradle with factory holes and attaching nuts in the cradle to accommodate the new design hose. The design change was made to the hose starting on March 26, 2012 with VIN C1278238. Vehicles built after this point are equipped with the latest design cradle and hose. Vehicles built between the two breakpoints may have a first or second design hose. If a vehicle has a dual line hose that requires replacement and has no factory holes and nuts in the cradle, please follow the procedure below.

The newly designed hose is a single hose that will need to be mounted to the cradle with bolts listed in the parts information table. DO NOT use the bolts that come with the production hose. Those are not self-tapping bolts and are meant for use on vehicles with the second design cradle. Remove and discard and use the bolts provided in the parts information table.

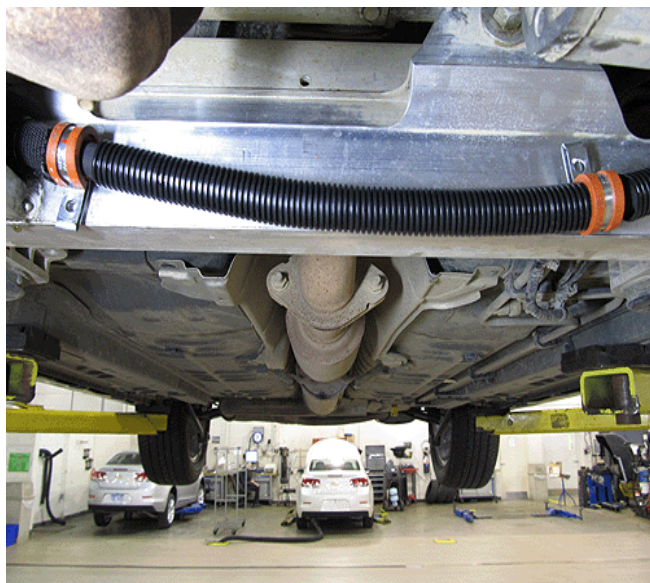
Figure 1

7. Install new power steering hose and connect to the steering gear.

Tighten to 34 N•m (25 lb ft).

8. Connect the power steering hose to the steering pump.

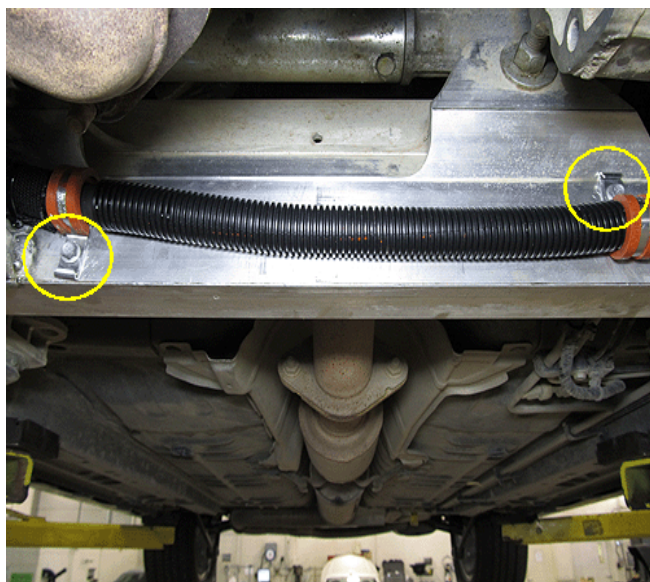
Figure 2

9. Line up the power steering hose clamp edges at the top and bottom edges of the cradle (as shown in Figure 2) and mark the placement of the holes with a punch.

Important: Make sure the new hose does not hang below the cradle. Also be sure that the clamp placement keeps the hose itself clear of any hard contact or rubbing on any parts of the cradle or other components.

10. Drill two 5.5 mm holes where the clamps will be bolted to the cradle.
