SUBJECT: Service Update for Inventory and Customer Vehicles
Loose Water Pump Pulley
Expires with Base Warranty

MODELS: 2012 Chevrolet Silverado
2012 GMC Sierra
Equipped with 4.3L V6 Engine (LU3)

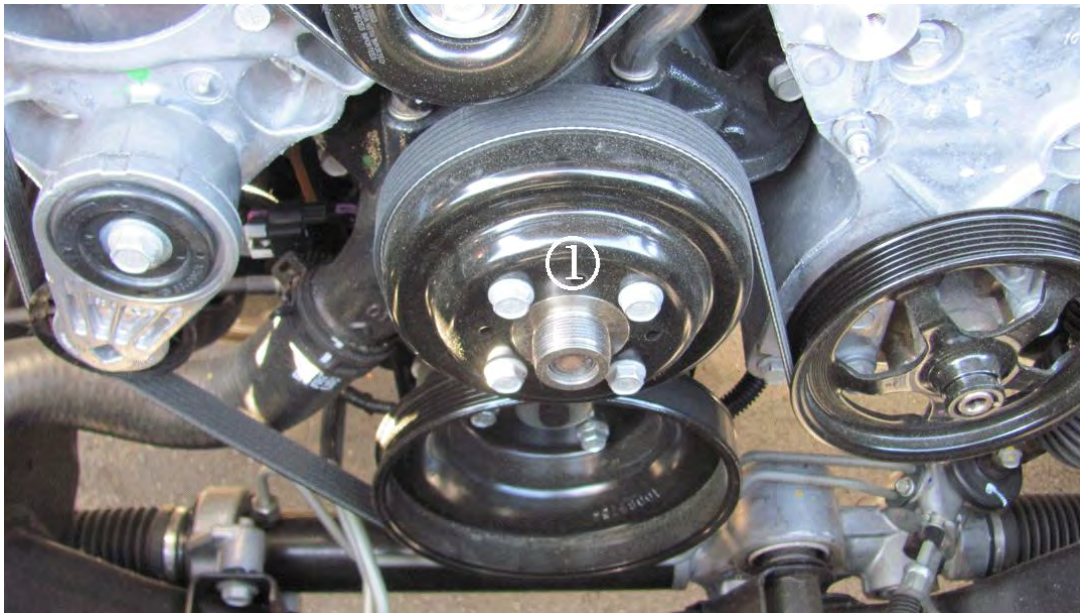
2864907

This bulletin provides a service procedure to verify that the 4 water pump pulley bolts are present and torqued to the proper specification on **certain** 2012 model year Chevrolet Silverado and GMC Sierra vehicles, equipped with a 4.3L V6 engine (LU3). If the bolts are not properly tightened, the bolts could back out or break.

1. Locate the water pump pulley (1).

Note: Replace missing or damaged pulley bolts if required.

2. Verify that the four pulley bolts are present and tightened to 25 N m (18 lb-ft).
